# Damage due to Earthquakes and Improvement of Seismic Performance of Reinforced Concrete Buildings in Japan

Prof. Maeda Masaki  
Tohoku University

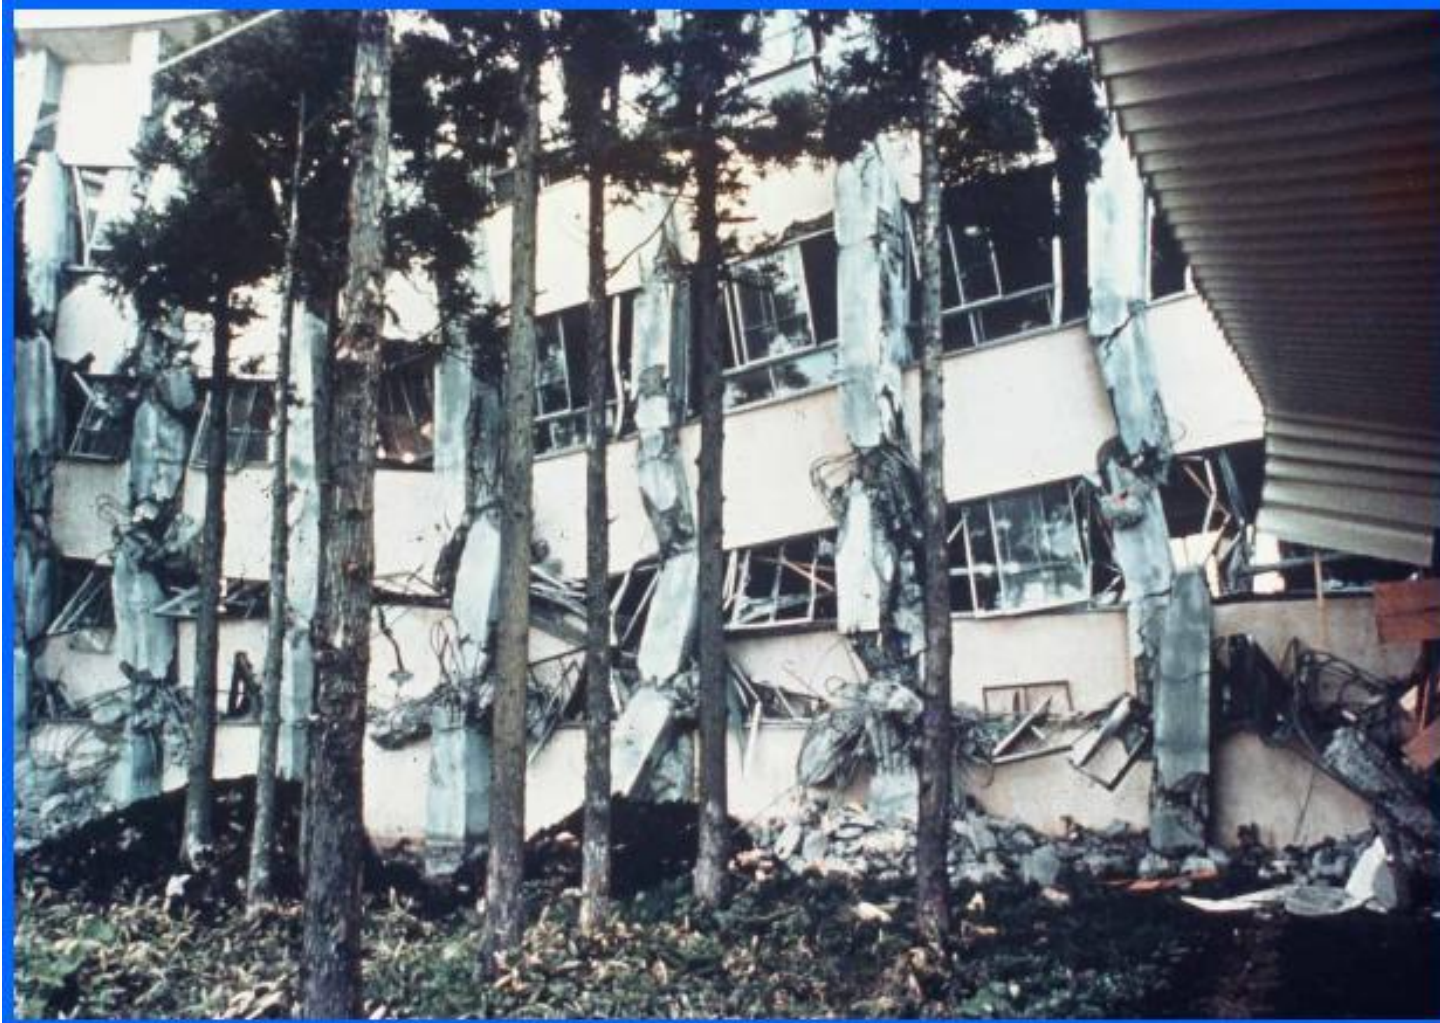
(1968 Tokachi –oki EQ)

# Damage to RC Buildings

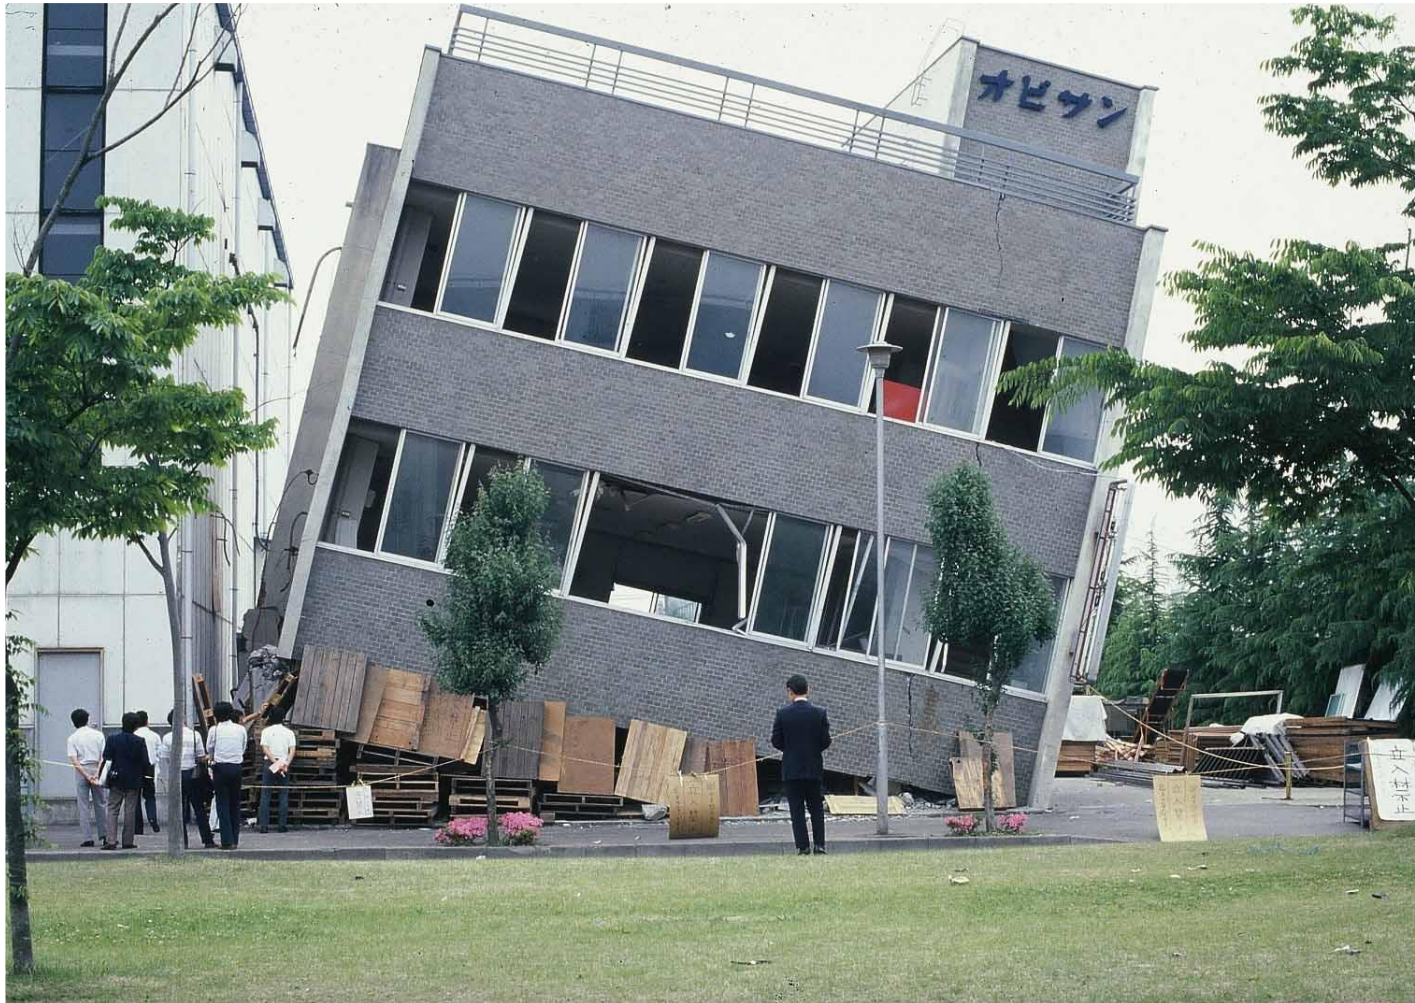
# Damage to RC Buildings (1978 Miyagiken-oki EQ)

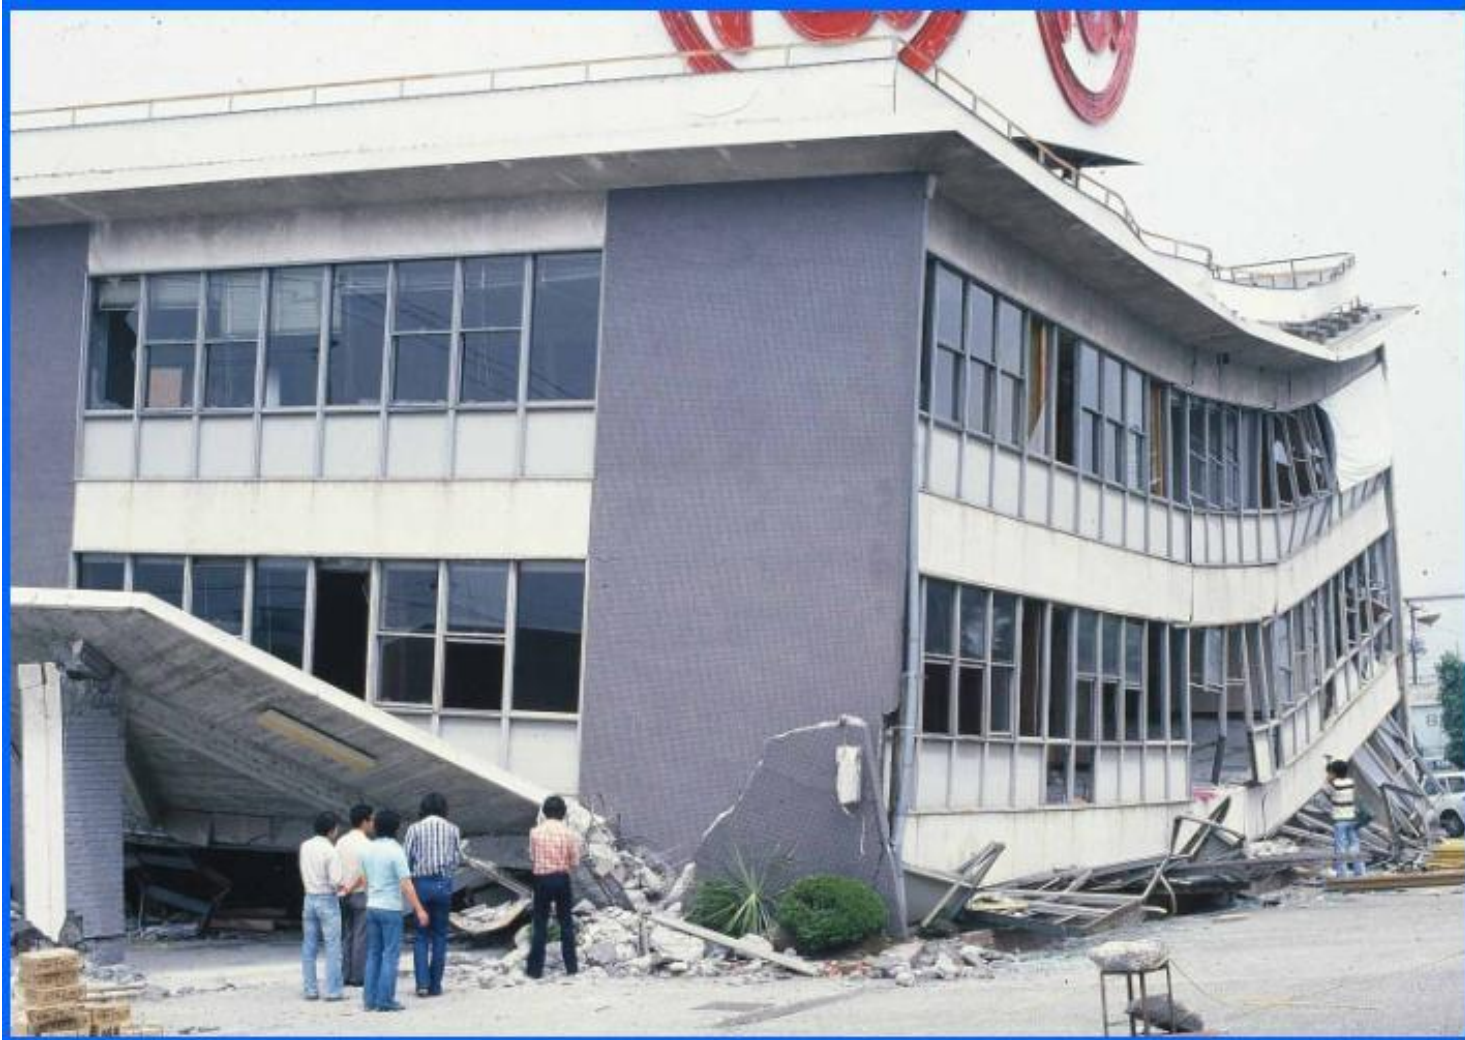
# Damage to RC Buildings (1978 Miyagike-oki EQ)

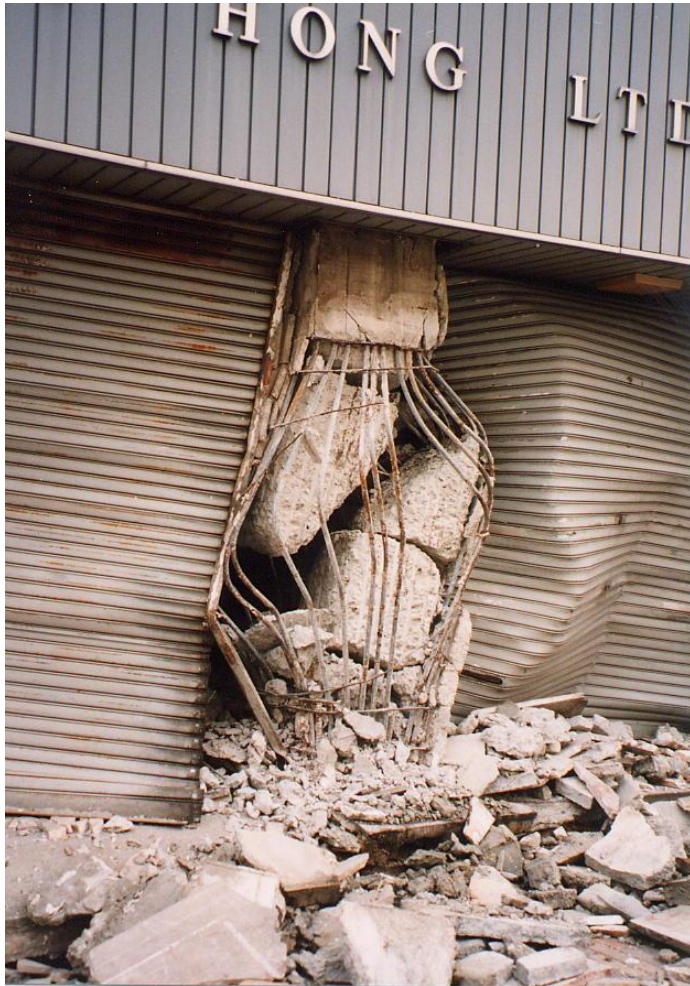
# Damage in old and new Buildings

Few hoops (pre-1971)

Hoop spacing is 10cm (Post-1971)

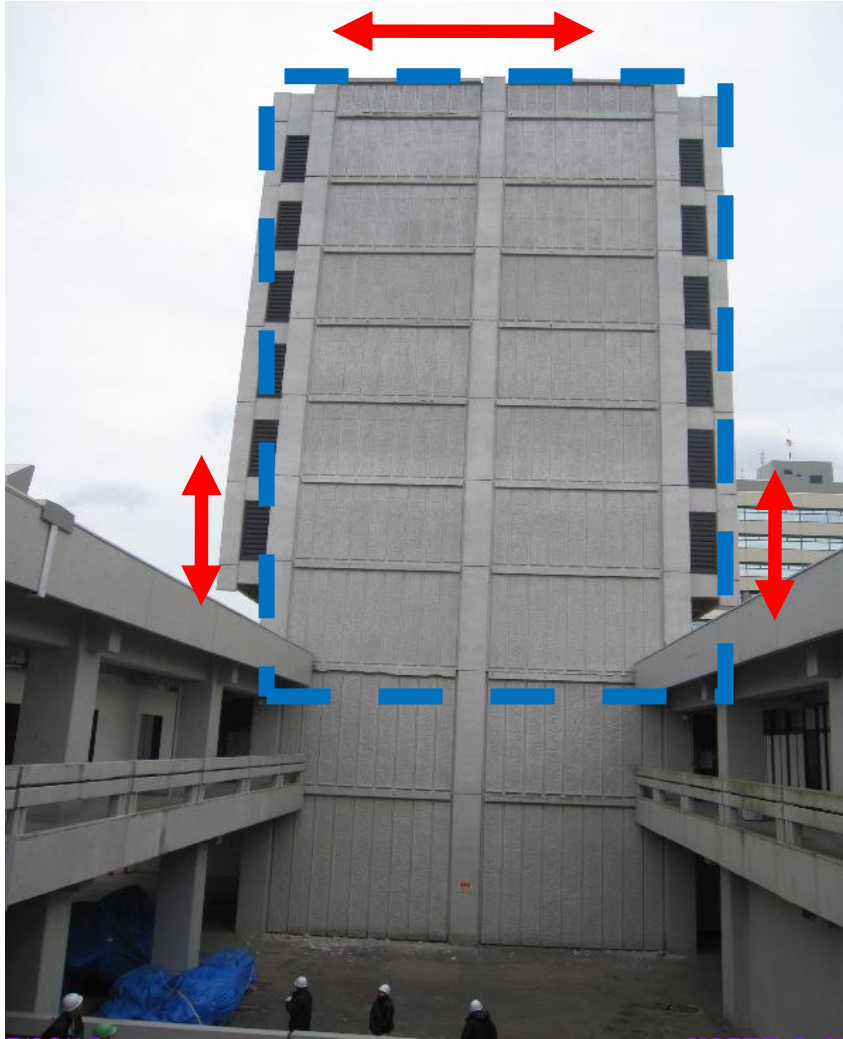
# Damage to Building of civil eng.

- ◆ 3<sup>rd</sup> story was most severely damaged.
- ◆ Large displacement occurred in shear wall.
- ◆ Spalling and crush of concrete, fracture and buckling of rebars are observed in corner columns.

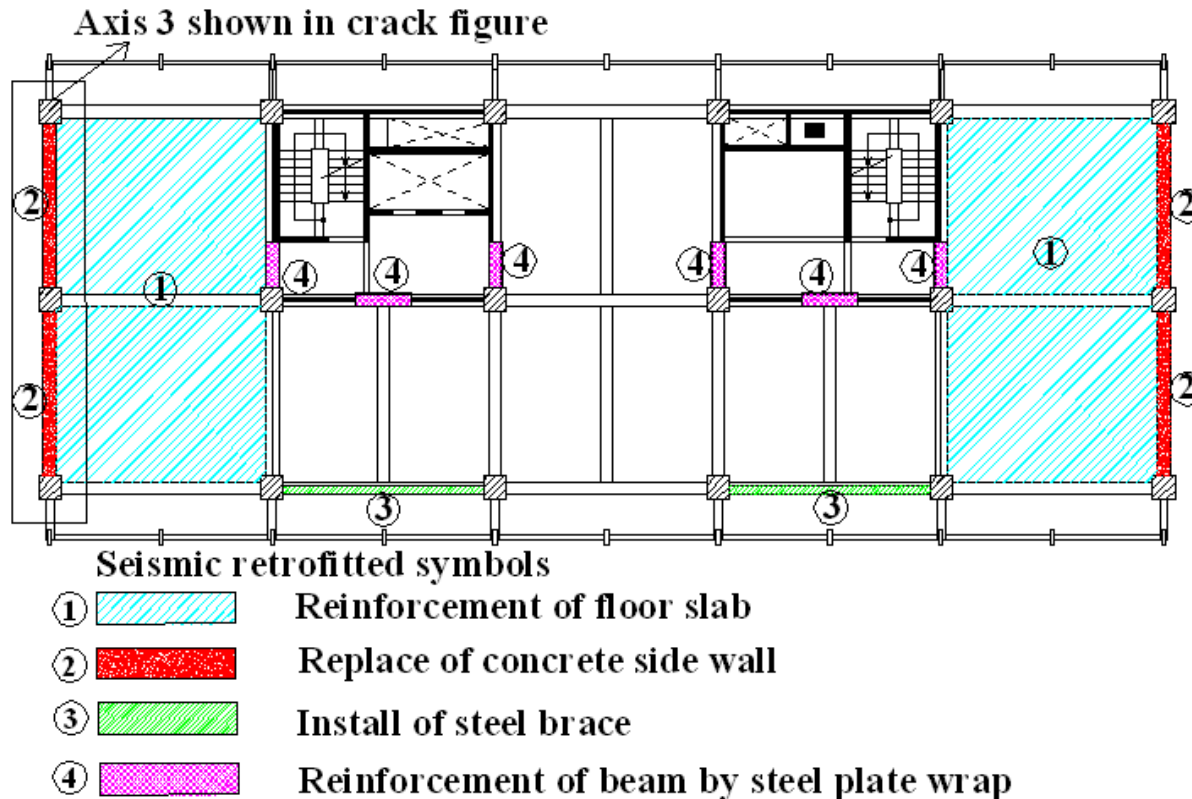
# 3<sup>rd</sup> floor plan and seismic retrofit

- ◆ Damage levels are classified by residual seismic capacity ratio  $R$ .
- ◆ Correlation between damage level and  $I_s$ -index are observed.

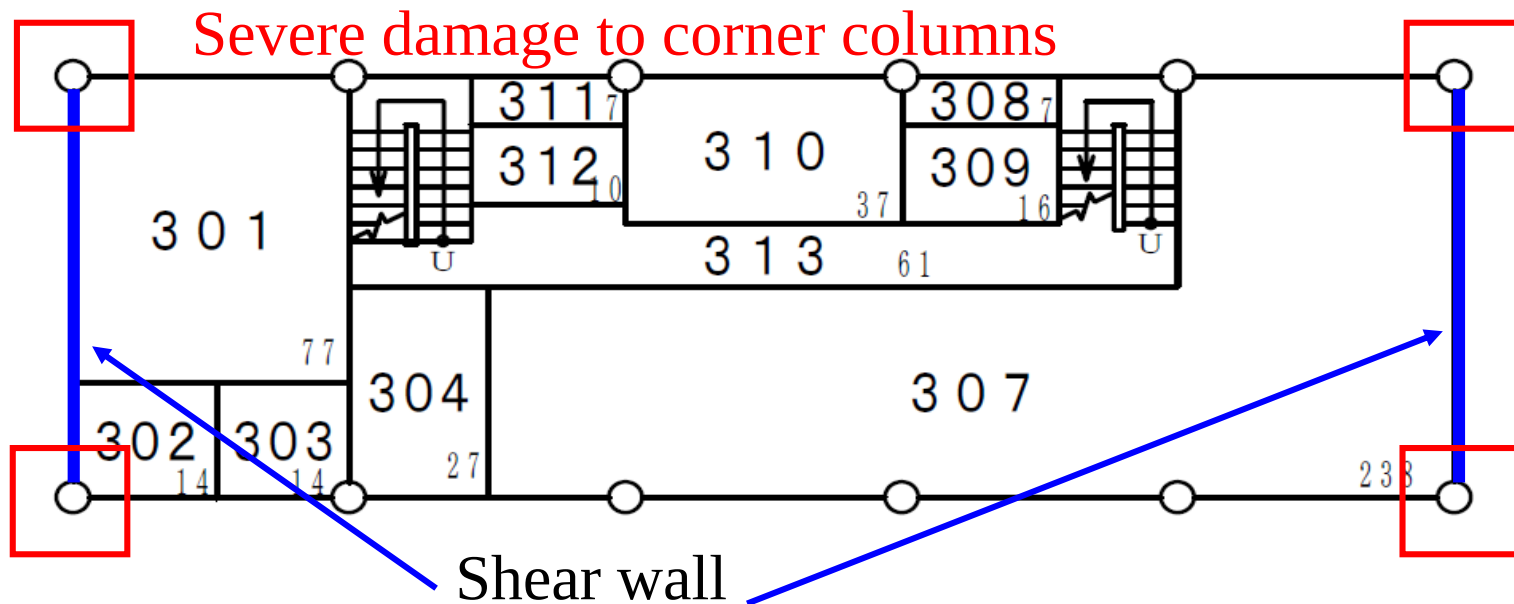
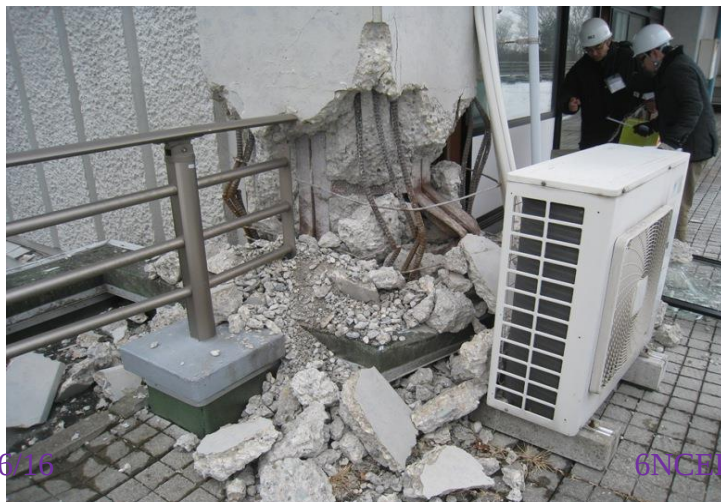
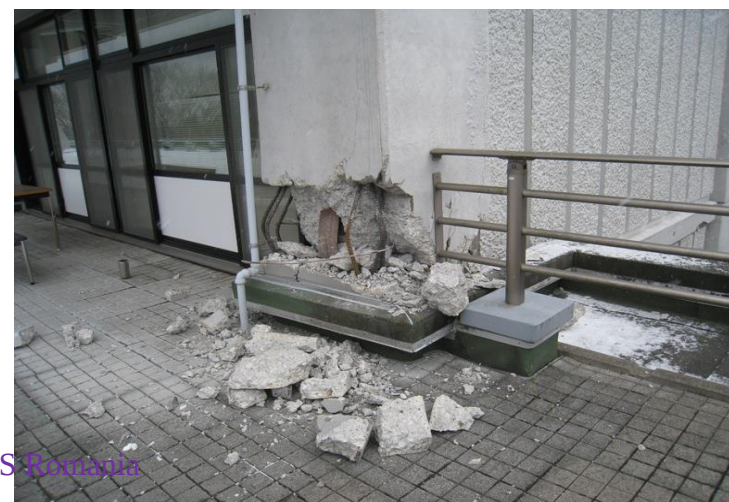
# Damage to columns in 3<sup>rd</sup> story

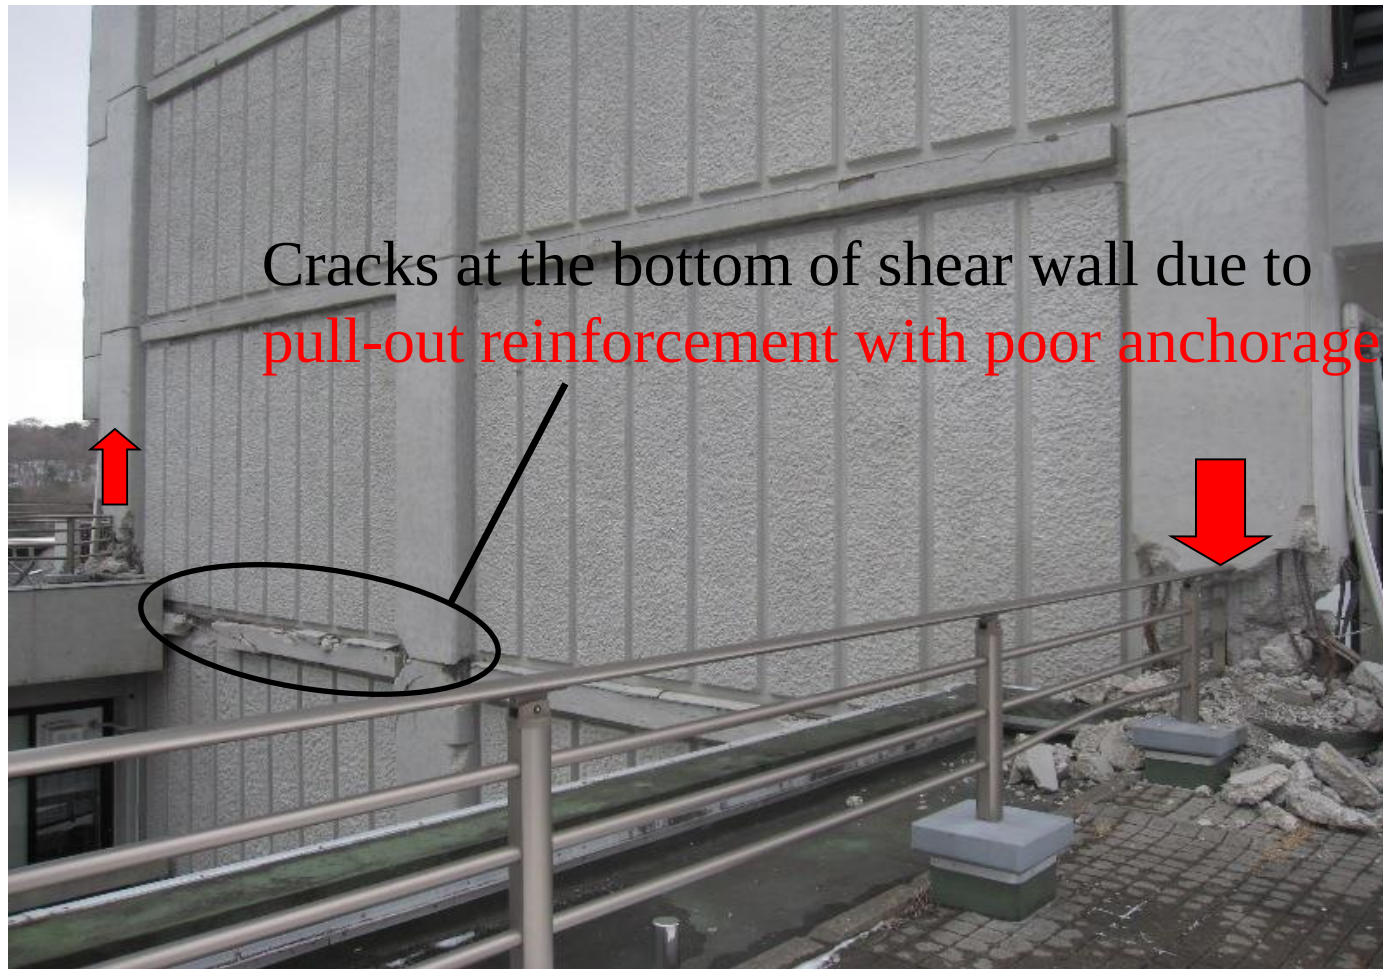
# Damage to shear wall and columns in 3<sup>rd</sup> story

High axial load in column due to overturning moment

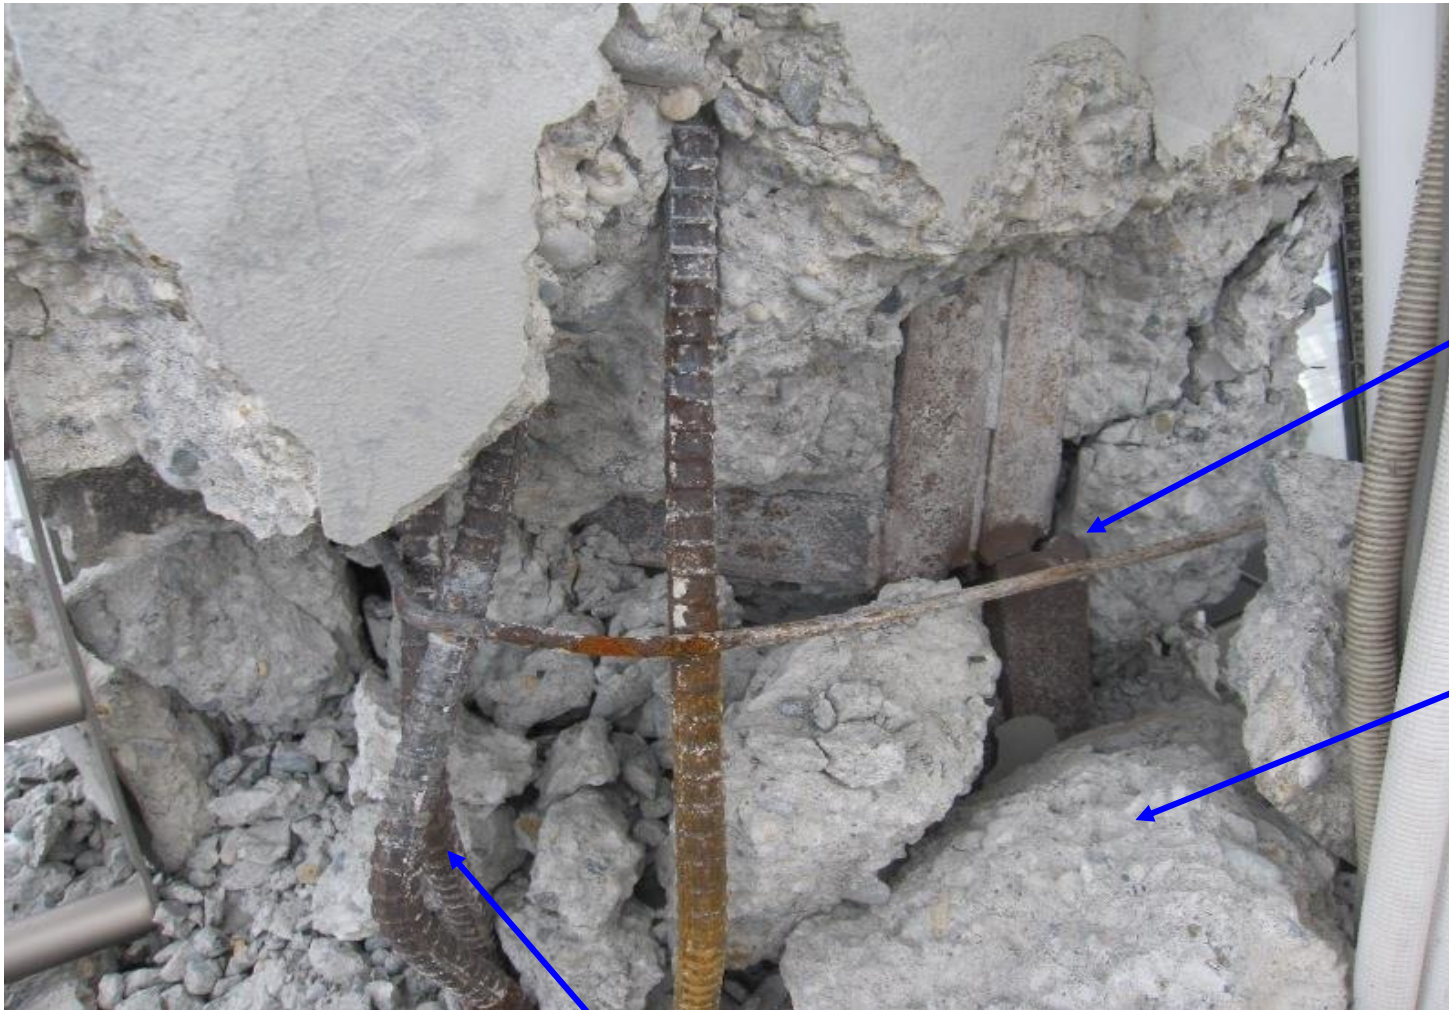
# Damage to corner columns in 3<sup>rd</sup> story

Fracture of steel

Crush of concrete

Buckling

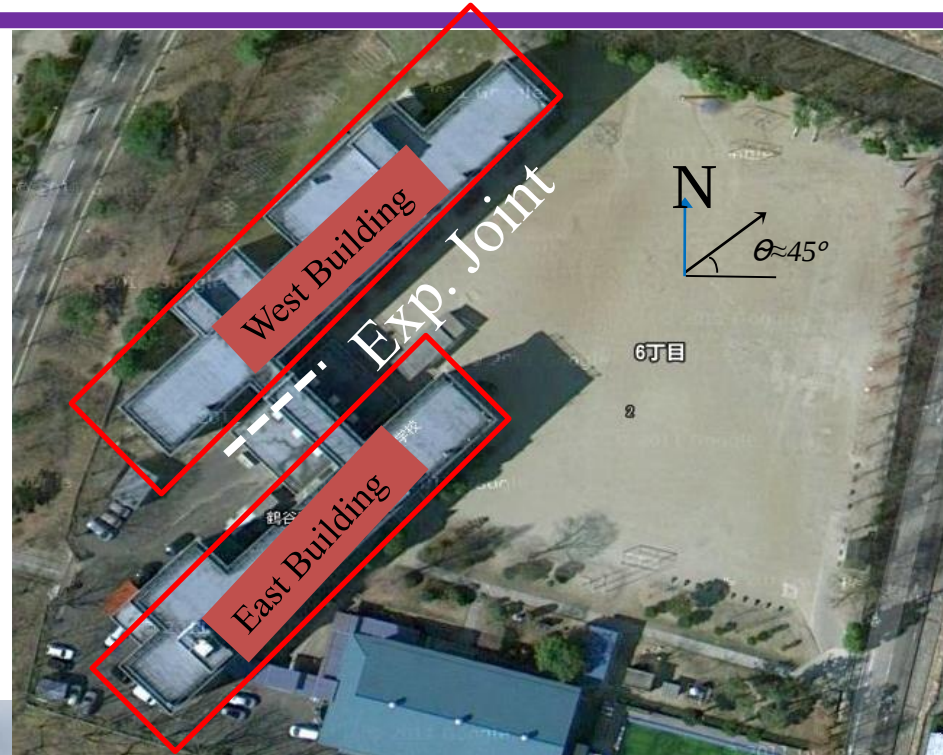
◆ West side structure

$I_s = 0.8 > I_{s0}(\text{required})$

**moderate** damage

◆ East side structure

Seismically retrofitted

**slight** damage

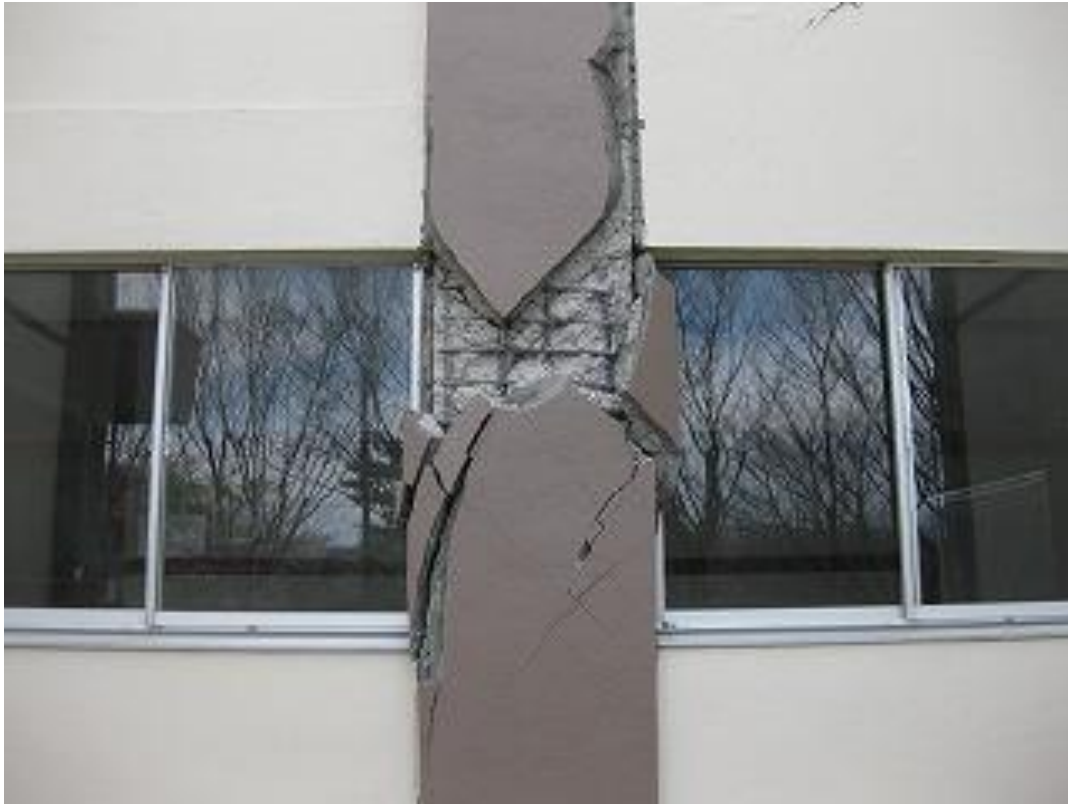
# Shear failure of column and wall observed in un-retrofitted west building

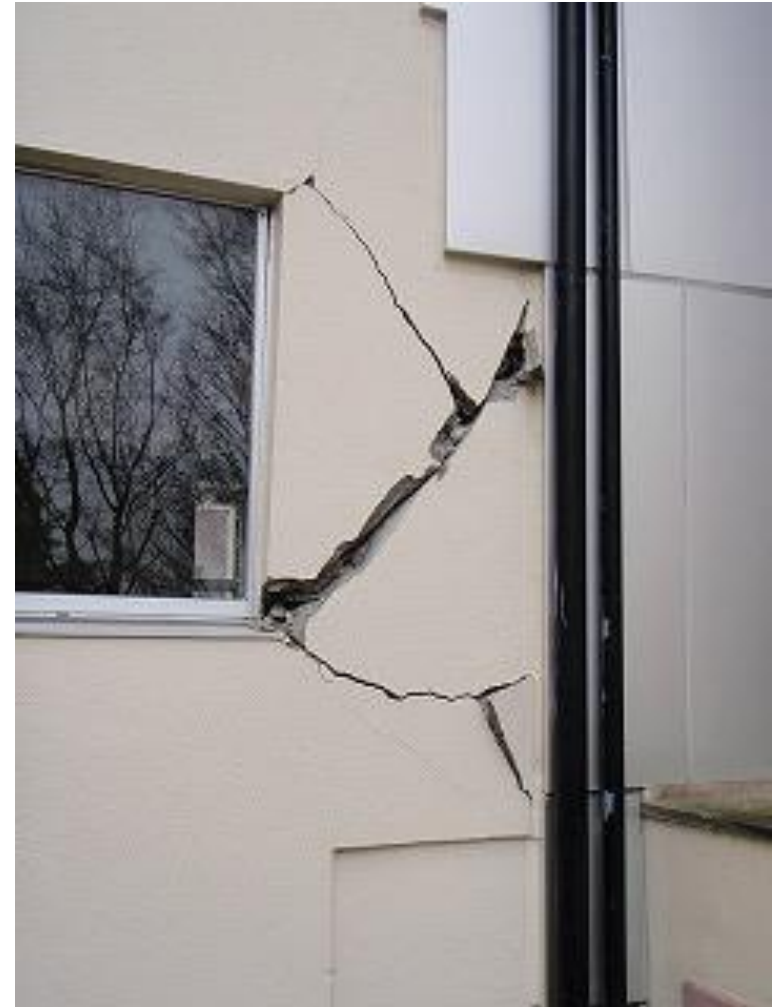
Short column failed in shear

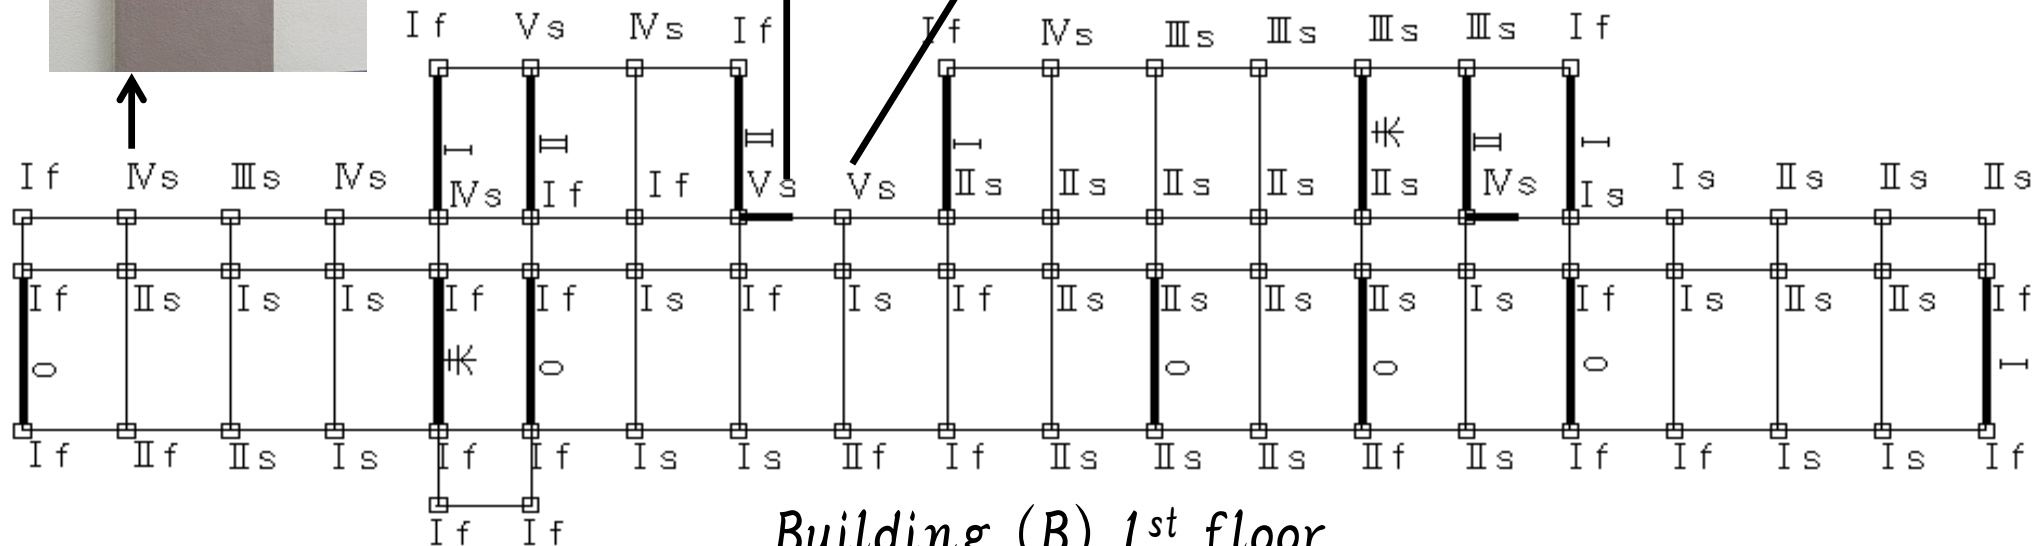
Building (B) 1<sup>st</sup> floor

# Damage distribution in west building

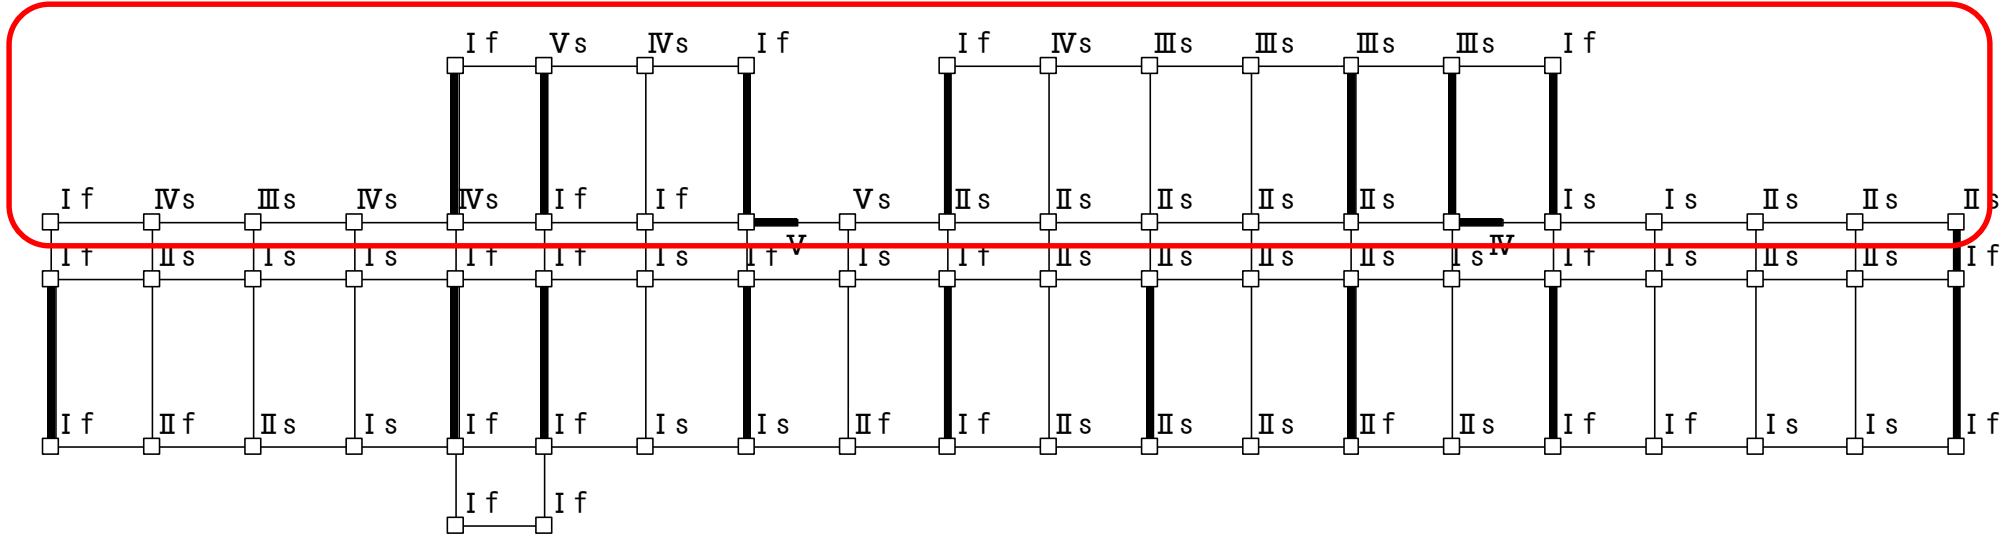
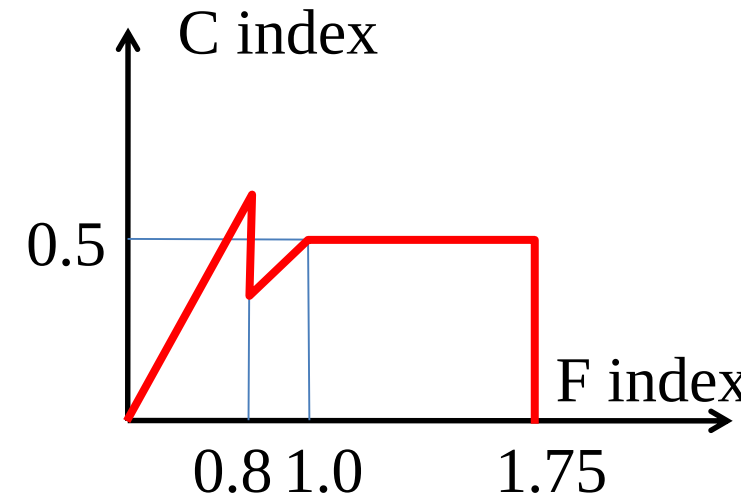
- ◆ Damage was concentrated to short columns in North side corridor.
- ◆  $I_s = \text{strength index} \times \text{ductility} = C \times F = 0.5 \times 1.75 = 0.875$  by ignoring brittle short column.
- ◆ The damage pattern agree with seismic evaluation results.

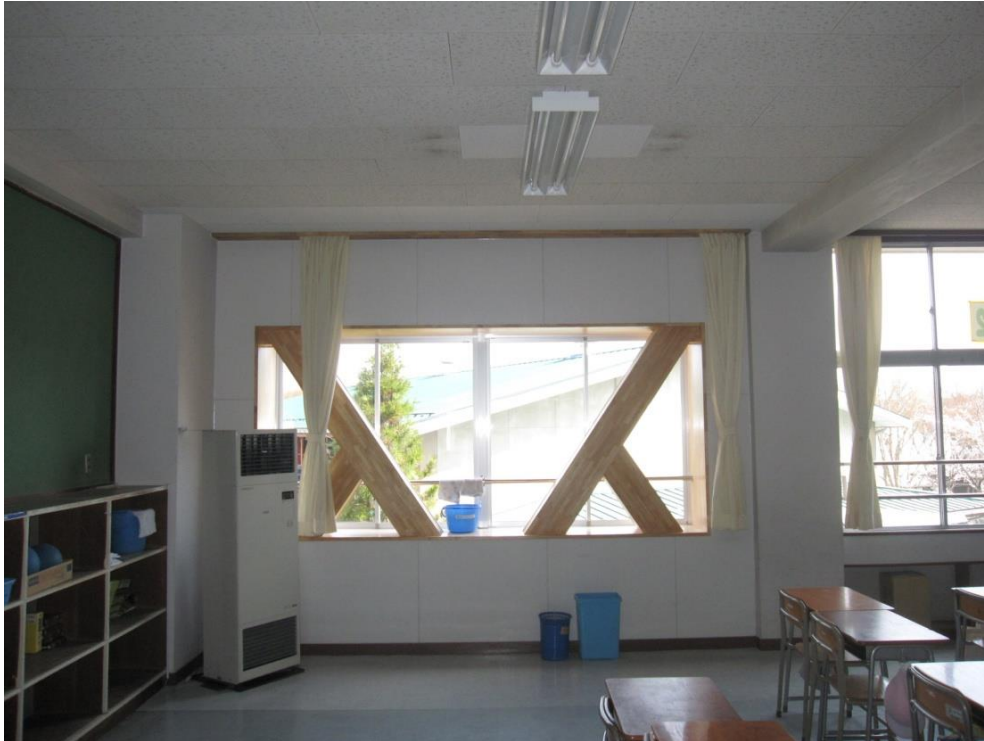
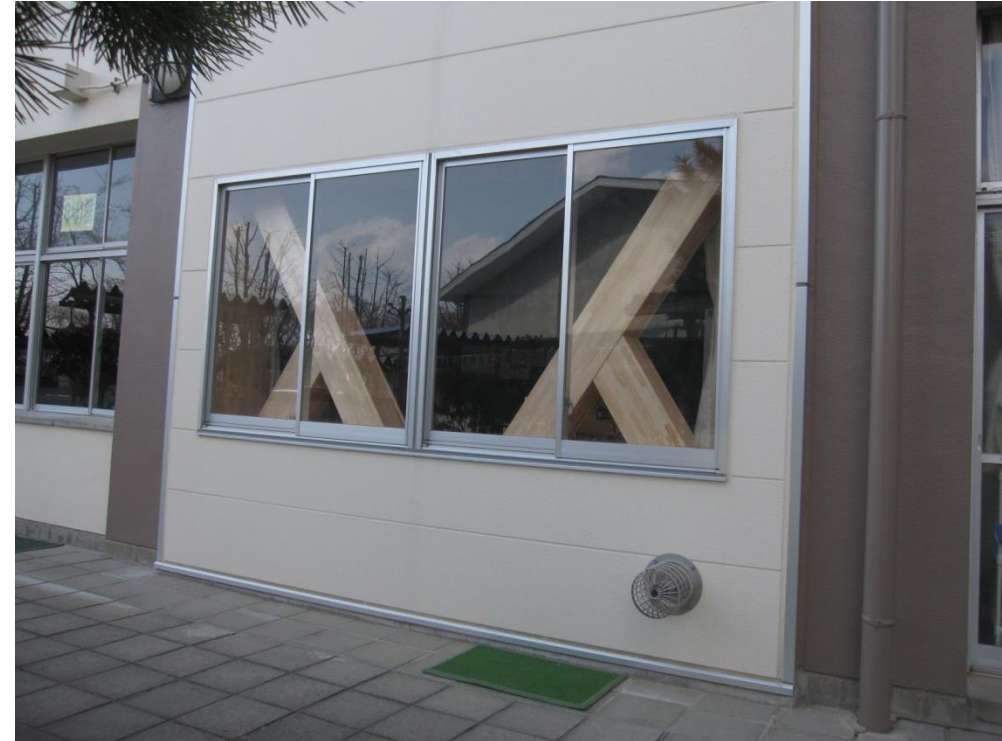
# Less damage to retrofitted building

Seismically retrofitted by steel bracing

Effect of seismic retrofit was observed

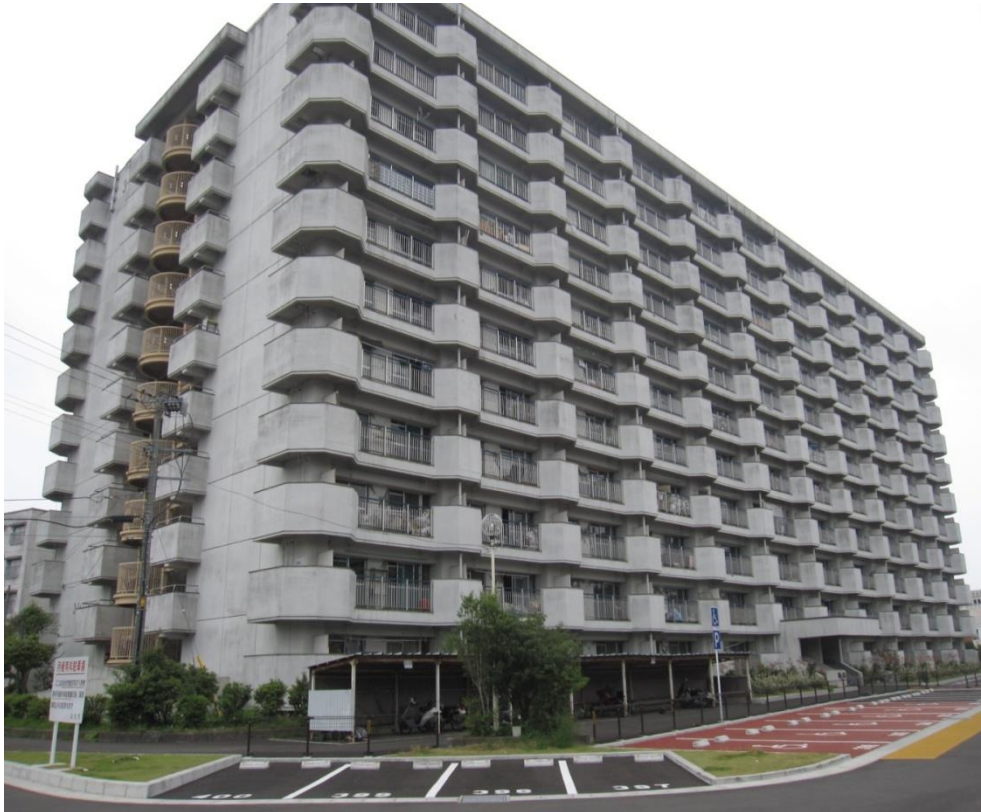
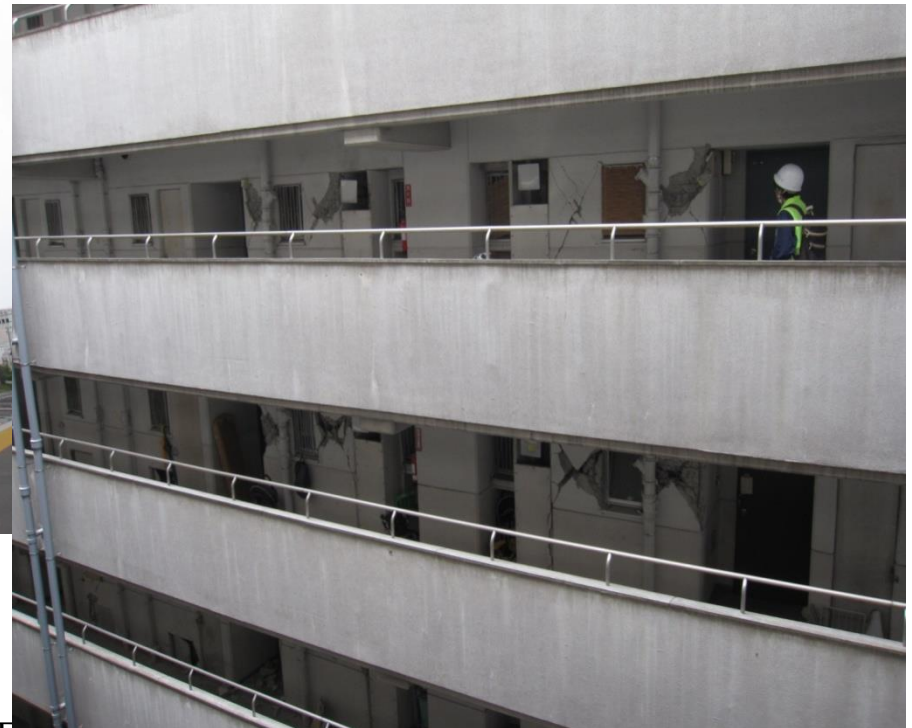
# Damage to non-structural concrete walls in apartment

- ◆ Const. in 1979
- ◆ 11 story, SRC
- ◆ Enough is-index, but...

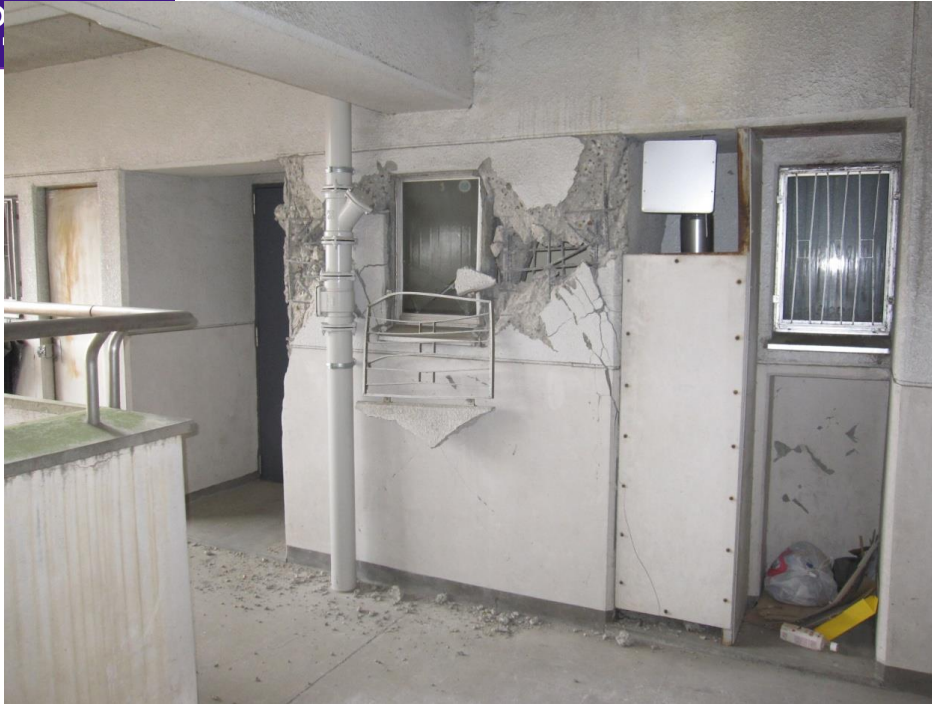
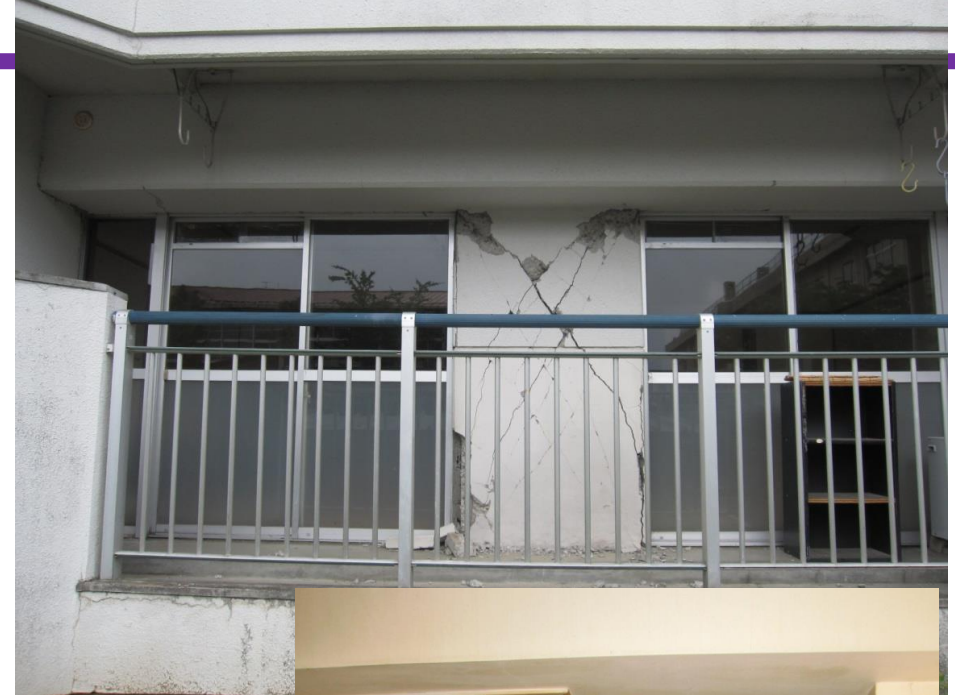
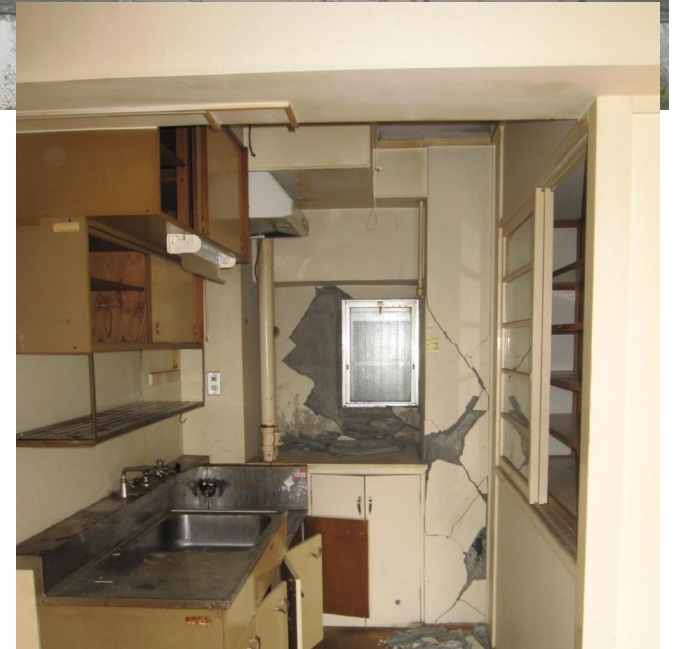
RC non-structural walls failed in shear

- ◆ RC moment frame structure escaped from major damage.
- ◆ However,... Demolished.

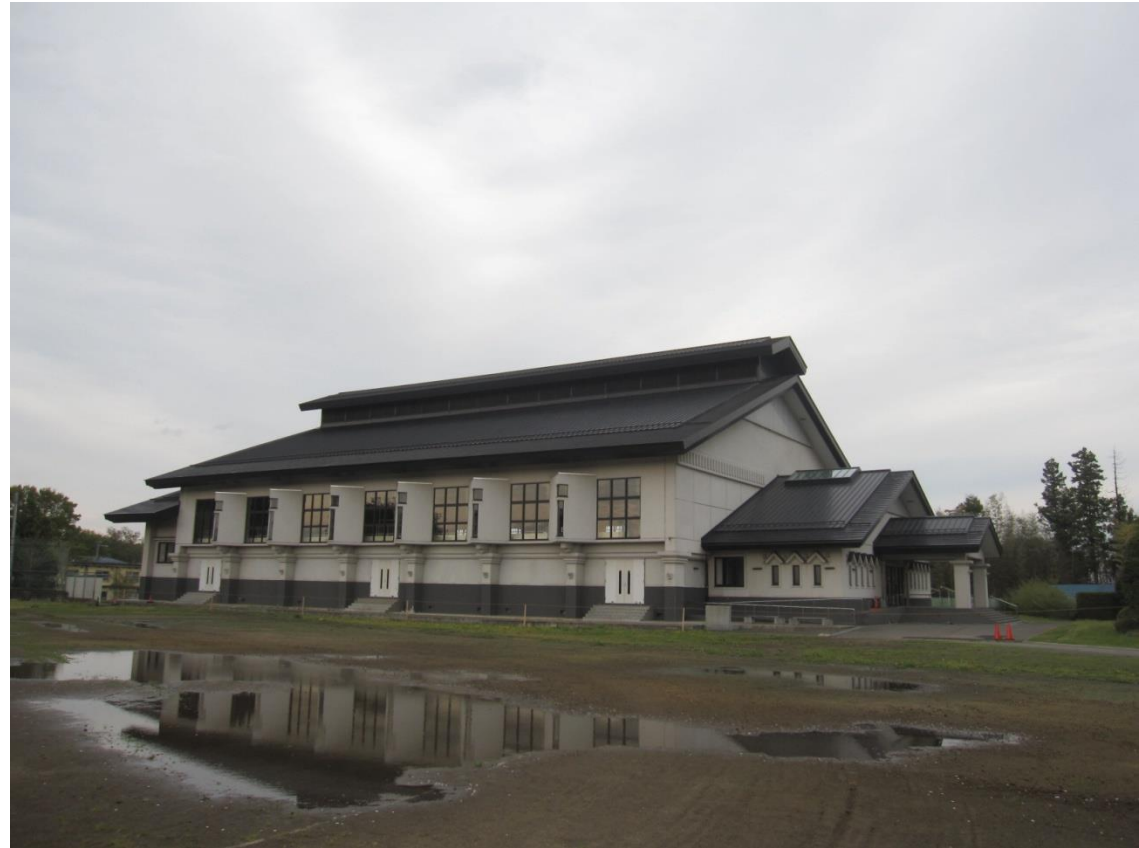
## ◆ Gym

- Rehabilitated after Iwate-Miyagi EQ in 2008
- Again damaged by 2011 earthquake

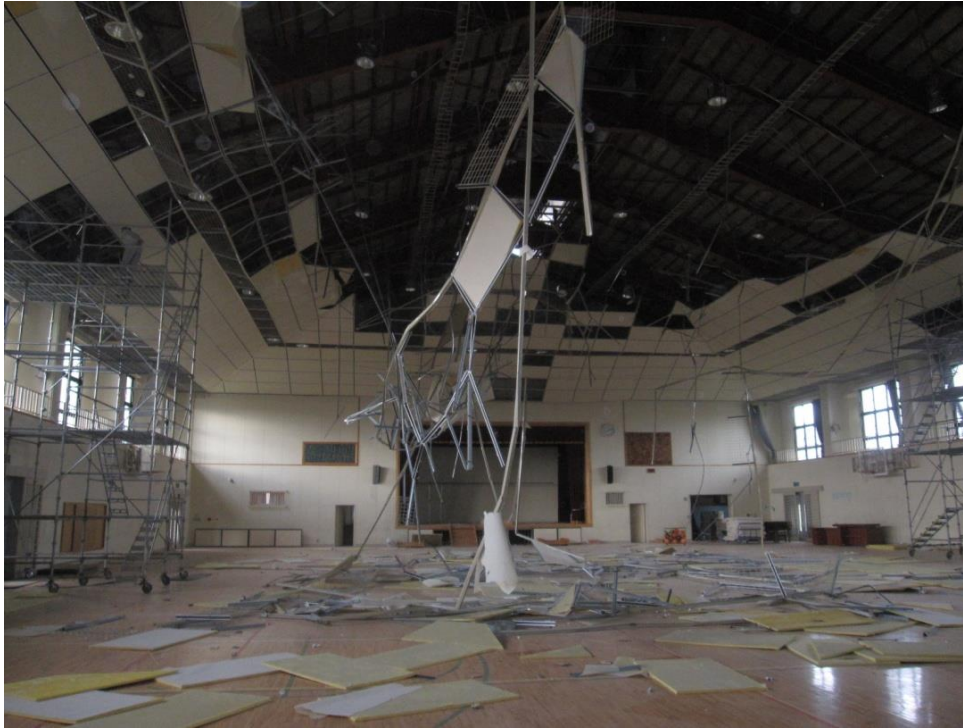
Large parts of the ceiling fell down  
(3/11, and also in 4/7)
