# Damage due to Earthquakes and Improvement of Seismic Performance of Reinforced Concrete Buildings in Japan

Prof. Maeda Masaki  
Tohoku University

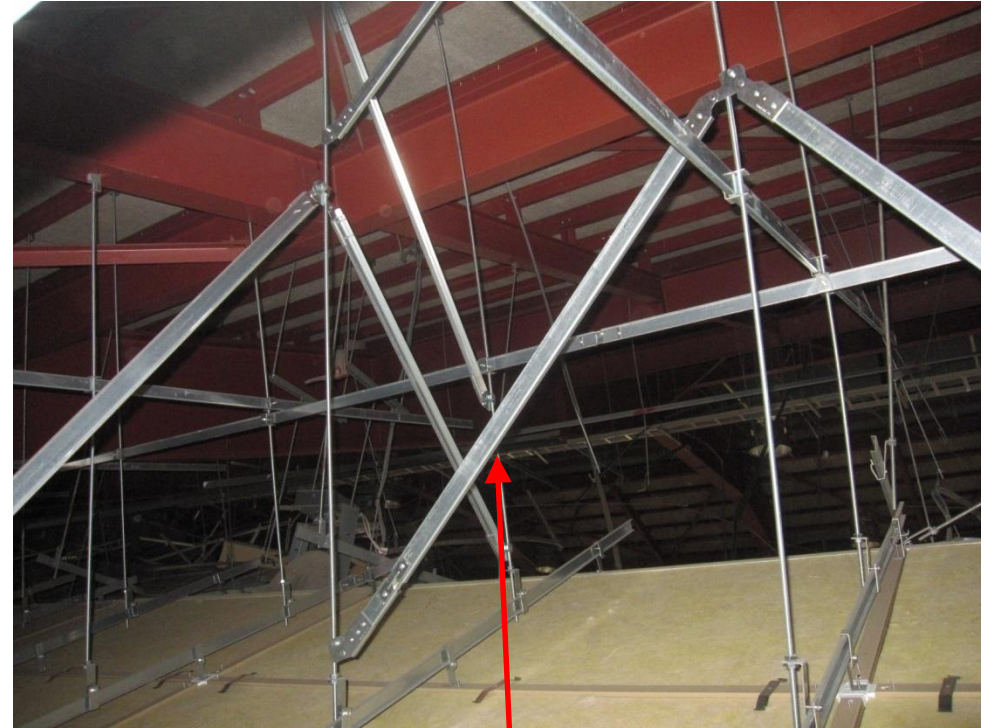
The fixed parts after 2008 EQ  
escaped damage

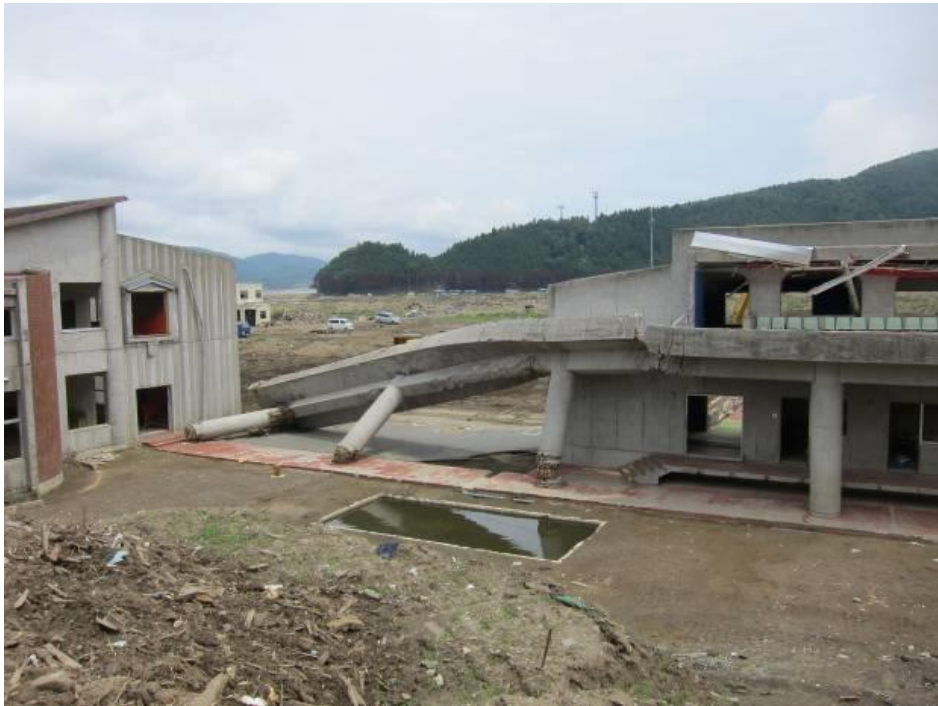
Passage collapsed due to tsunami.

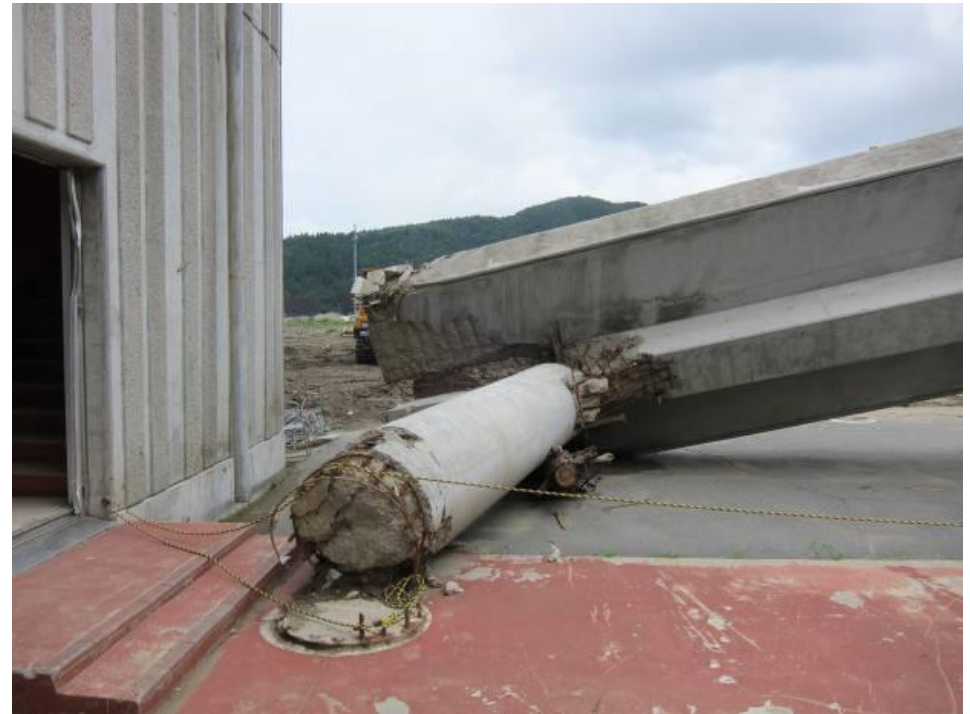
Bottom of column of passage.

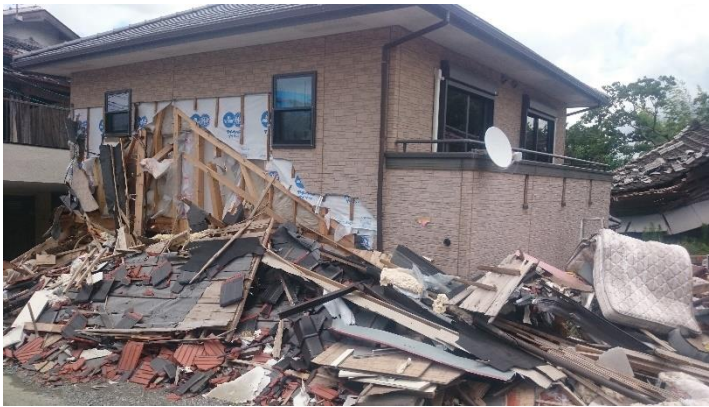
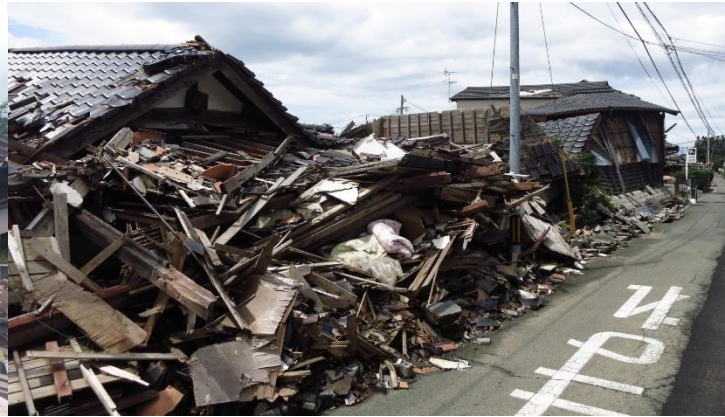
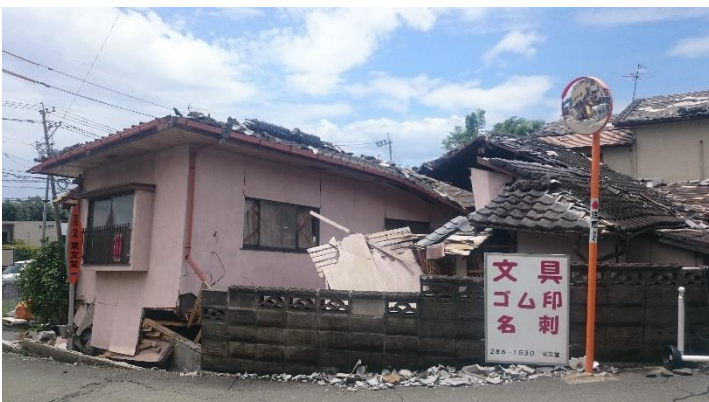
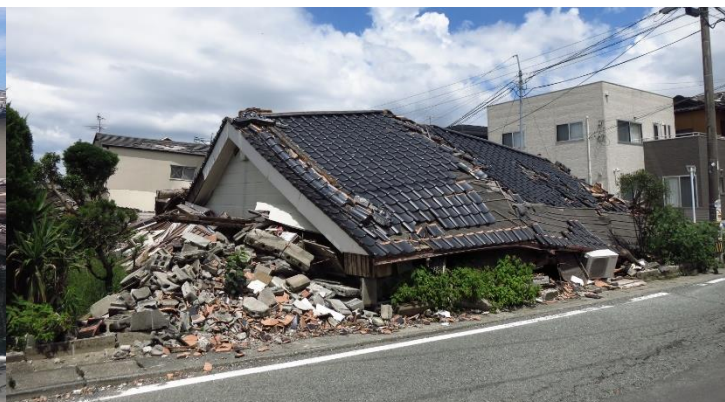
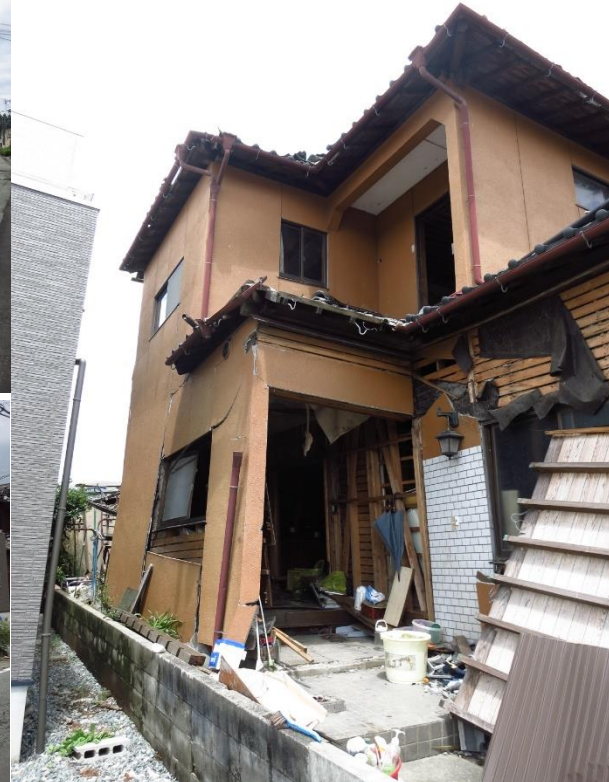
- ◆ Local destructive damage
- ◆ Some of current code timber houses suffered collapse or sever damage

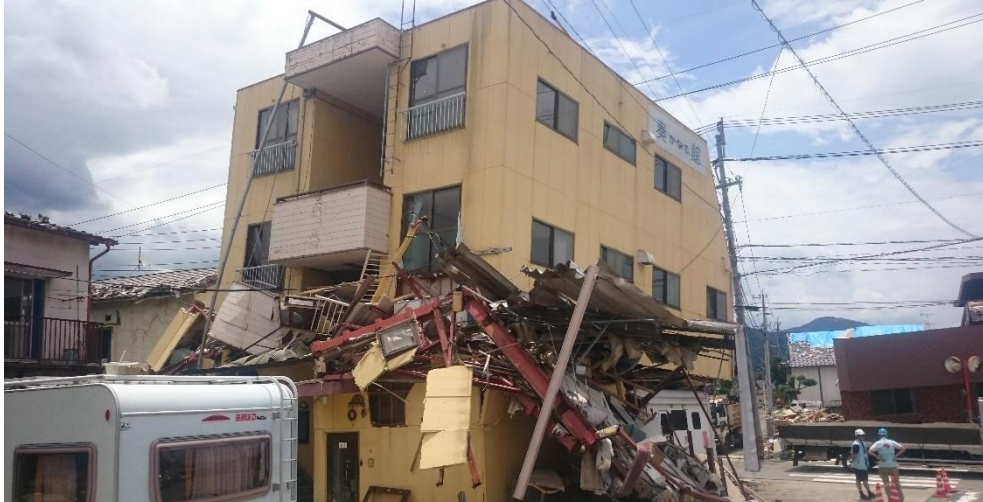
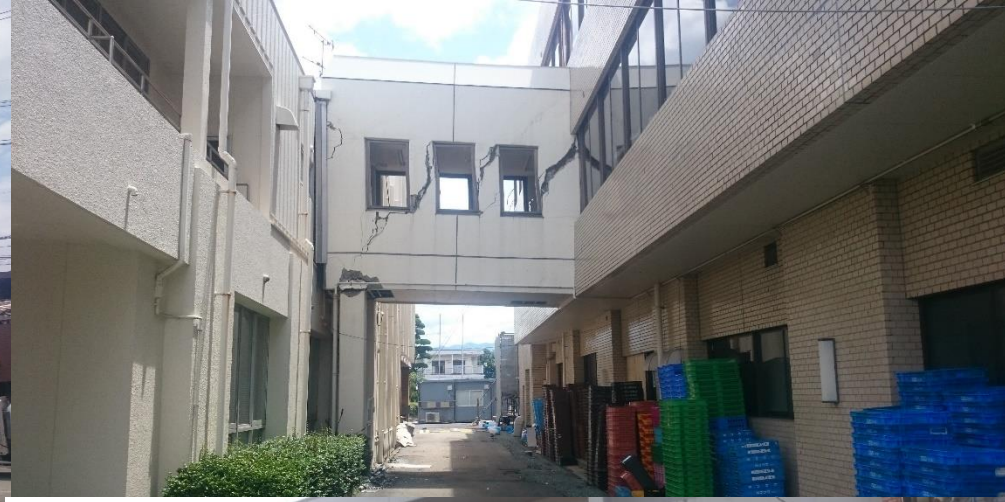
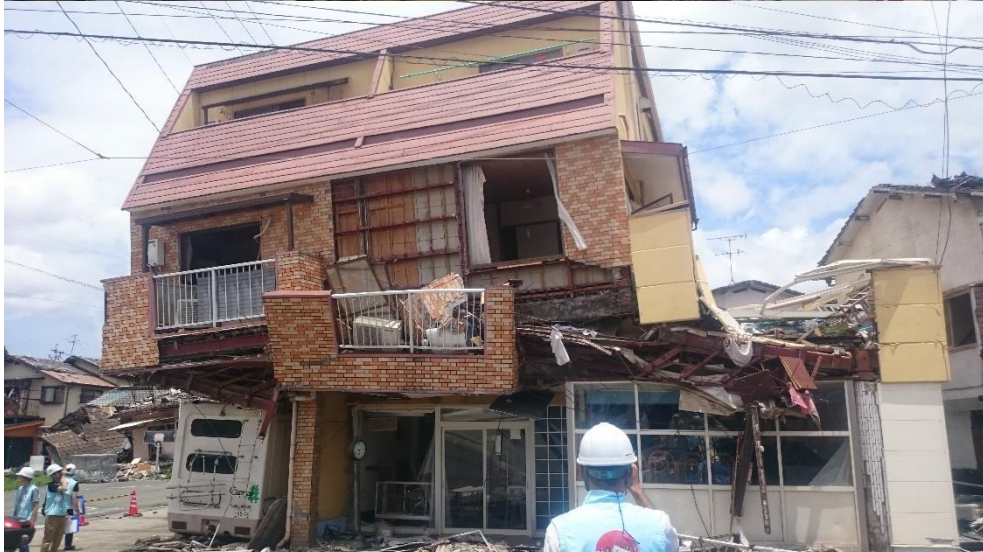
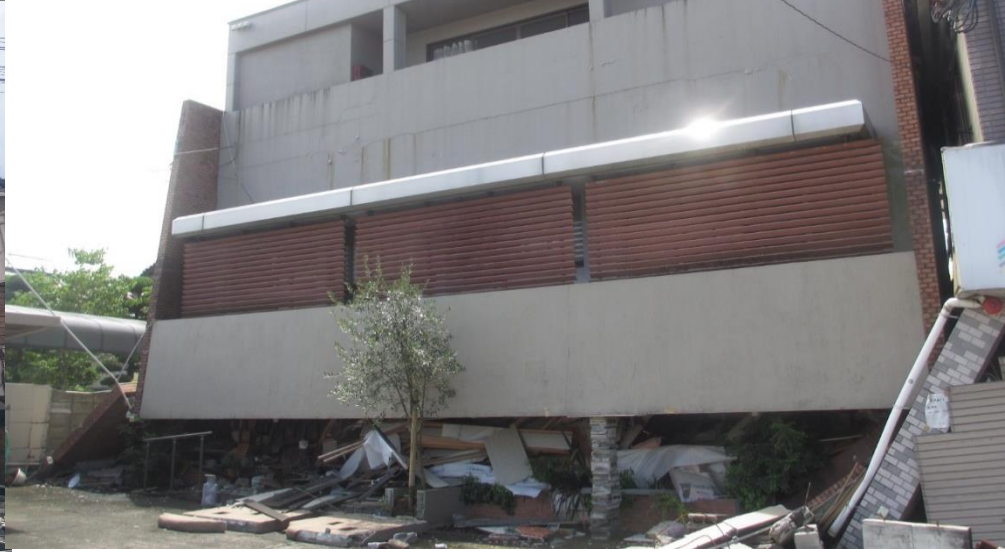
## ◆ Damage to steel and RC structures

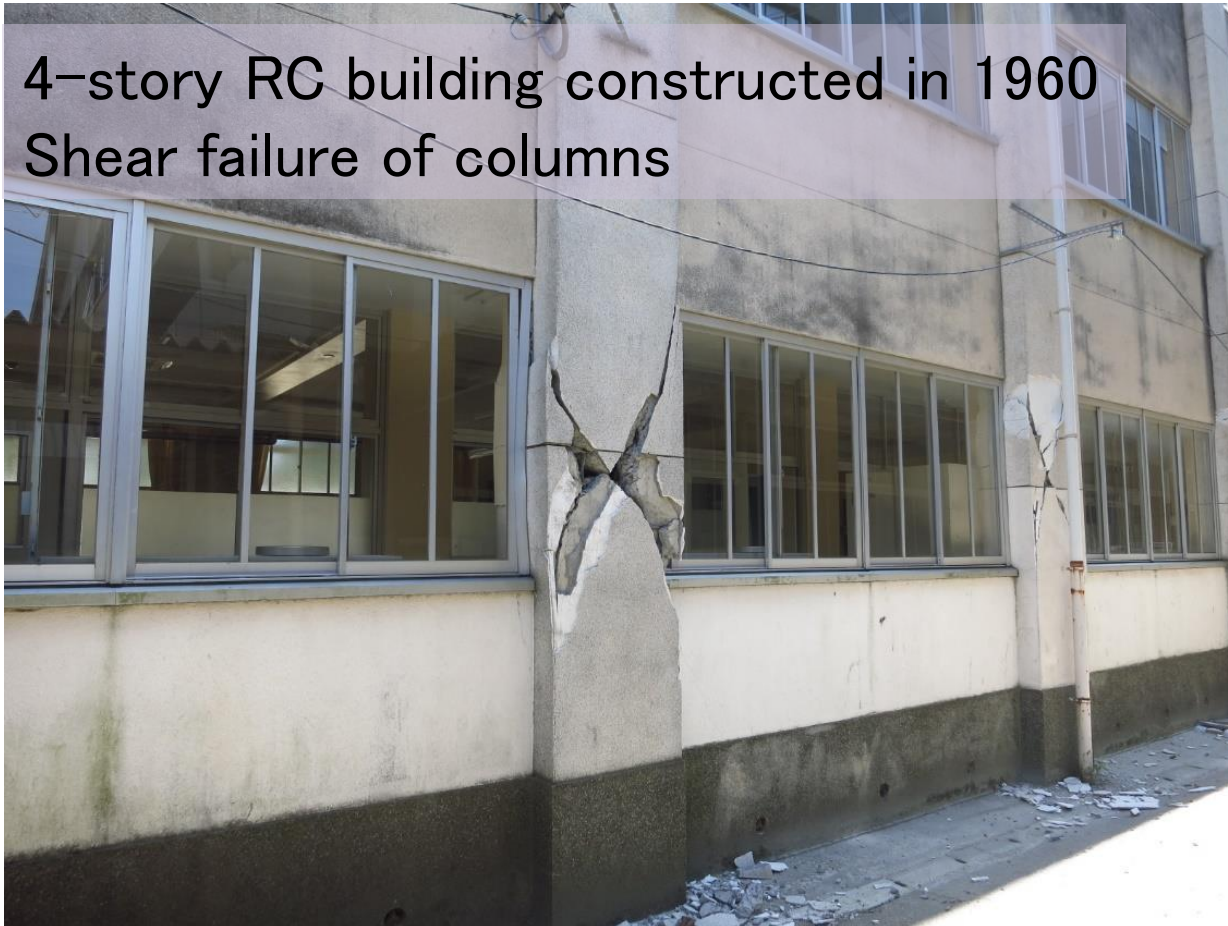
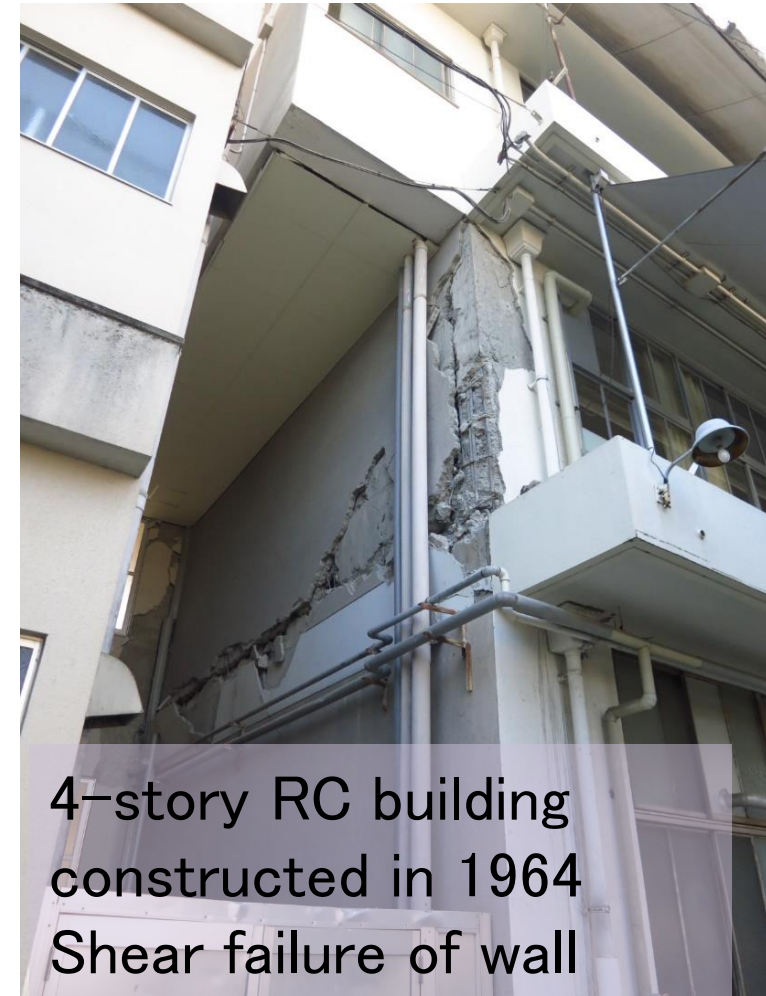
4-story RC building constructed in 1960  
Shear failure of columns

4-story RC building  
constructed in 1964  
Shear failure of wall

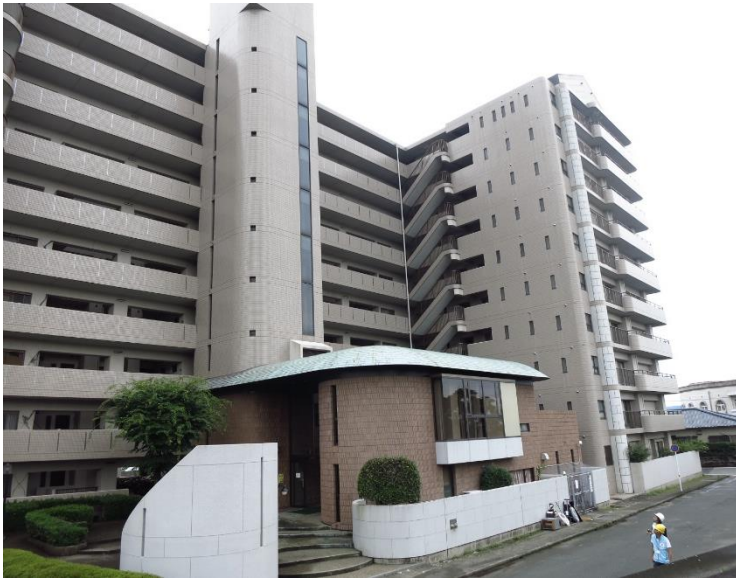
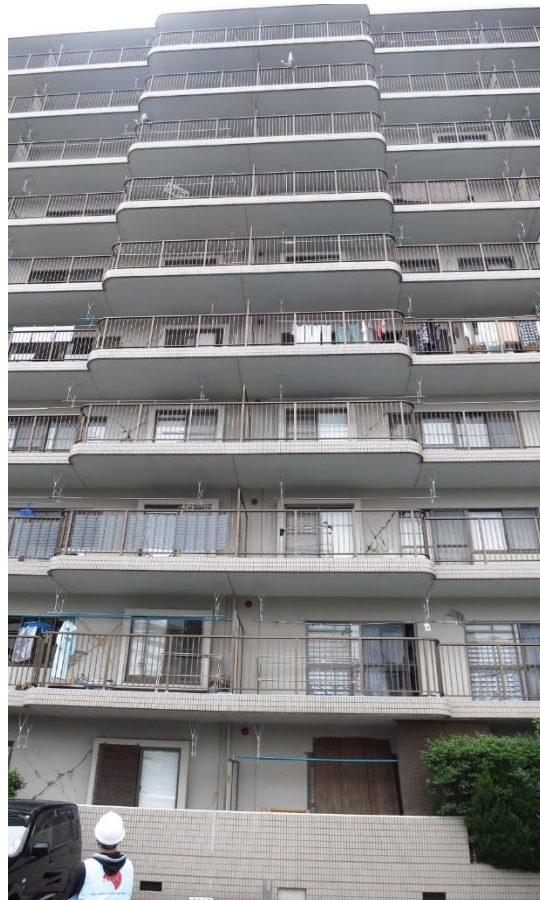
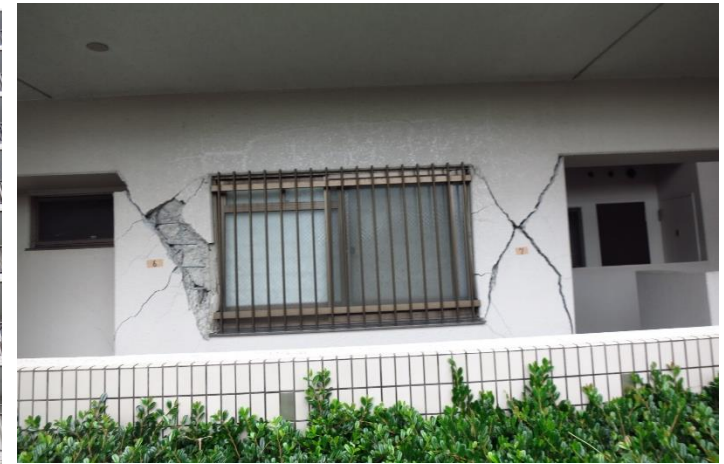
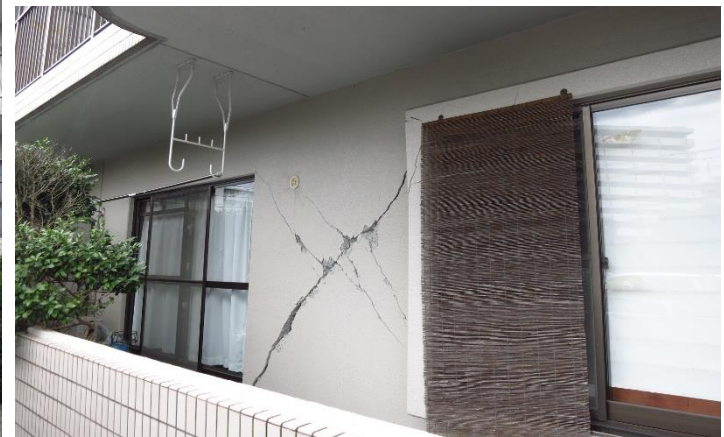
## ◆ Apartment G

- Damage to structure elements is slight, nonstructural wall failed in shear.

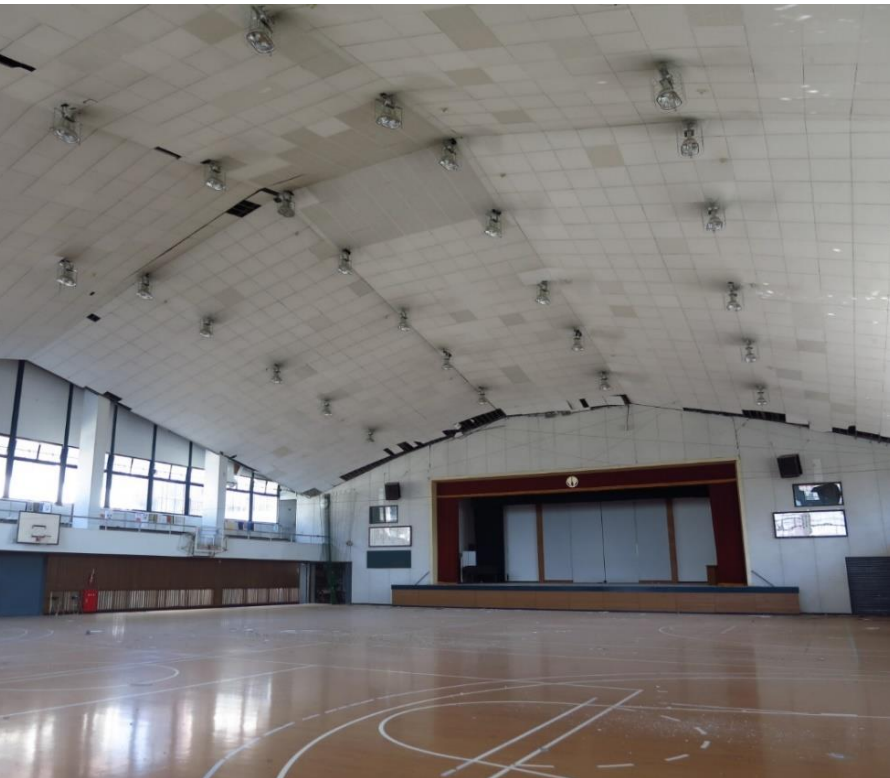
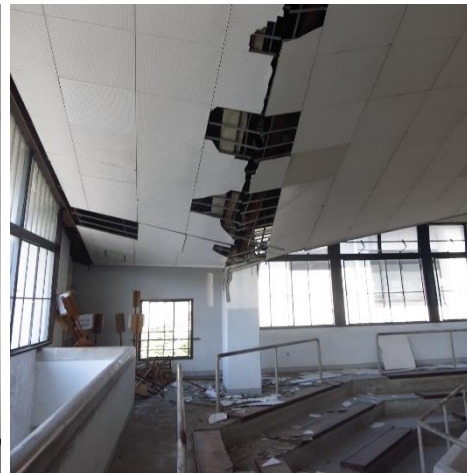
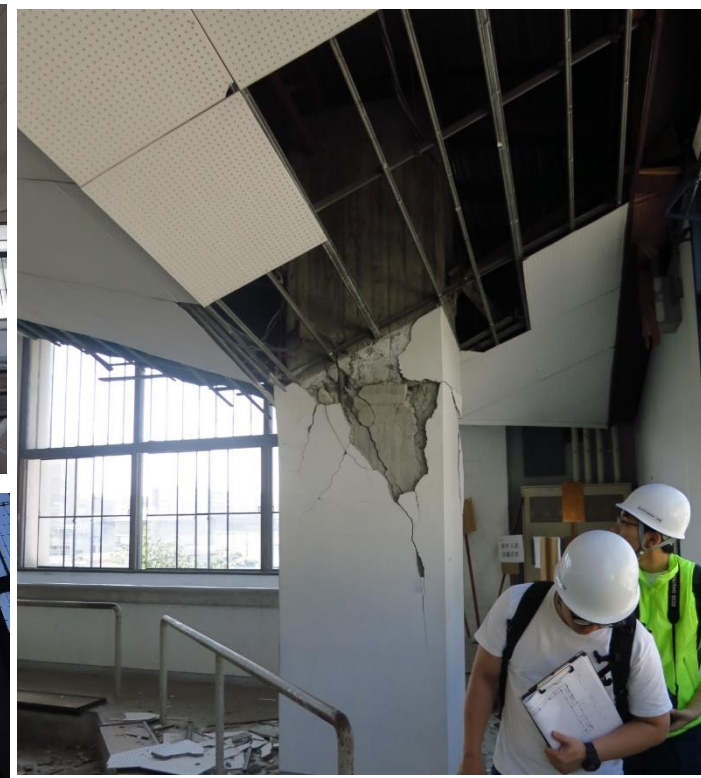
## ◆ School gym

- Falling of ceiling, exterior wall (window sash and glass)
- Damage of the steel frame-RC column joint
