Seismic Isolation Buildings in Japan

Building Research Institute, Japan

Matsutaro SEKI

Damage of Seismic Isolation Buildings Building Research Institute, Japan International Institute of Seismology and Earthquake Engineering (IISEE)

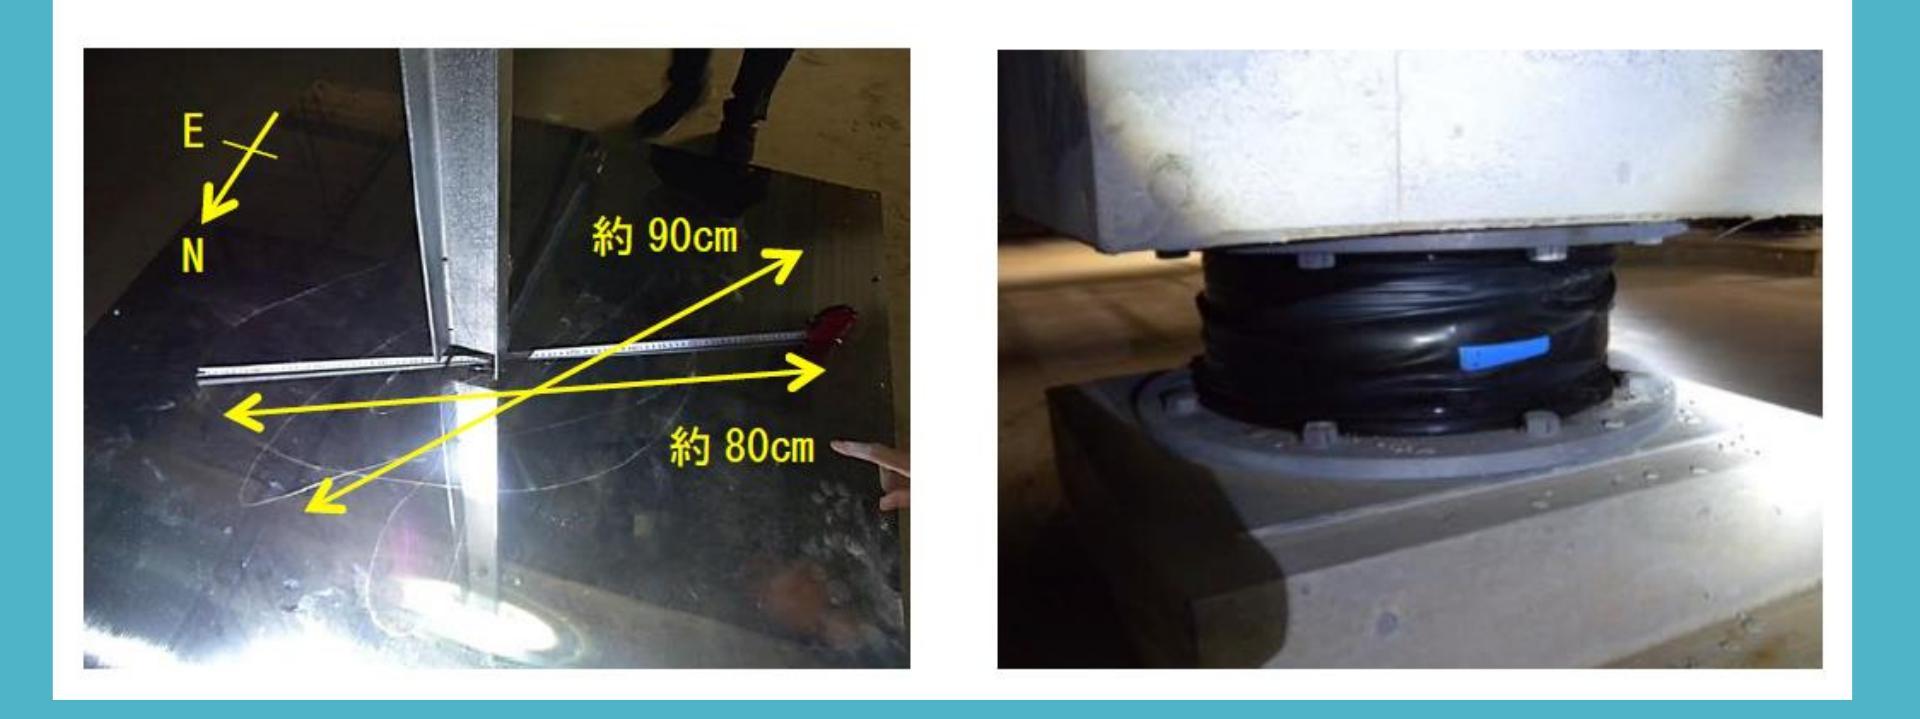
A building: monitoring by scriber, Swelling of covering rubber

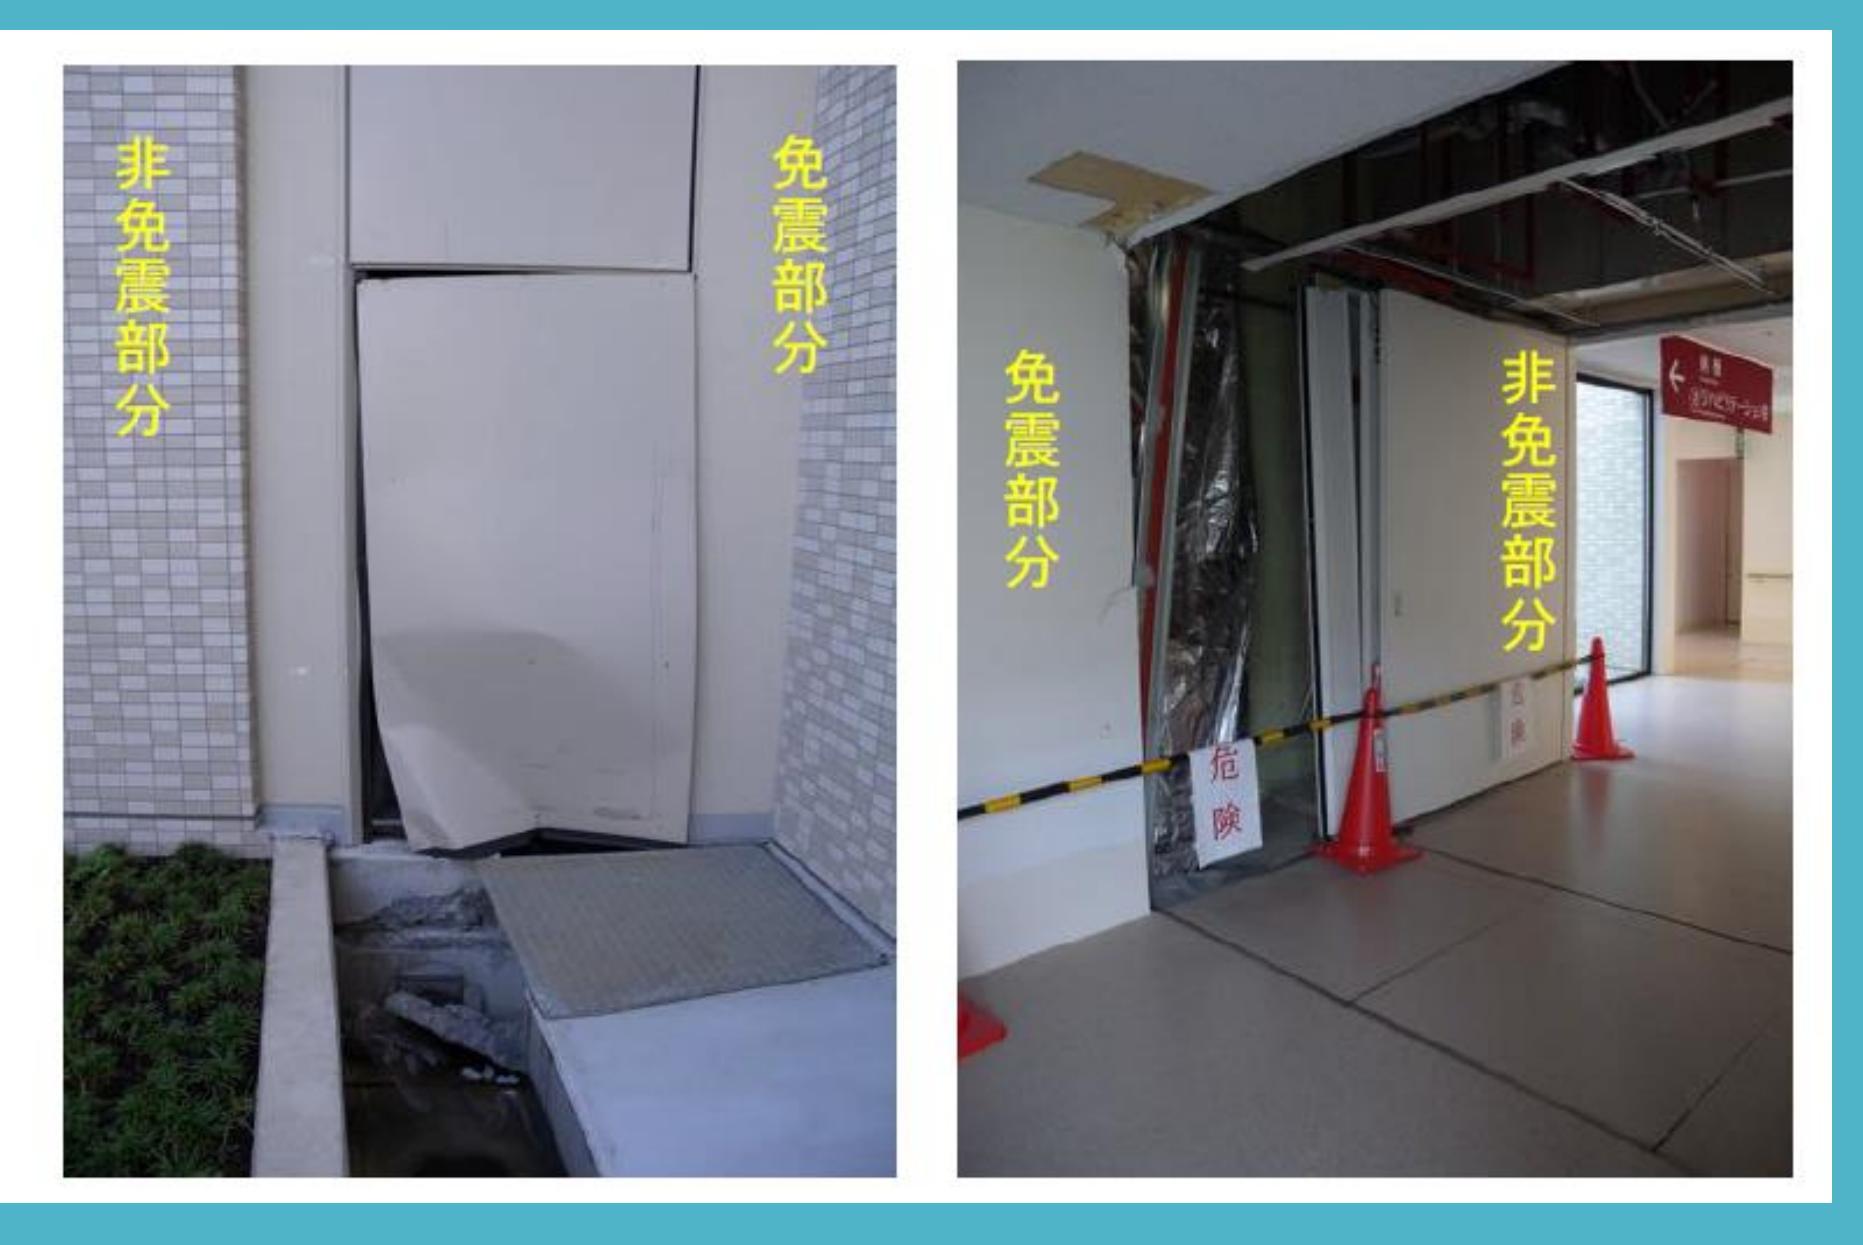
A building: Damage of expansion joint

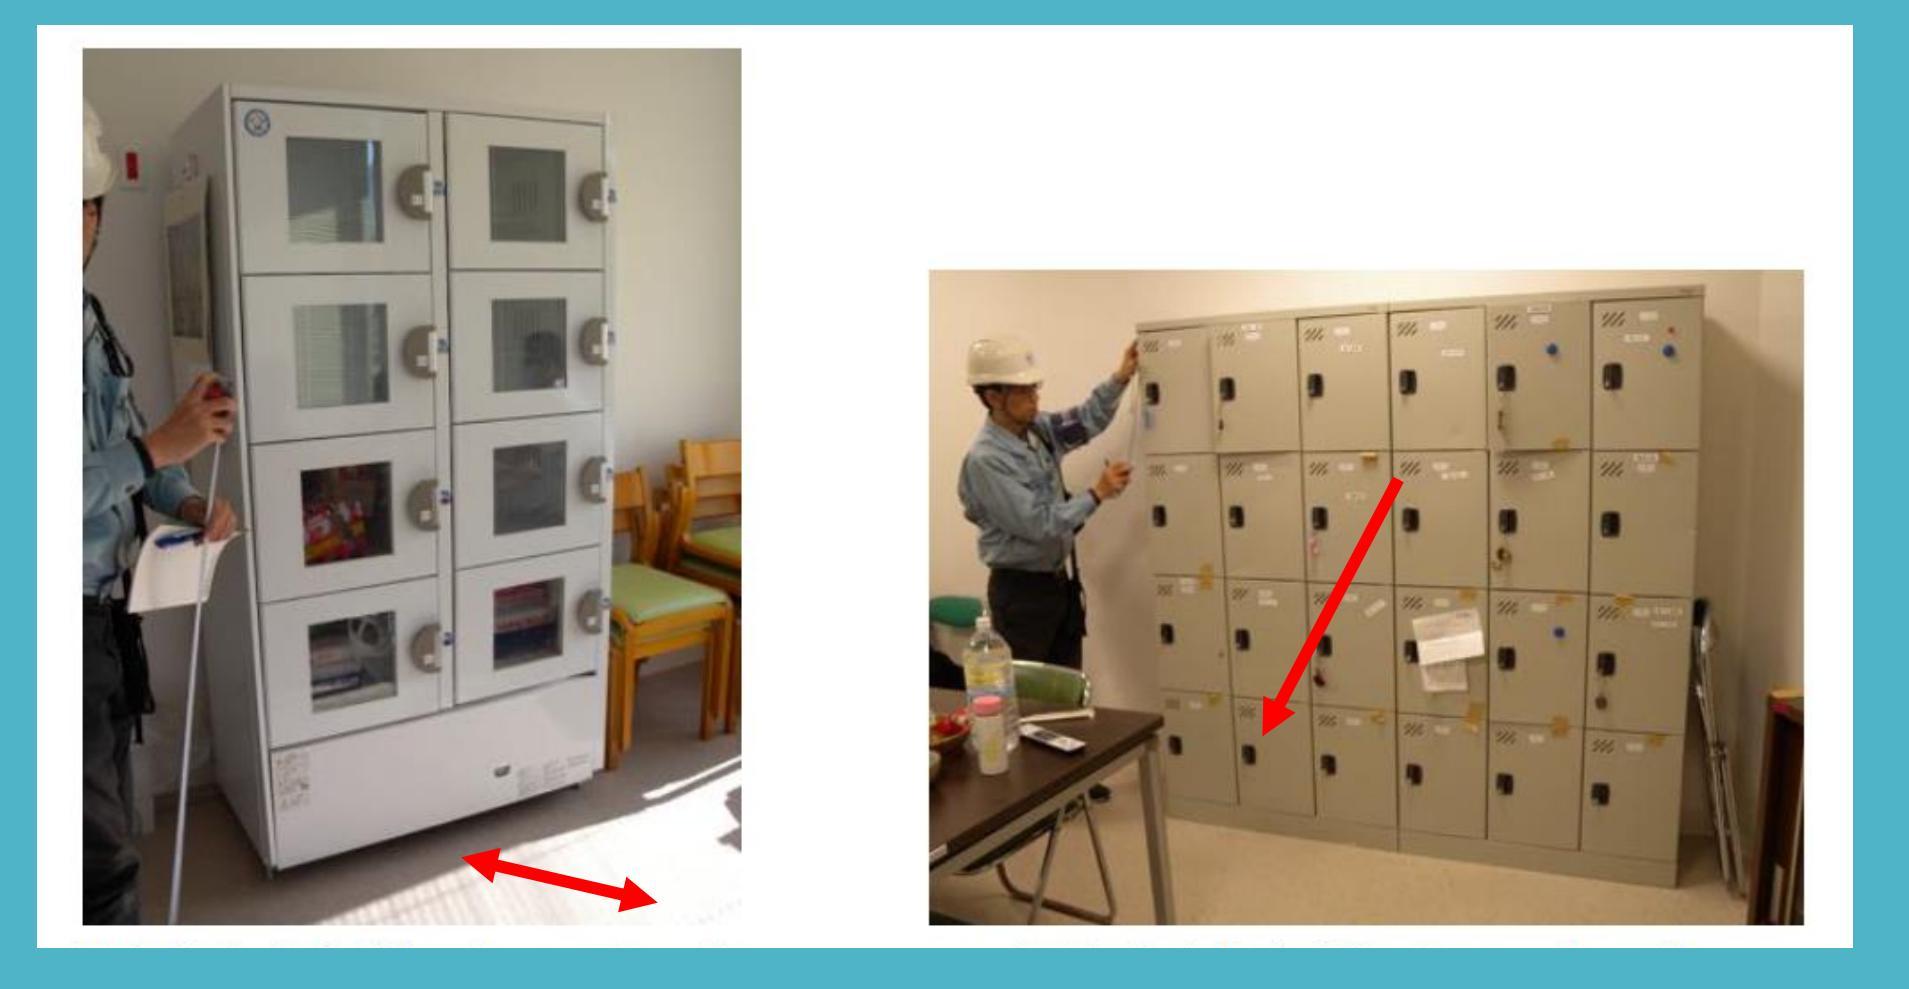
A building: Sliding and Overturning of locker

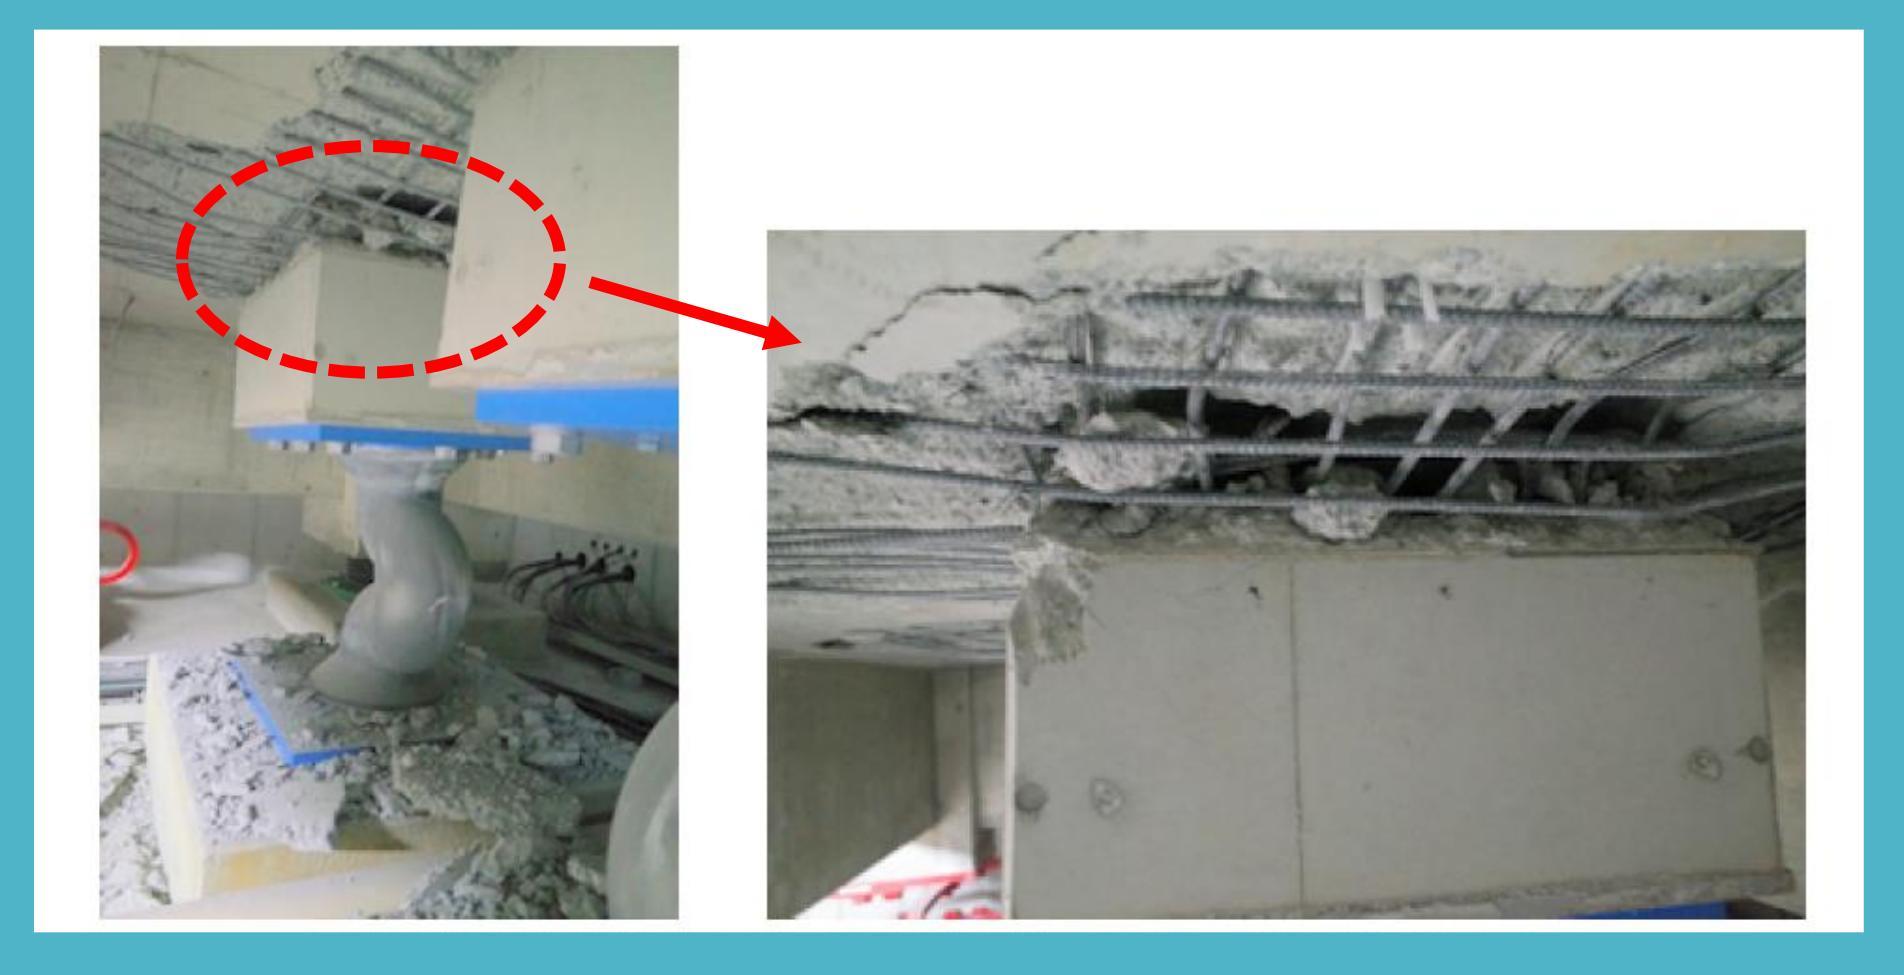
C building: Damage of supporting portion of lead plug damper

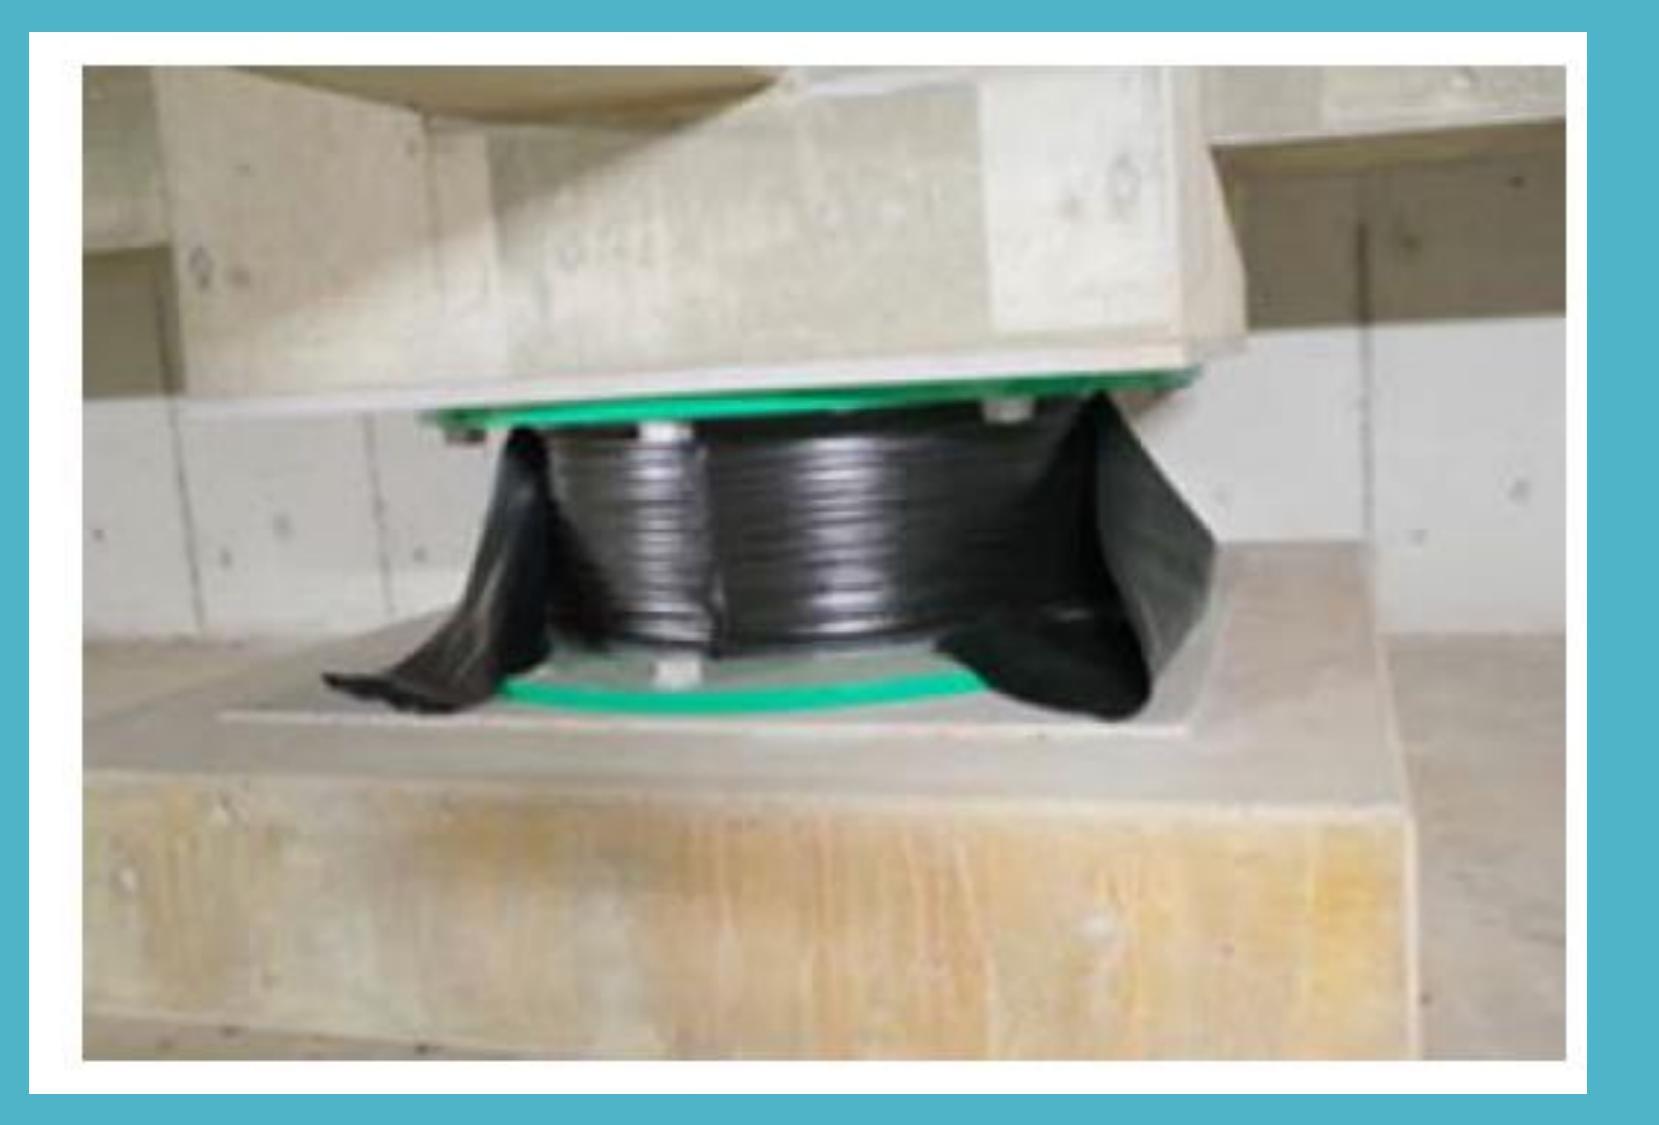
C building: Exfoliation of covering rubber

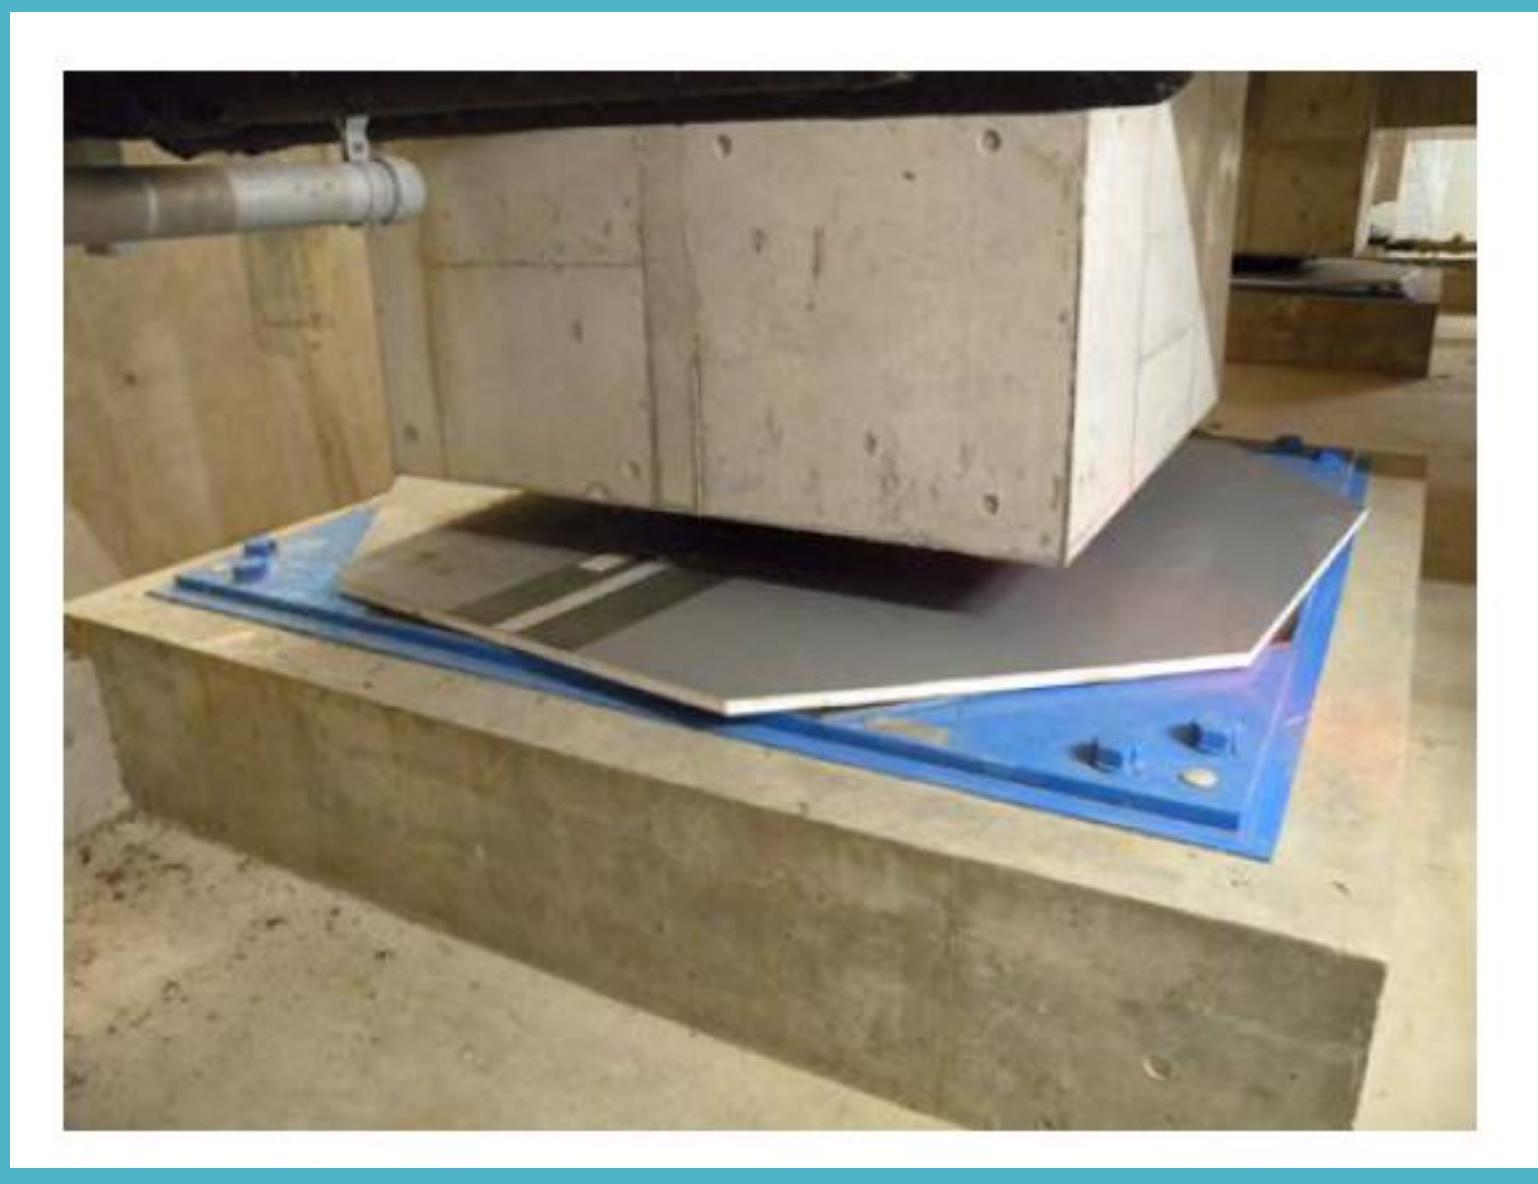
D building: Slippage of sliding plate of elastic friction damper

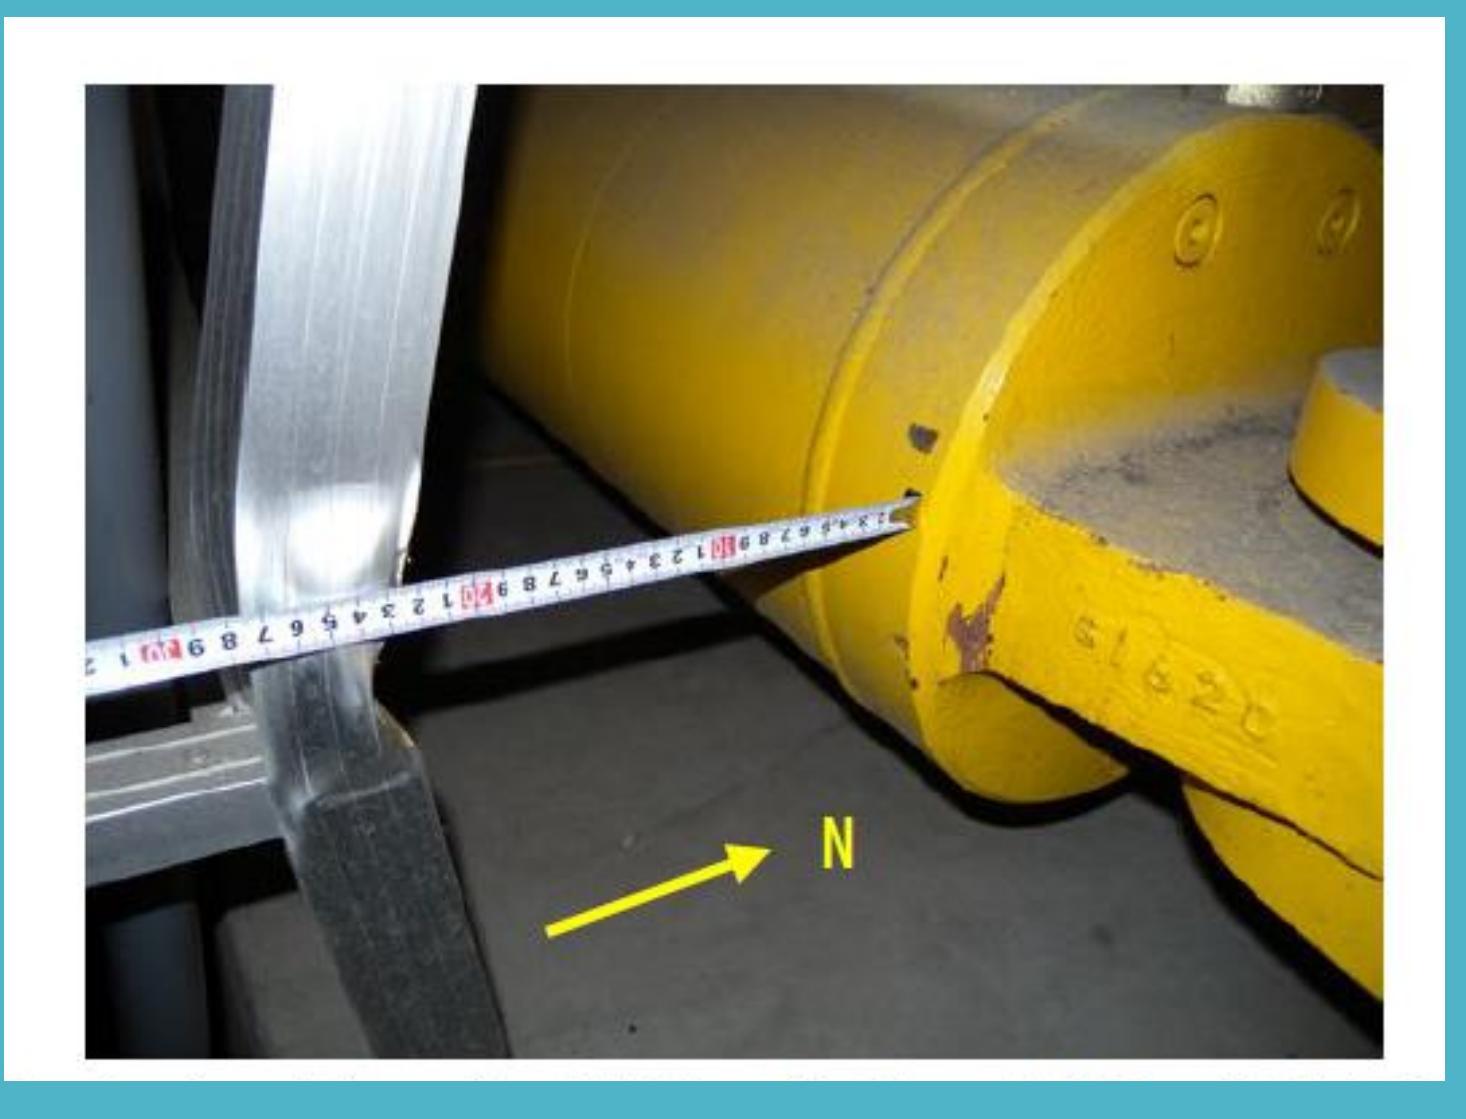
F building: Collision of oil damper and deformation of surrounding frame

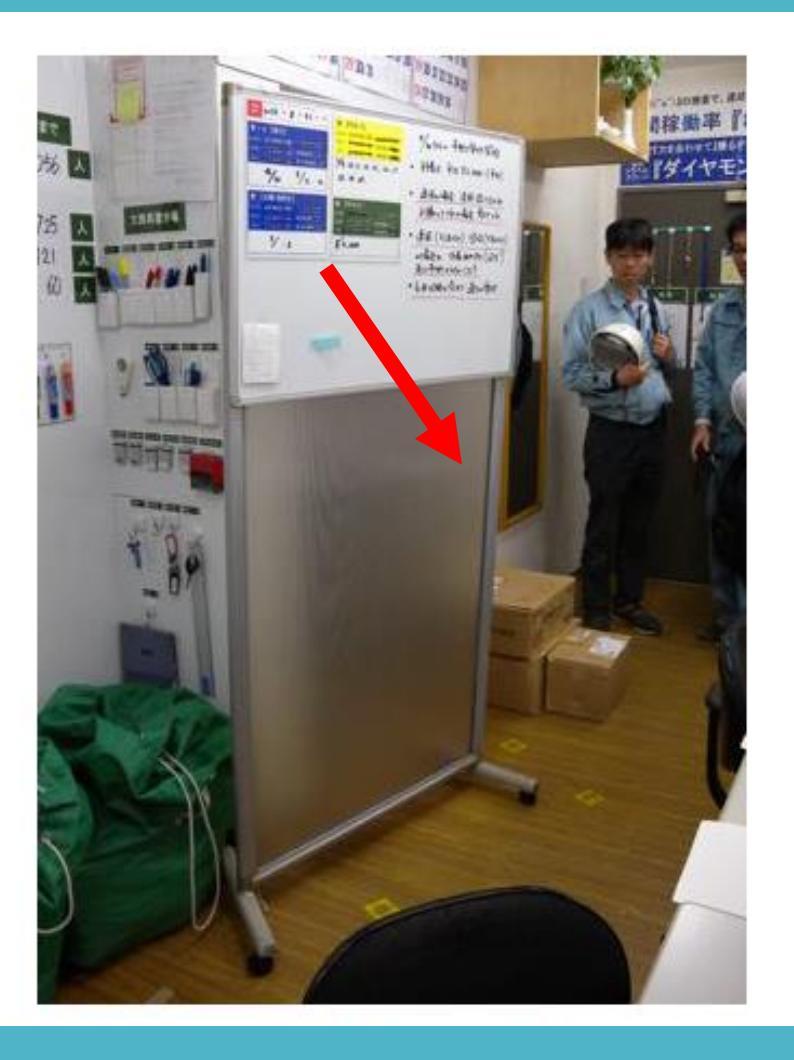
G building: Movement of copy machine, overturning of petition wall

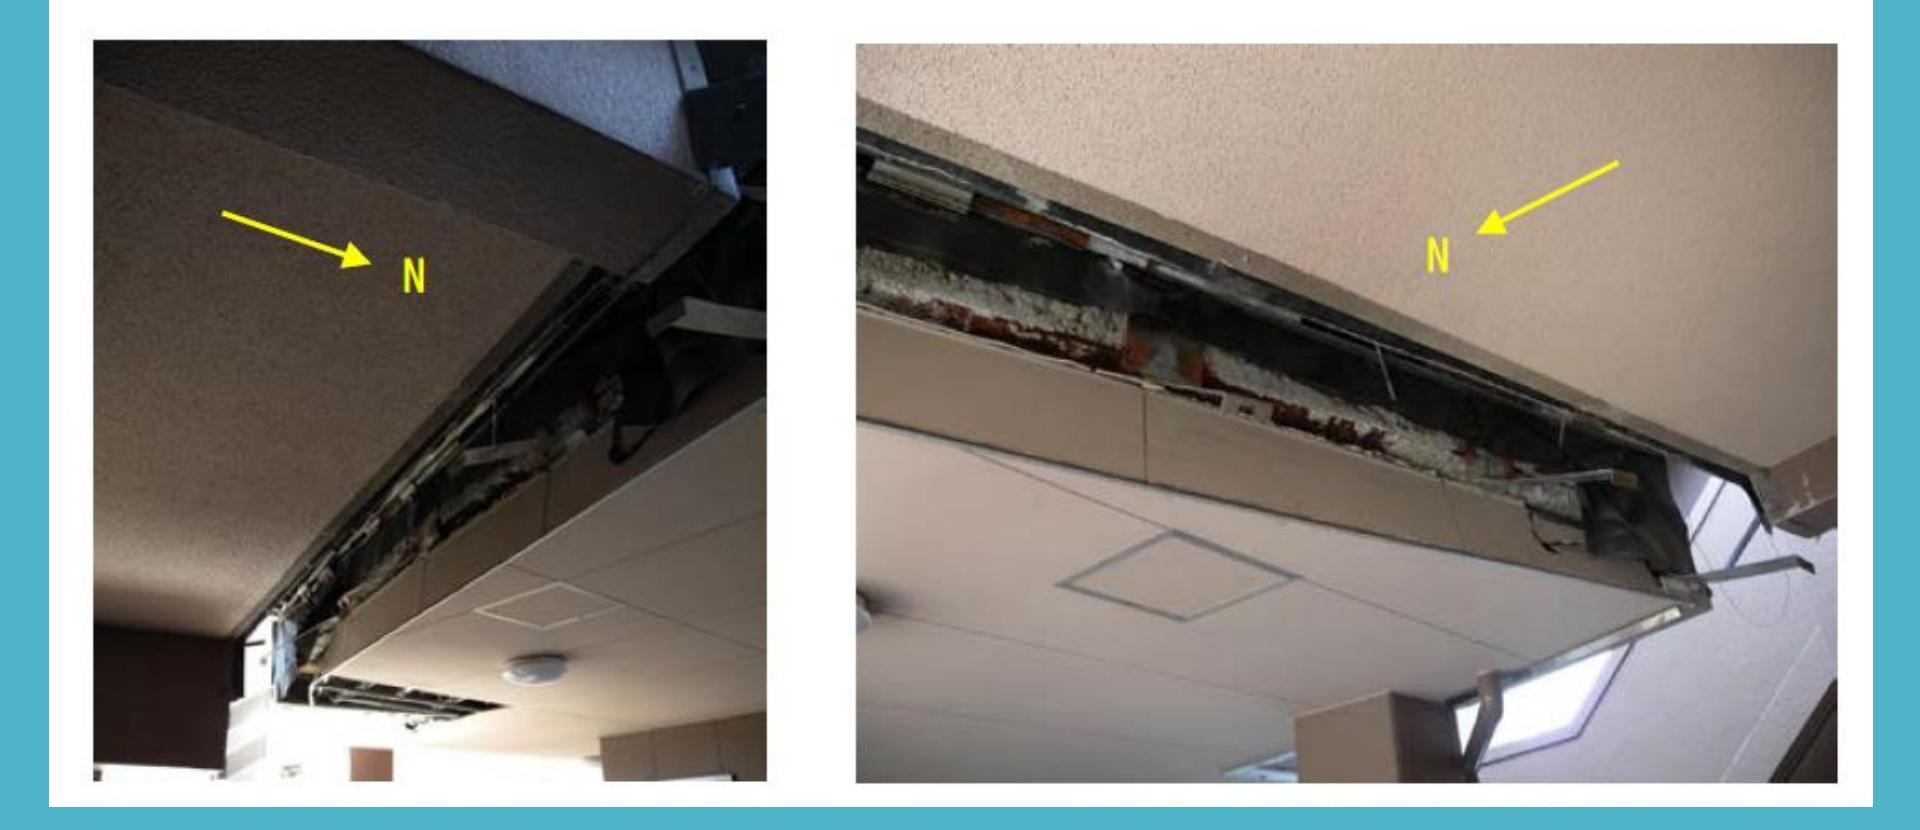
G building: Damage of expansion joint between building and connecting corridor

3. Damage of expansion joint is inevitable.

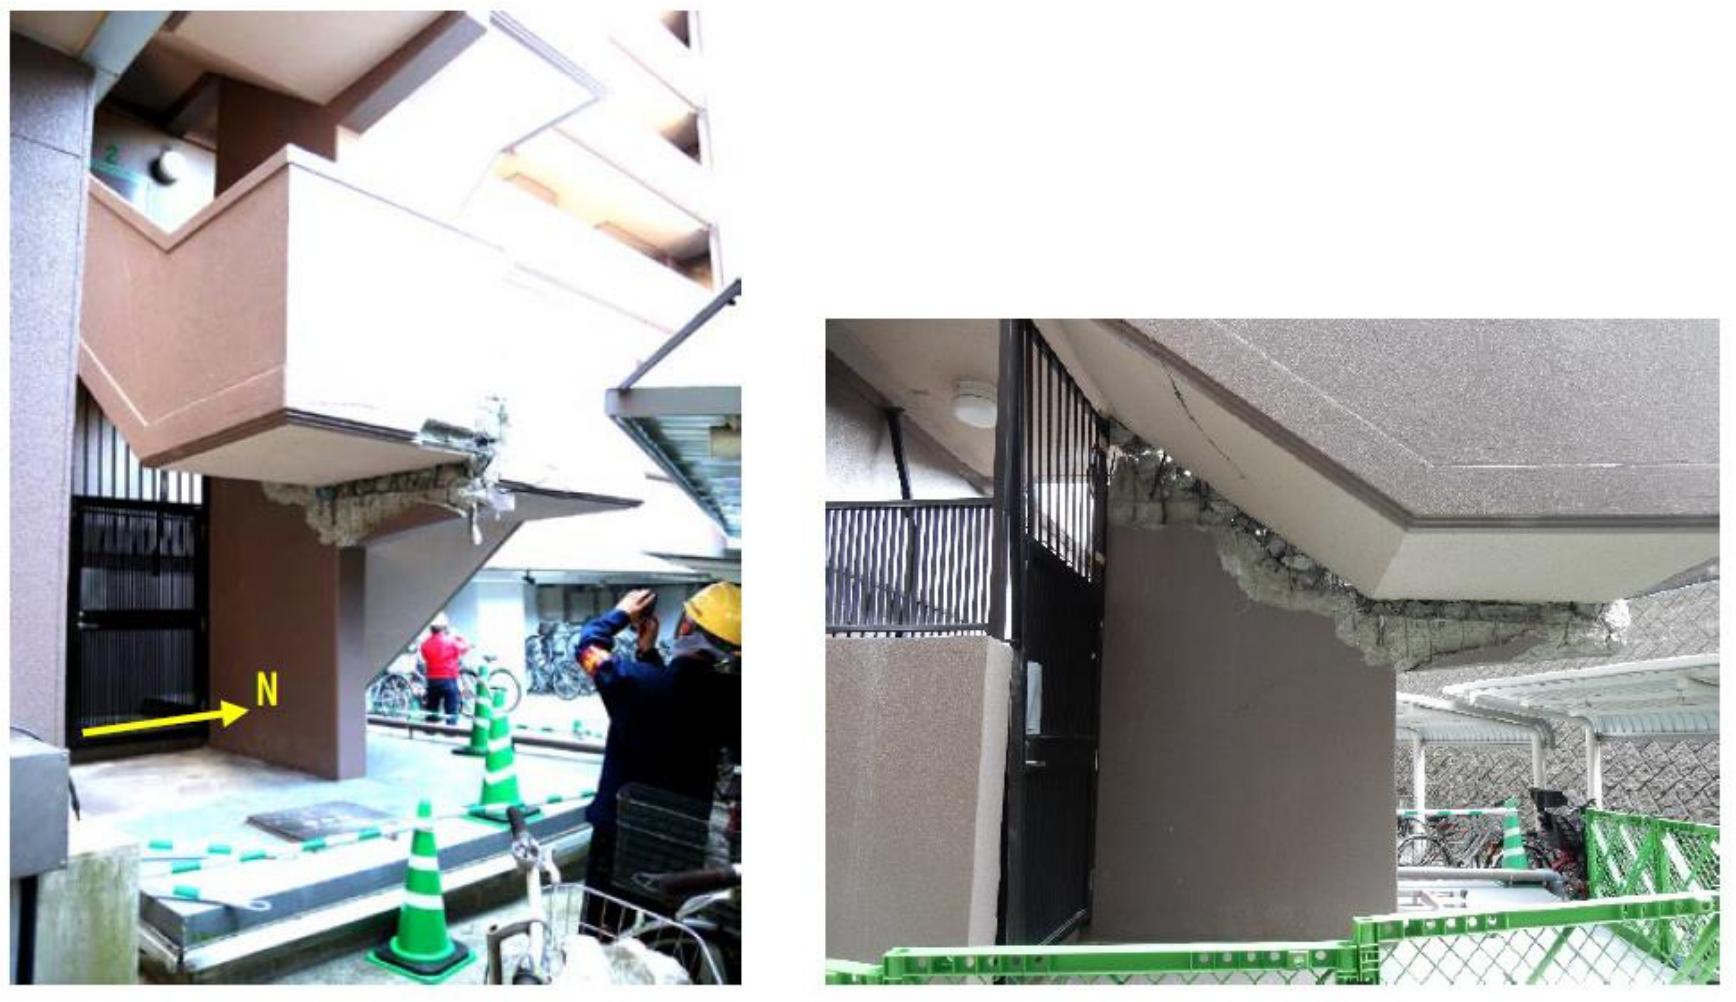
G building: Damage of connecting corridor (1st floor)

写真 5.7.2-39 外付け階段の被害状況①(階段南側)

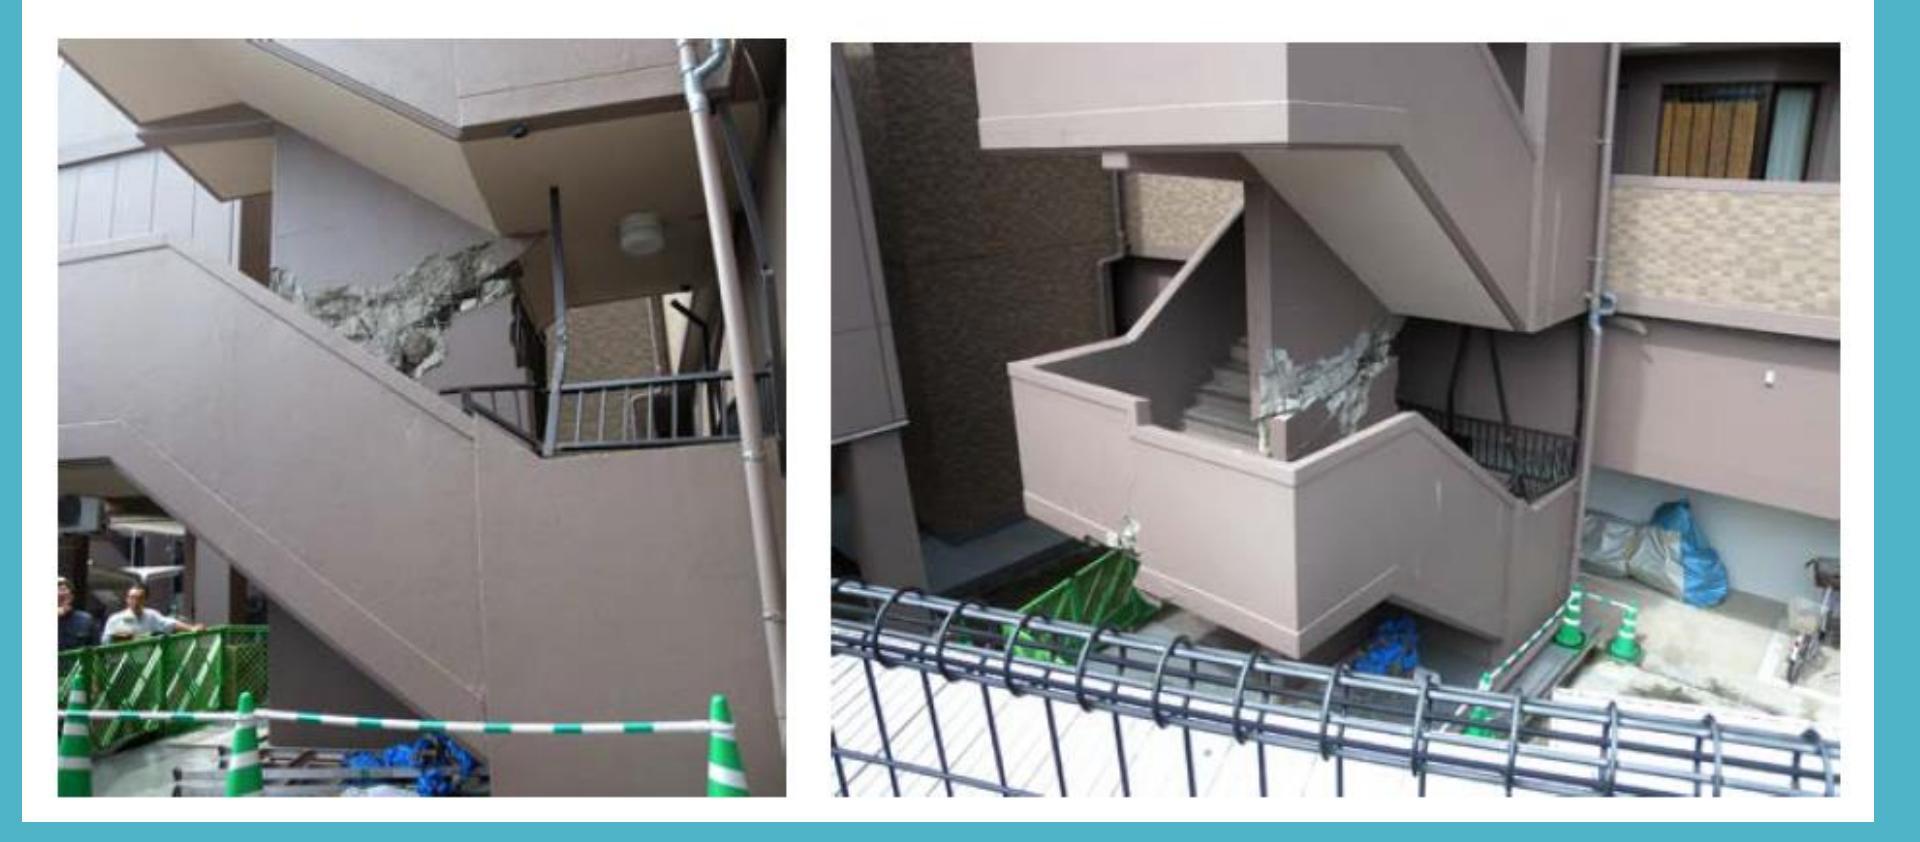
G building: Damage of connecting corridor (2nd floor)

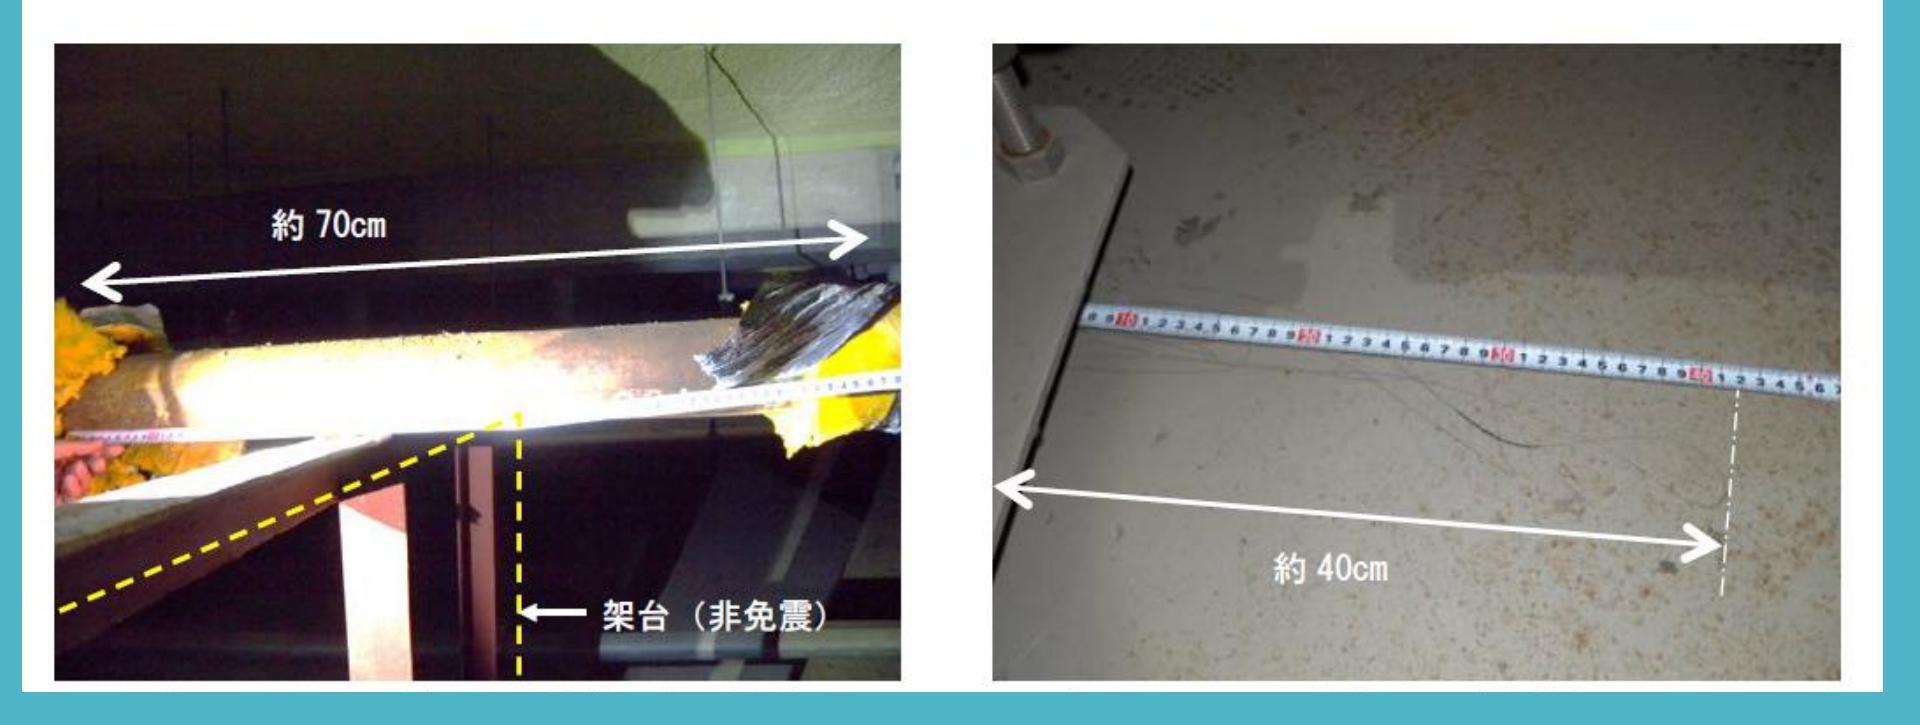
H building: Movement of cover sheet of pipe, movement of flexible equipment

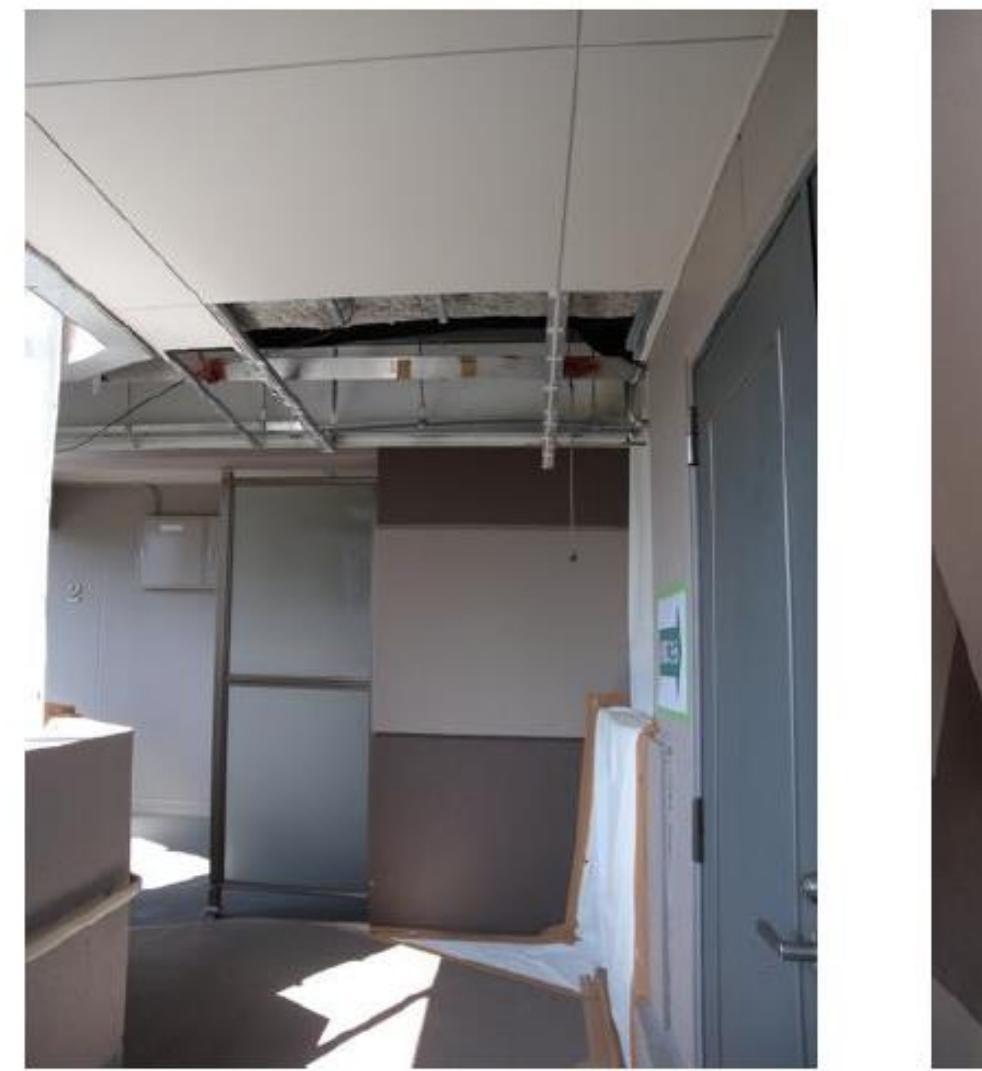
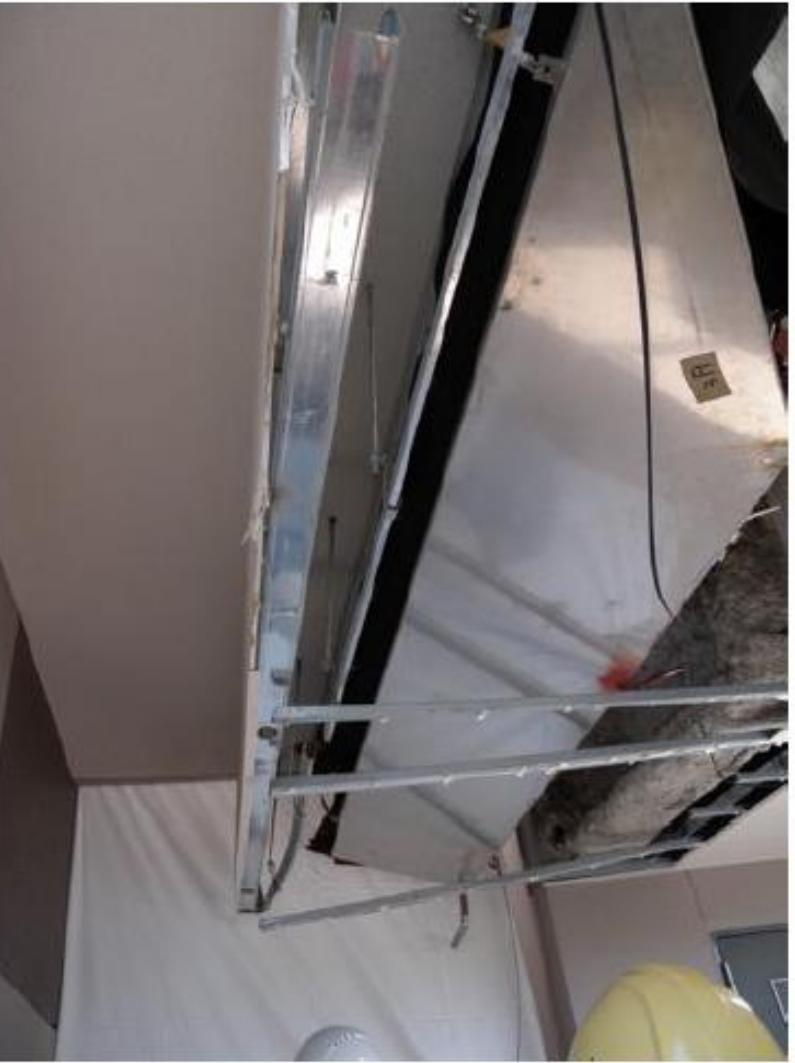
H building: Damage of expansion joint (ceiling)
