Seismic Isolation Buildings in Japan

Building Research Institute, Japan

Matsutaro SEKI

Damage of Seismic Isolation Buildings Building Research Institute, Japan International Institute of Seismology and Earthquake Engineering (IISEE)

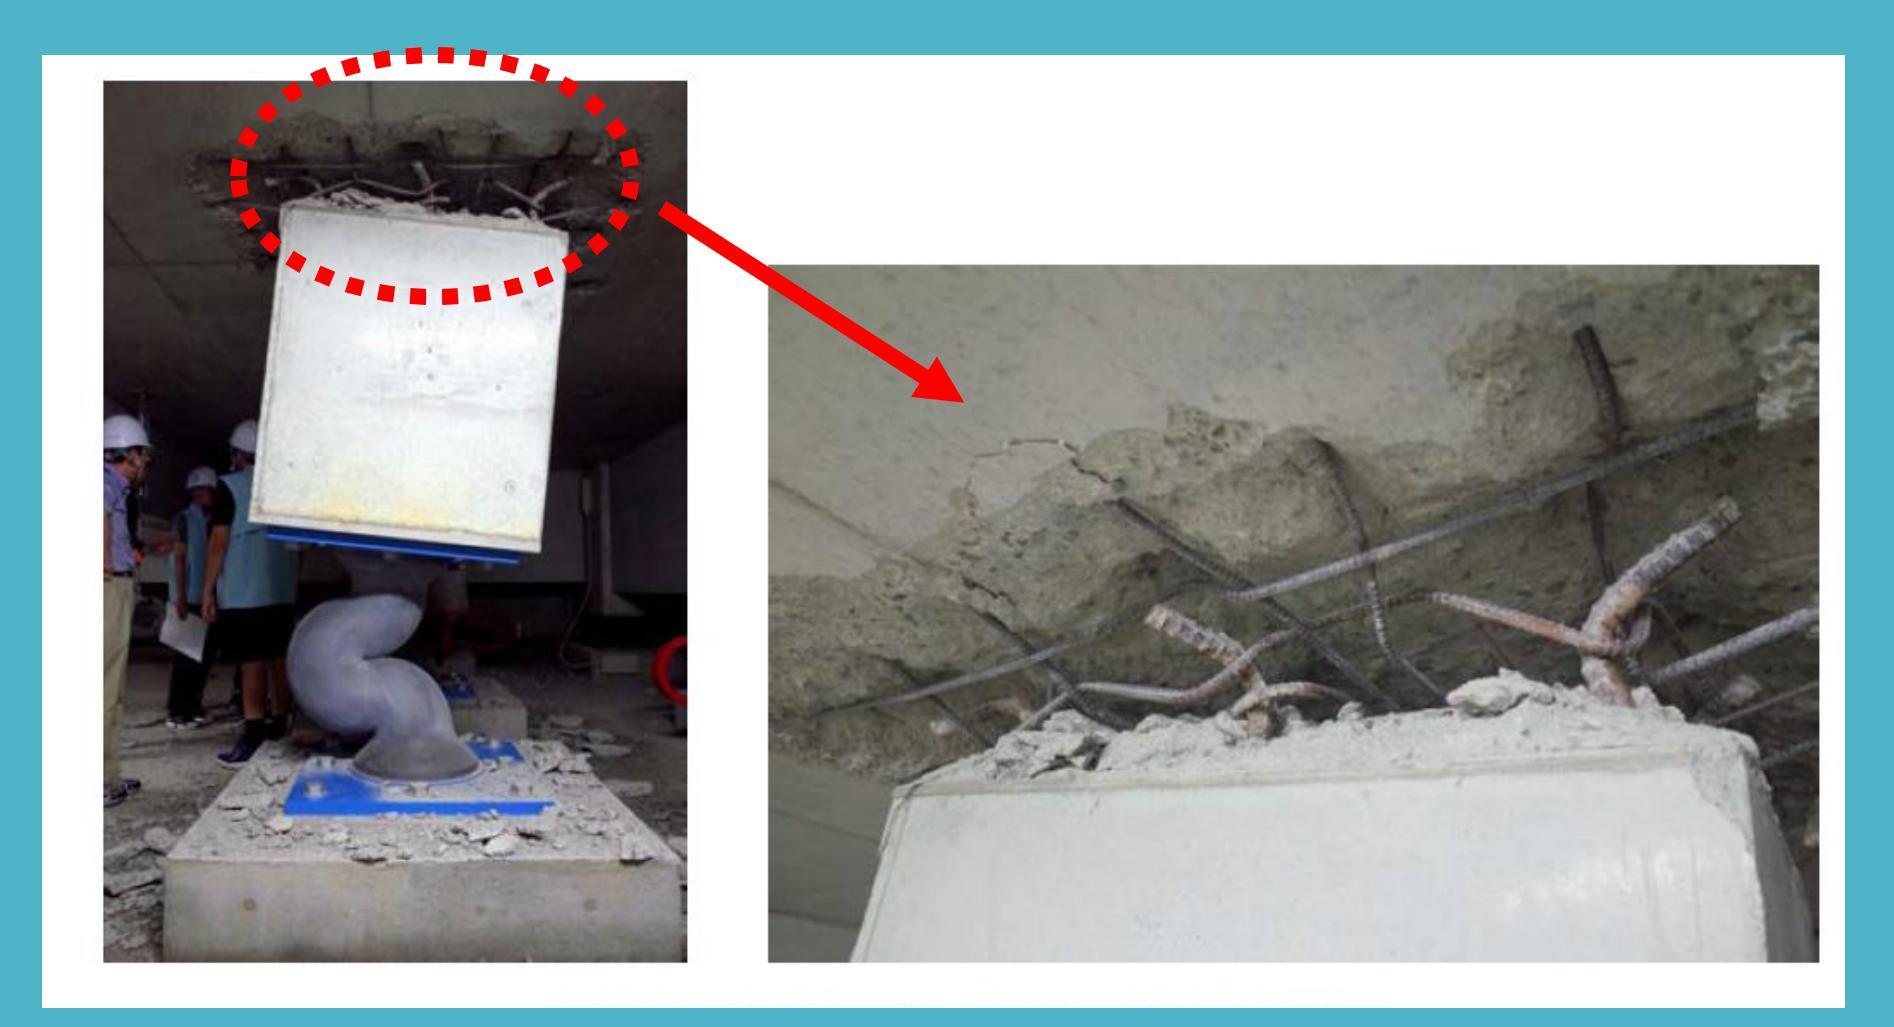
H building: Damage of supporting portion of lead plug damper

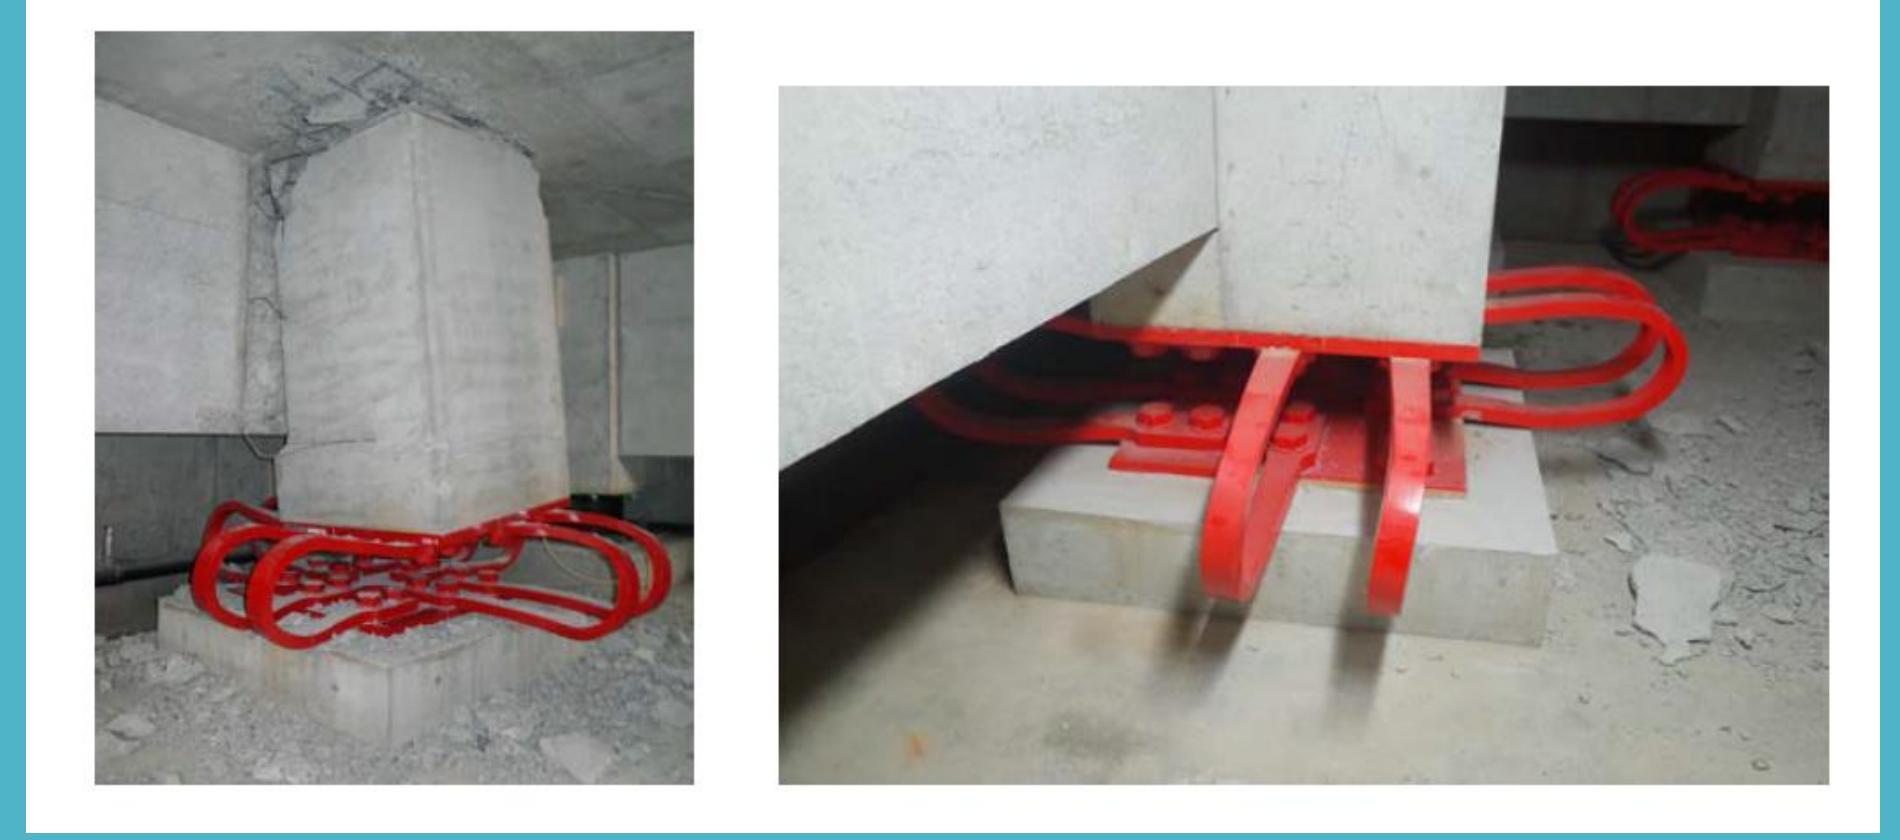
H building: Comparison of damage portion and no damage portion of steel damper

Structural capacity and durability should be reconfirmed after earthquake.

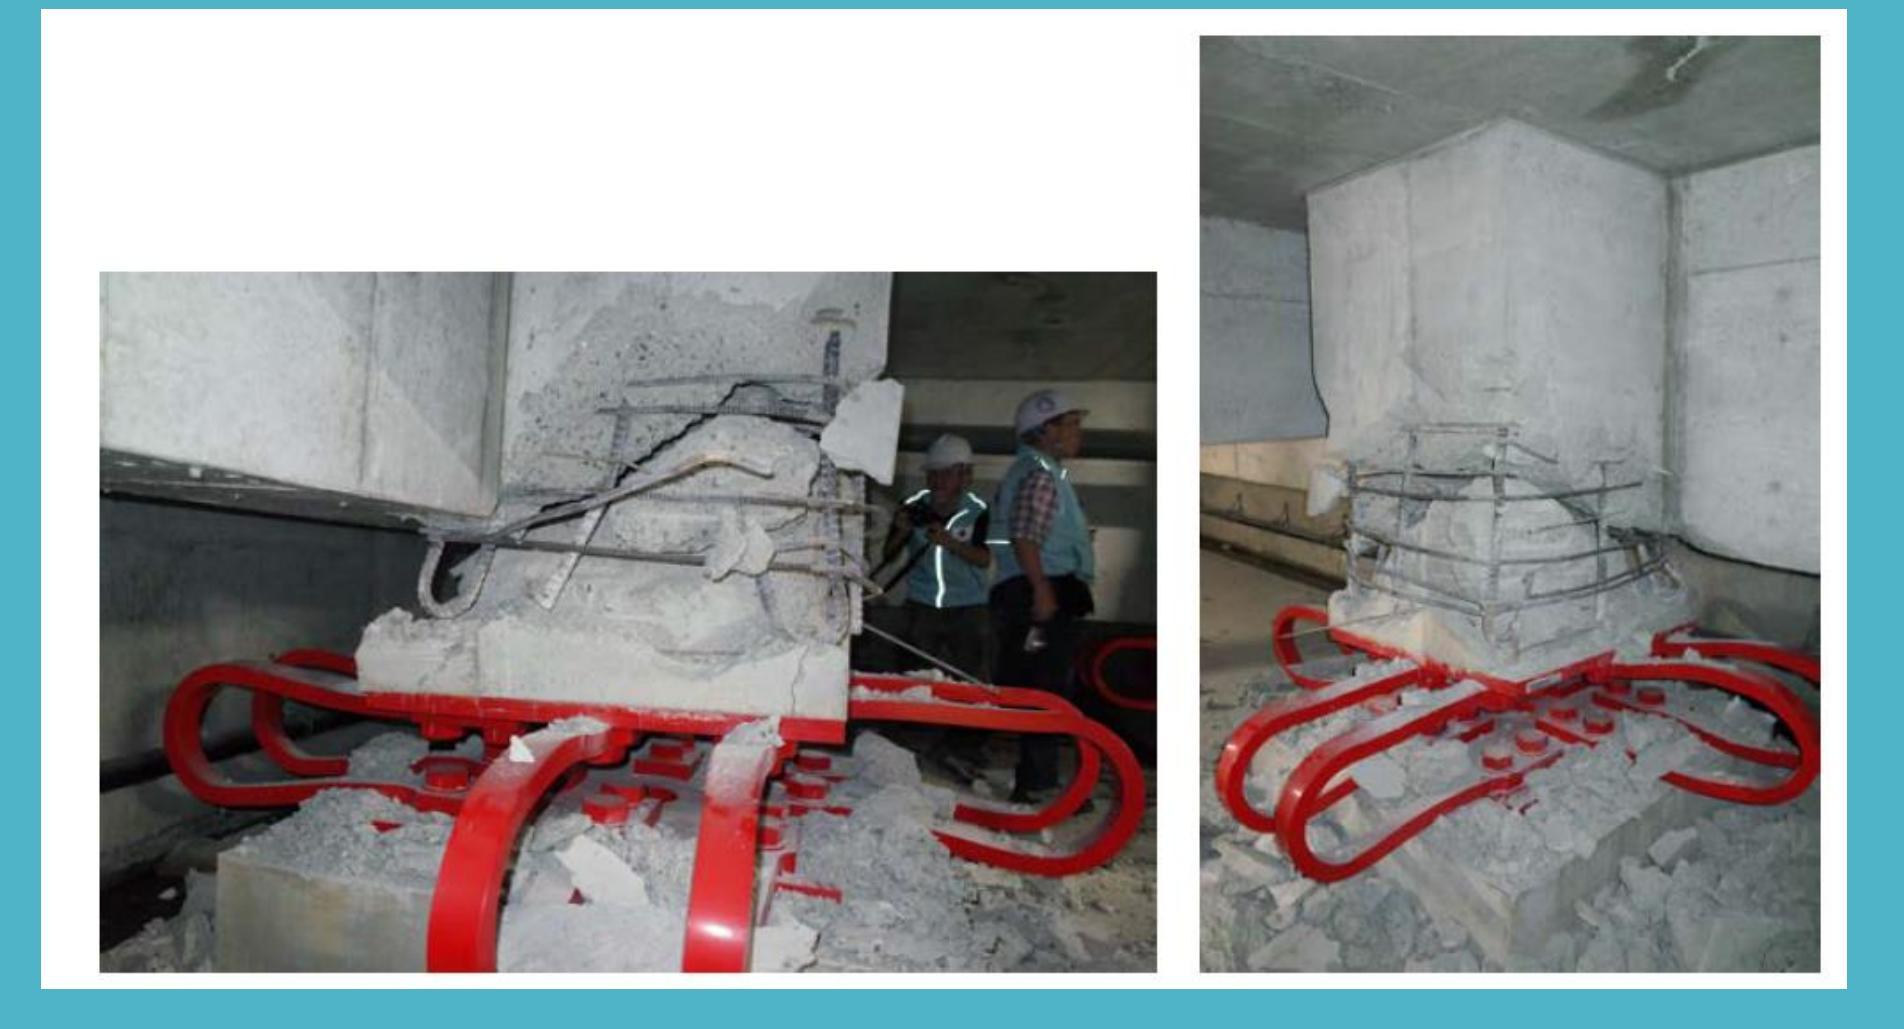
H building: Damage portion of steel damper

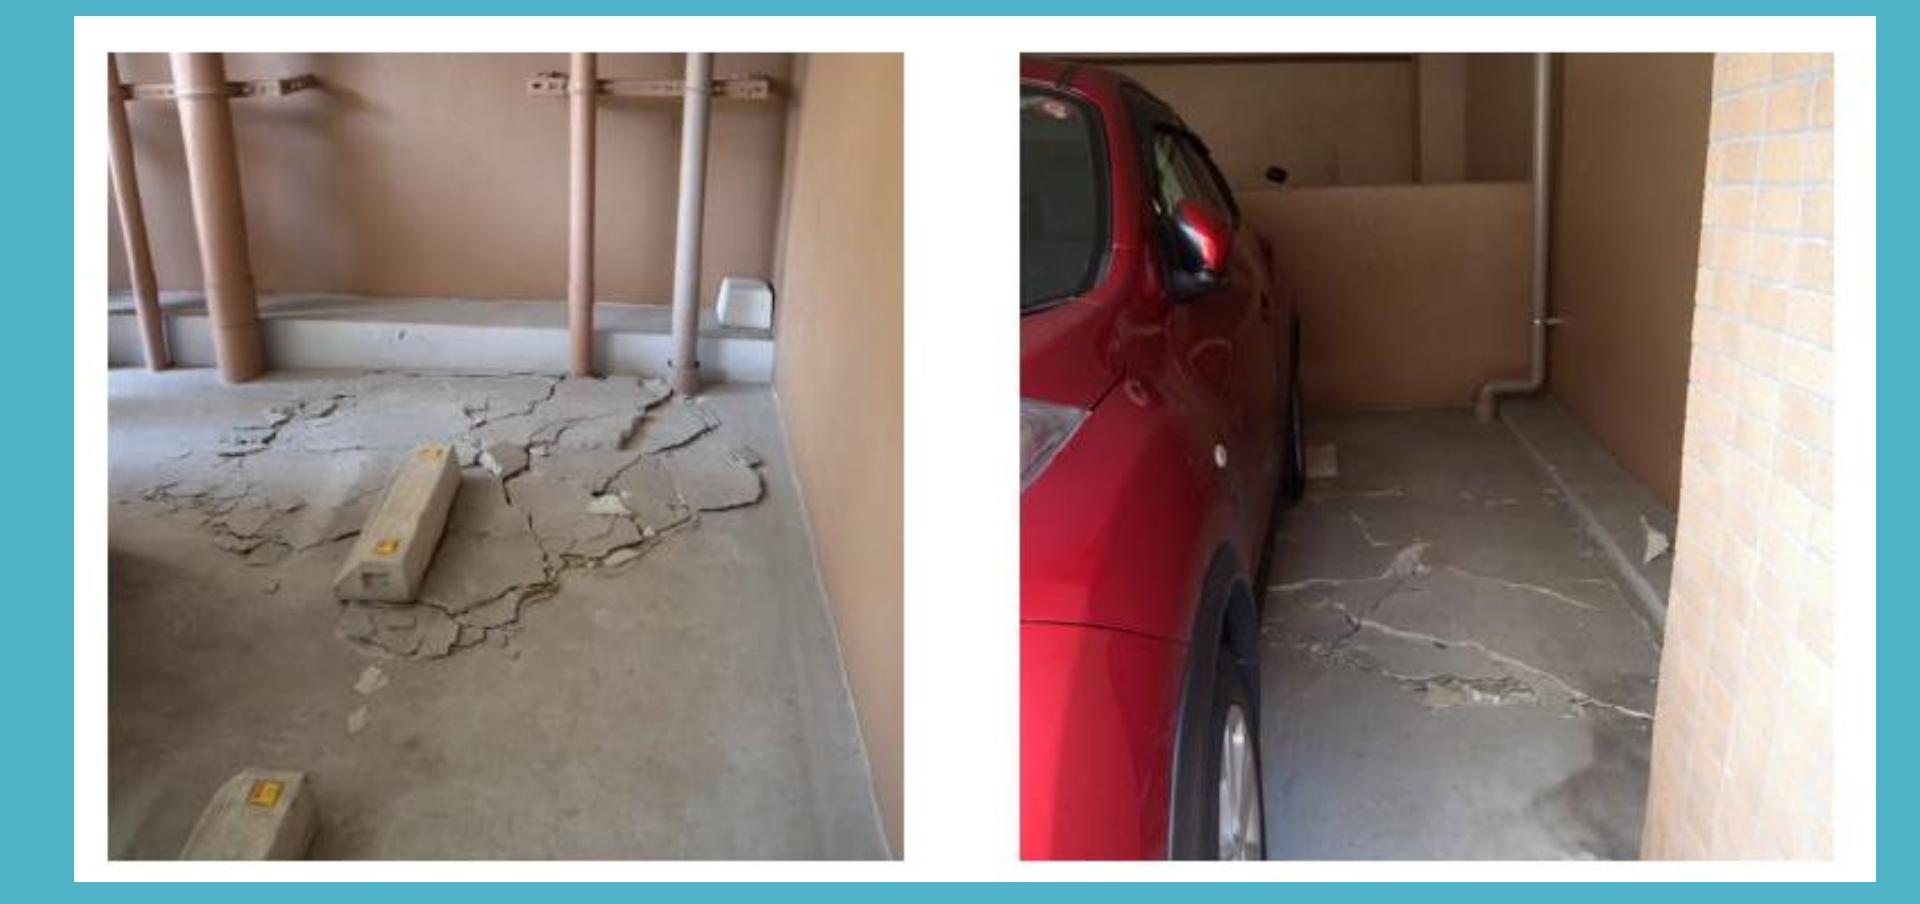
H building: Damage of the upper floor's slab
