A NEW STRUCTURAL HEALTH MONITORING SYSTEM FOR REAL-TIME EVALUATION OF BUILDING DAMAGE

Koichi Kusunoki
Earthquake Research Institute
The University of Tokyo

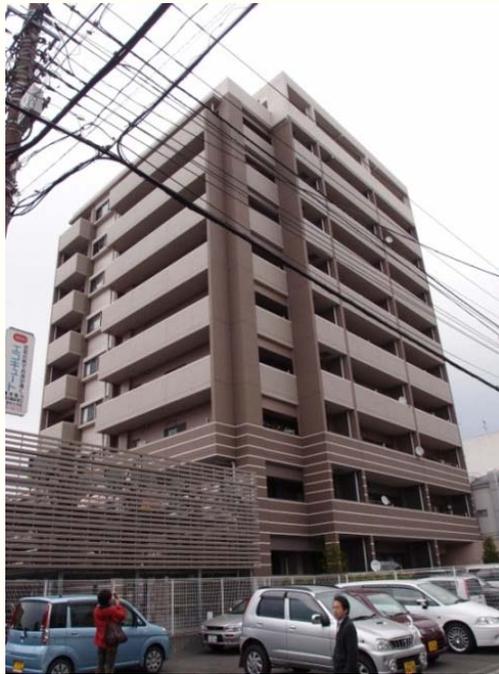
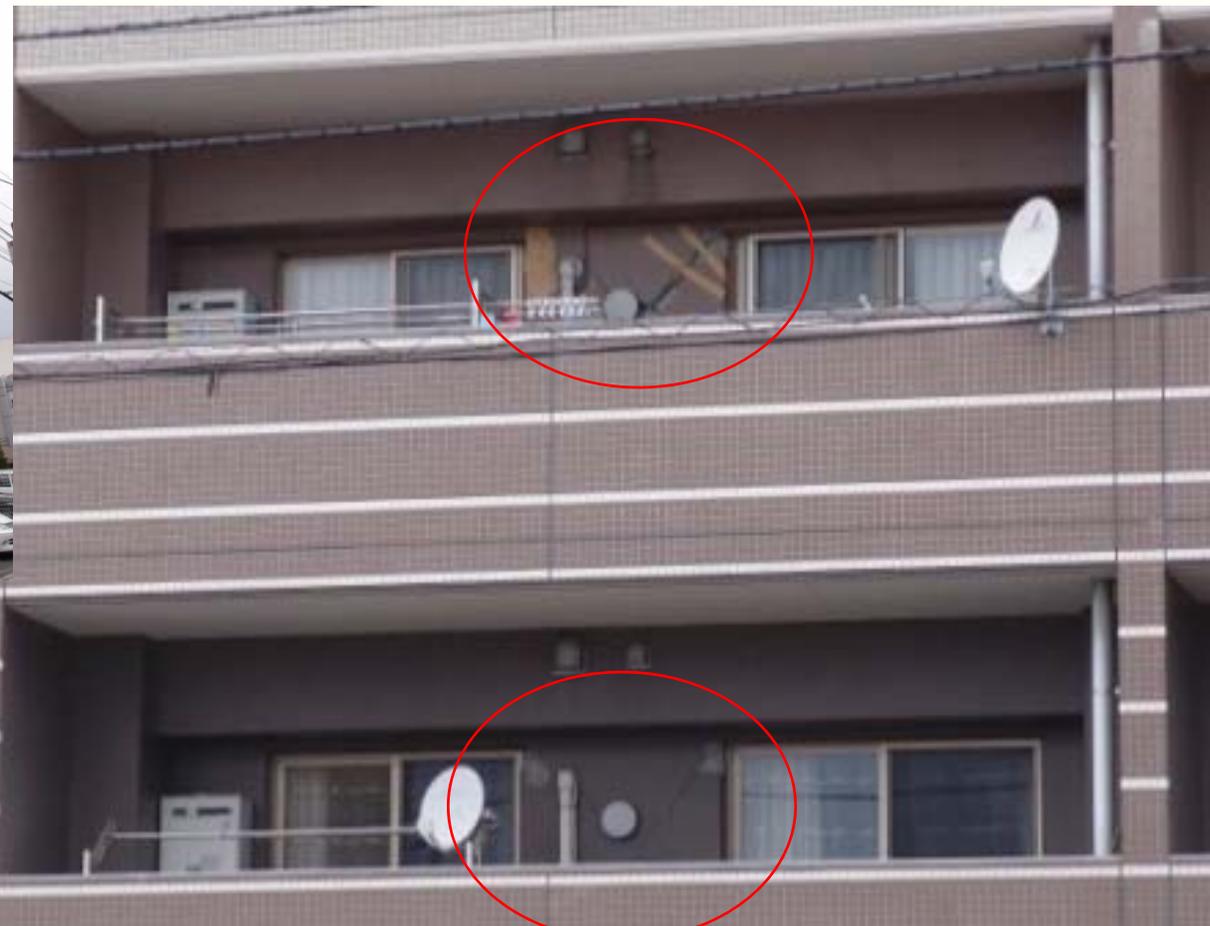
RC apartment building (10story, 2004)

Cracks in non-structural walls

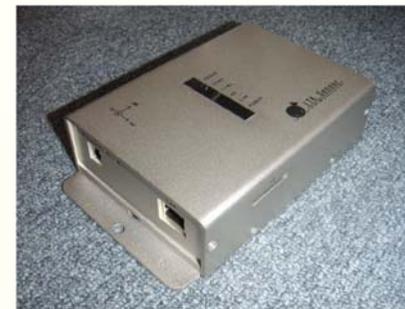
ITK sensor

- At MOST one sensor for each floor.
- Apply the Performance-based design procedure (Capacity design method).
- Compare performance curve to demand curve.
- Both curves are calculated only from the measured acceleration.

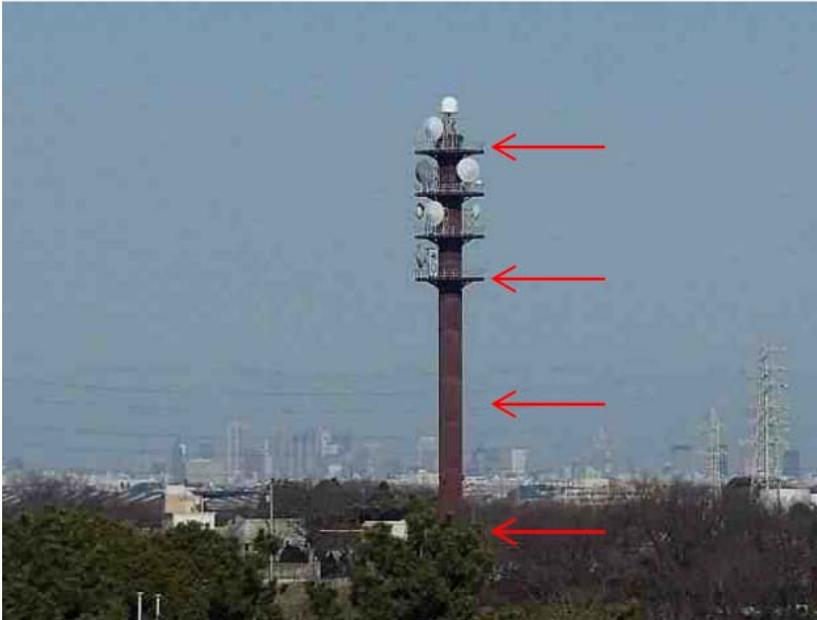
- Hazawa Tower
(H=58m)

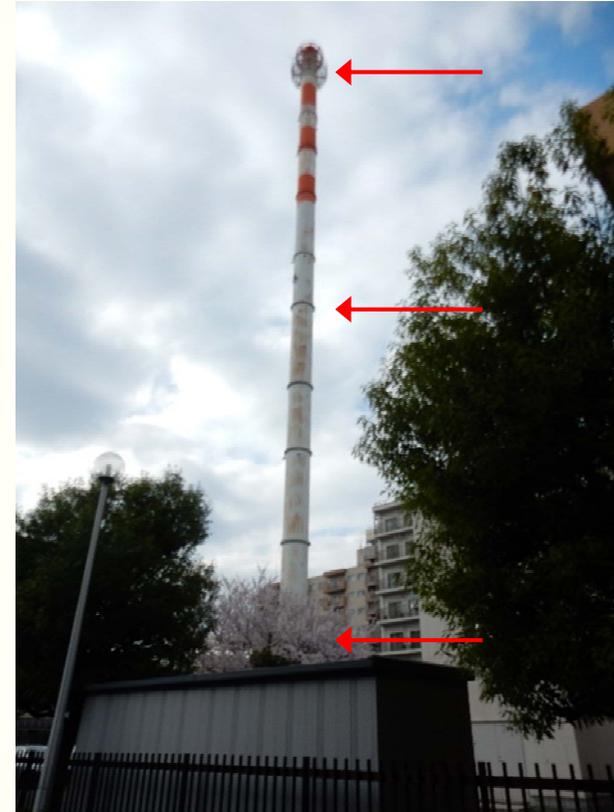
- Higashi Oshima Tower
(H=63m)

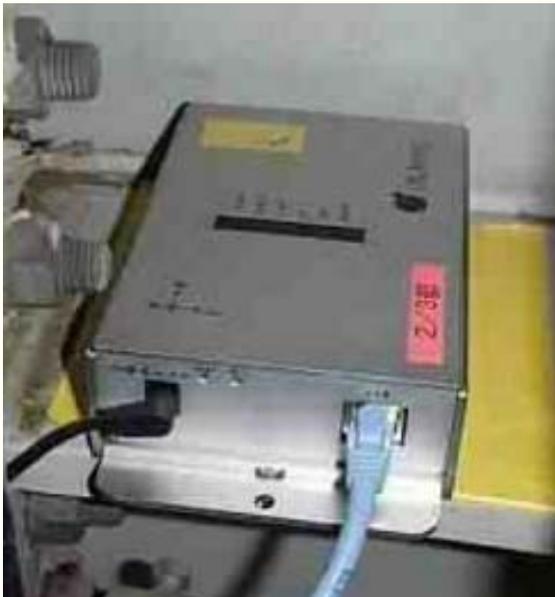
- ITK-002
Max. 2,450 cm/s²
Err. 0.1 gal/s

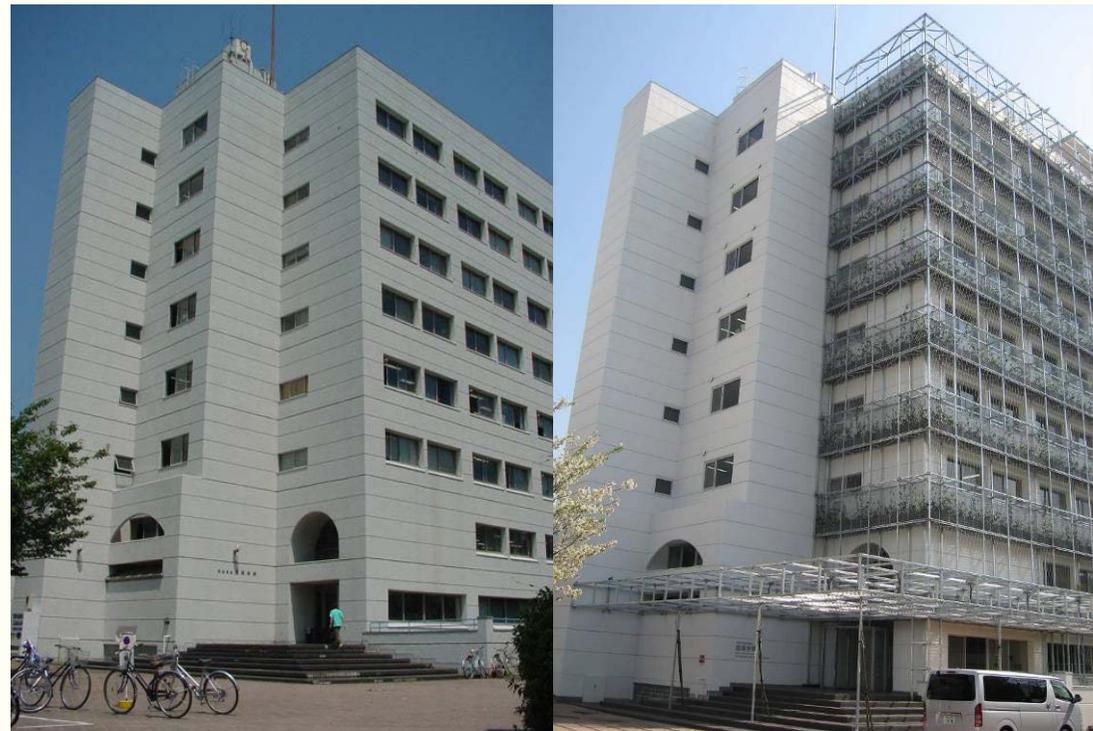
Yokohama National Univ.

- Department of architecture
- SRC structure
- H= 30.8 m
- 8-story + 1 BF
- Retrofitted before
Tohoku EQ
