# **Seismic Retrofit of the Existing RC buildings in Japan**

June 2017

Building Research Institute,  
Japan

Matsutaro SEKI

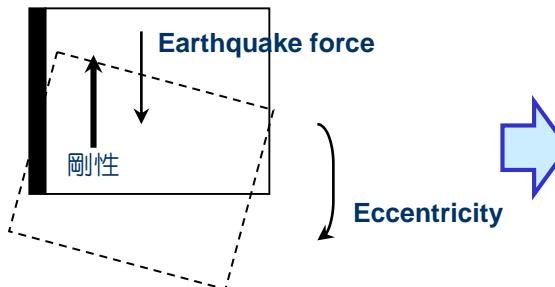
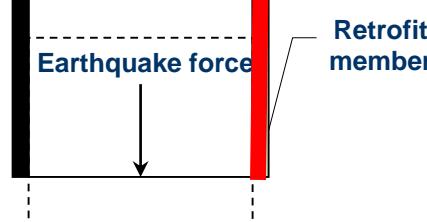
## Avoidance of the concentration of damage

Improvement of eccentricity

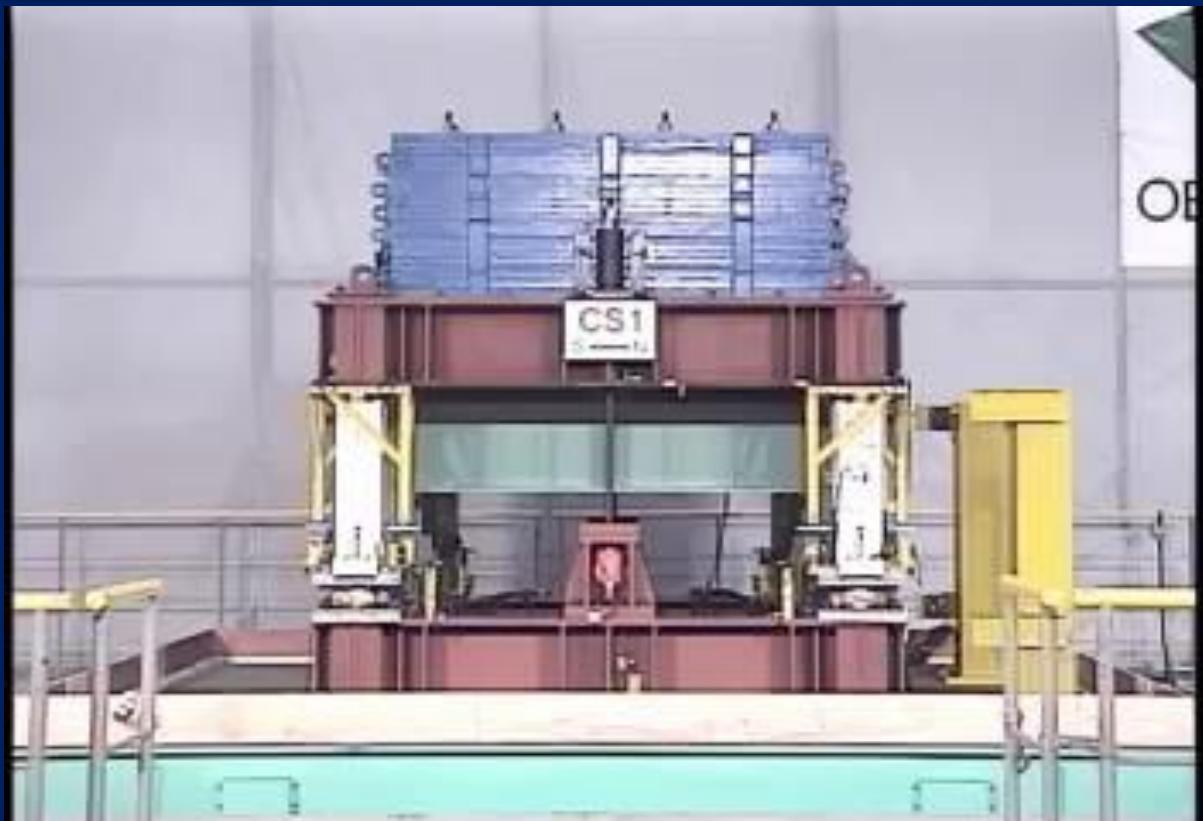
Shear failure column

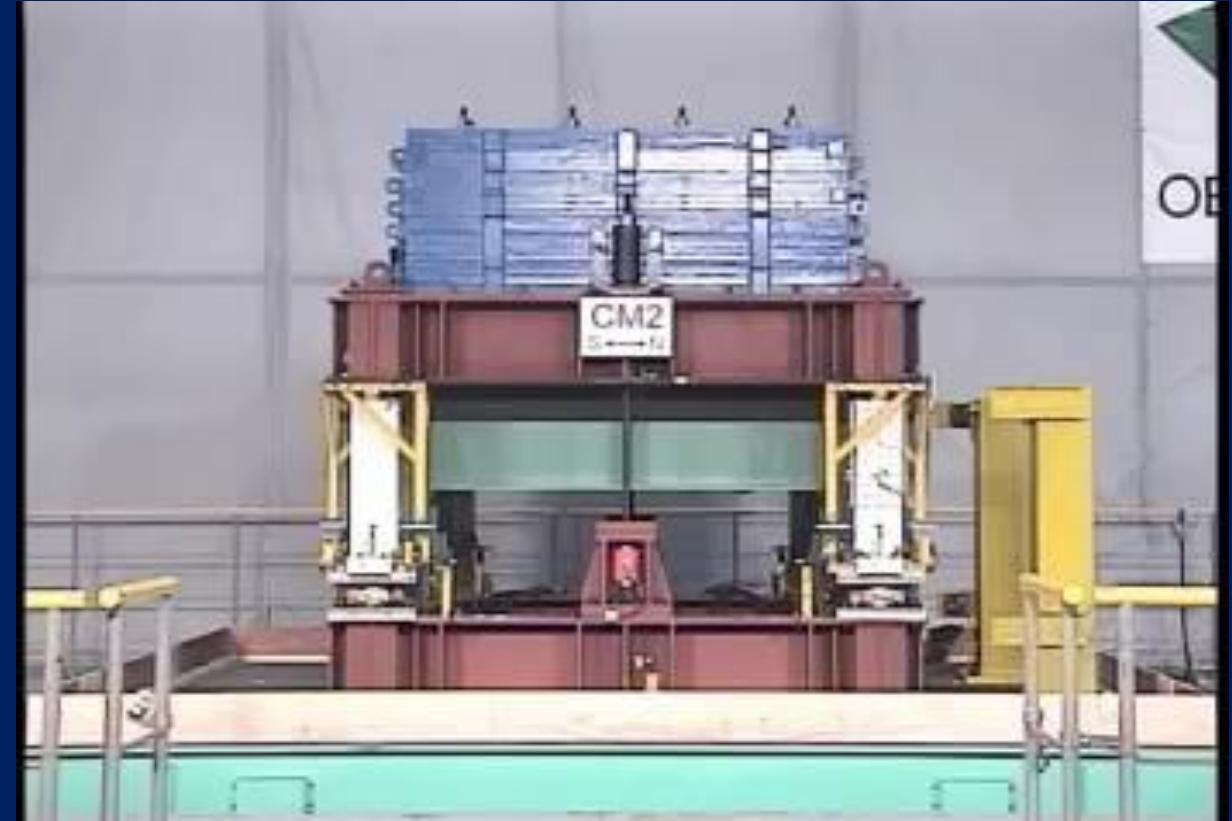
Flexural failure column

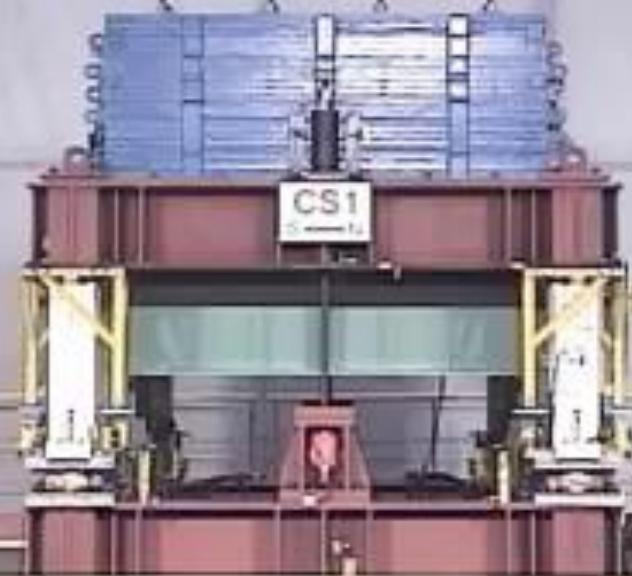
Shear failure column

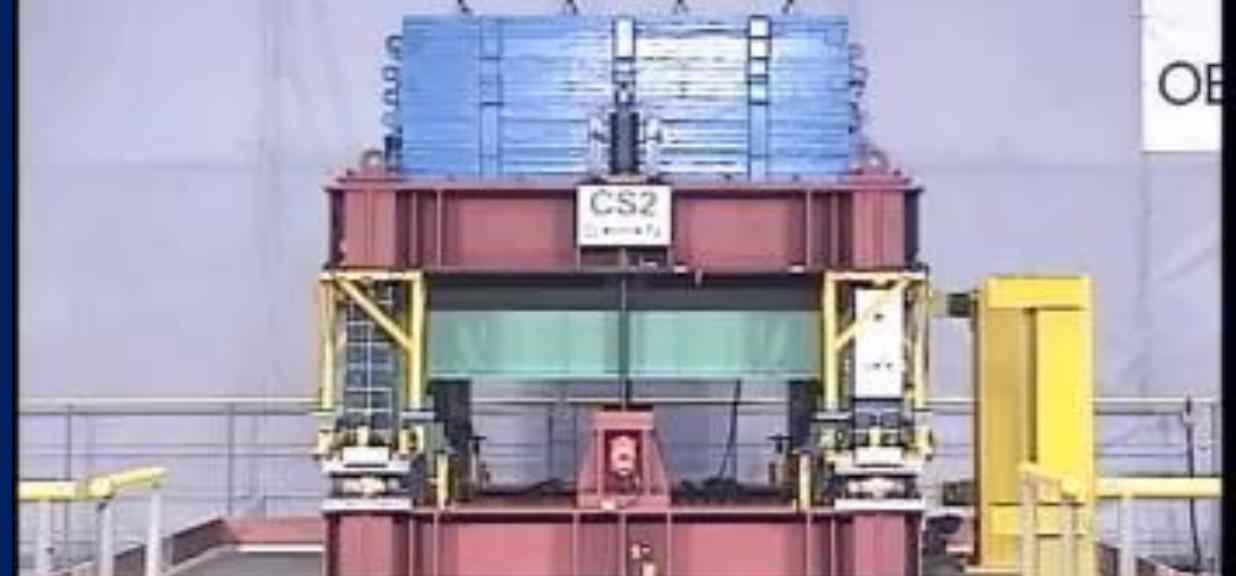
Column retrofitted  
by carbon fiber

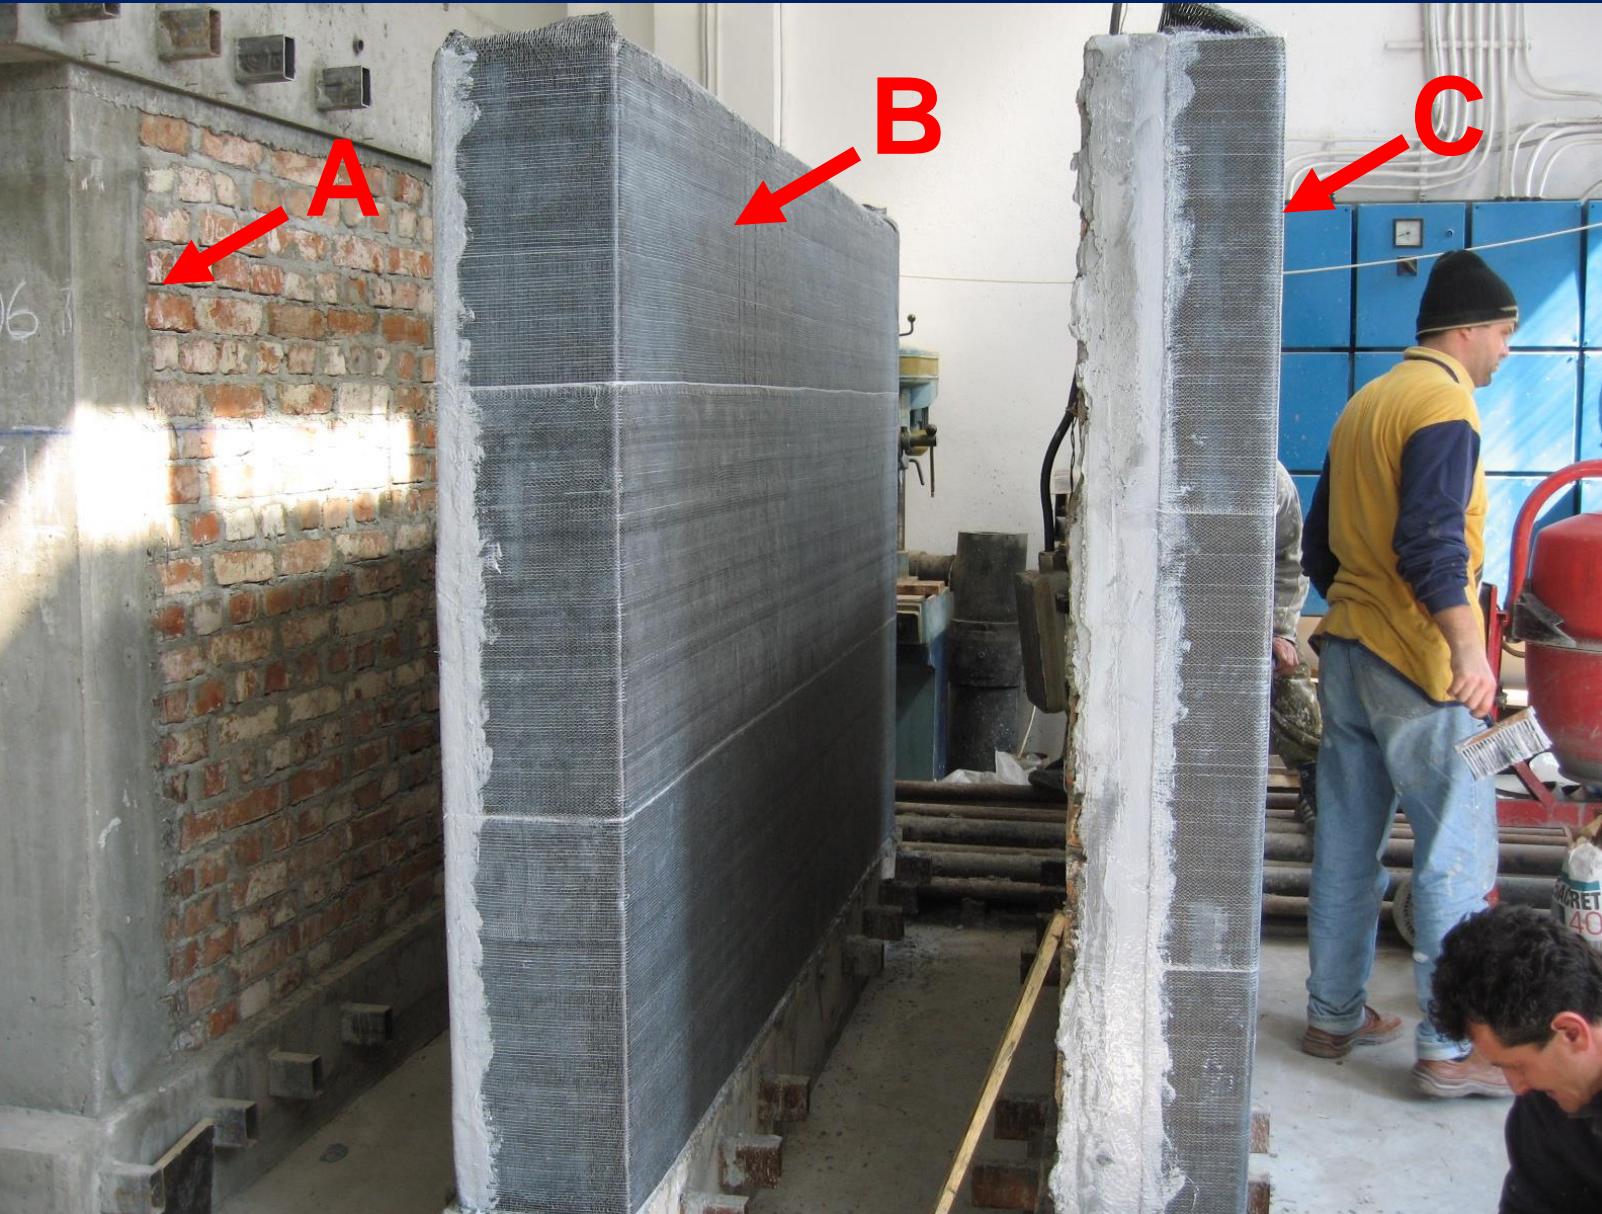
# Test specimens

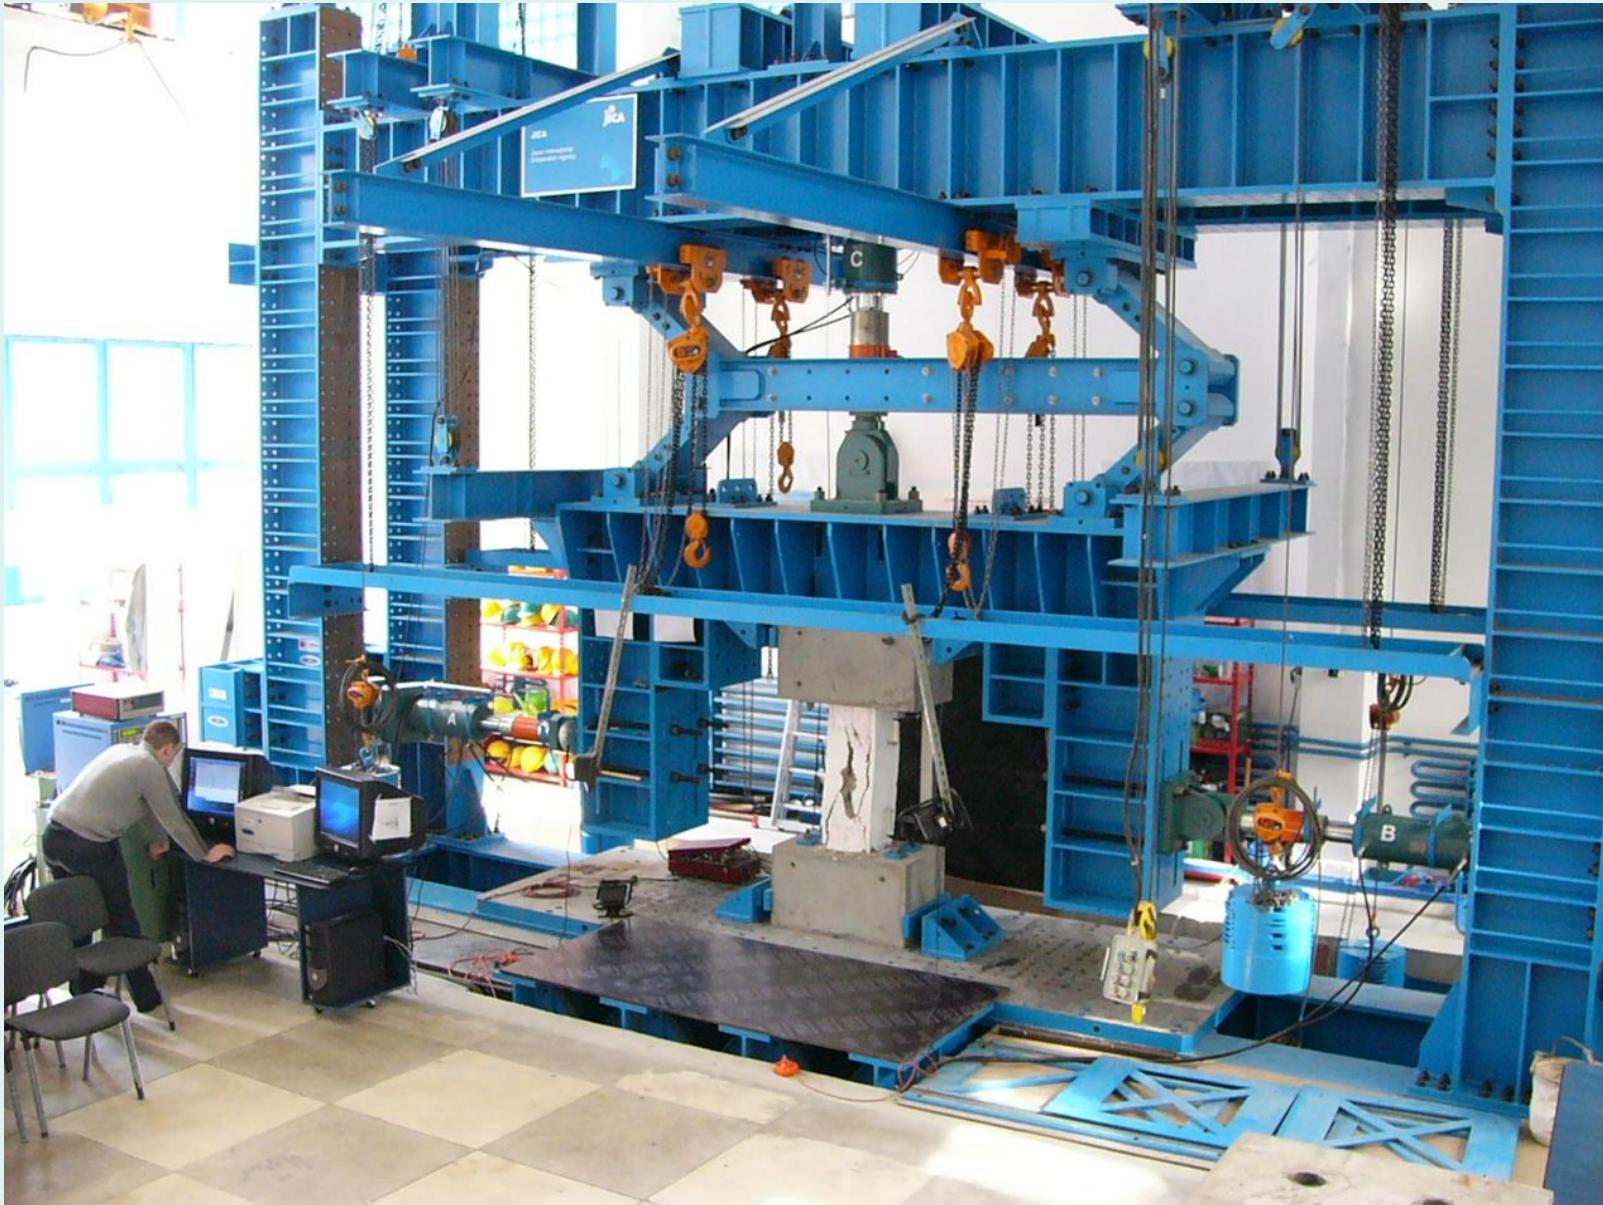
# Reaction frame at UTCB

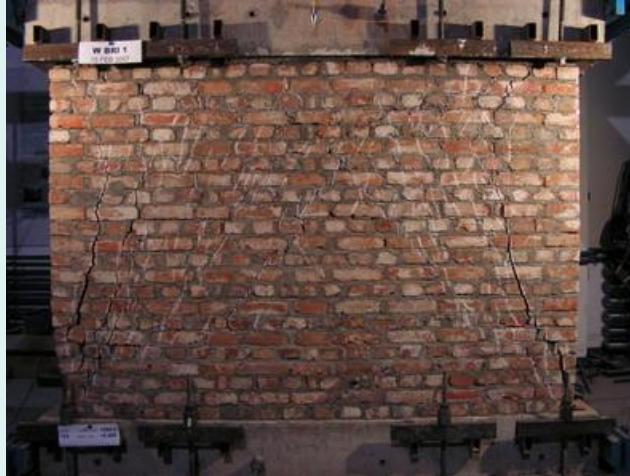
### Damage state of the Specimens at Collapse

WBRI1 (A)

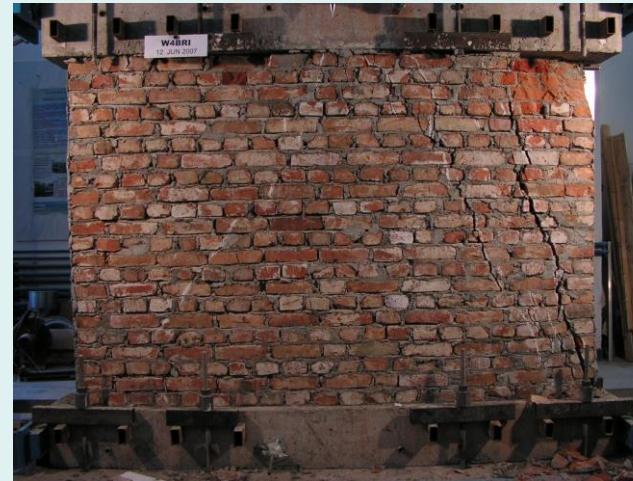
WBRI4 – carbon fiber on one face  
(C)

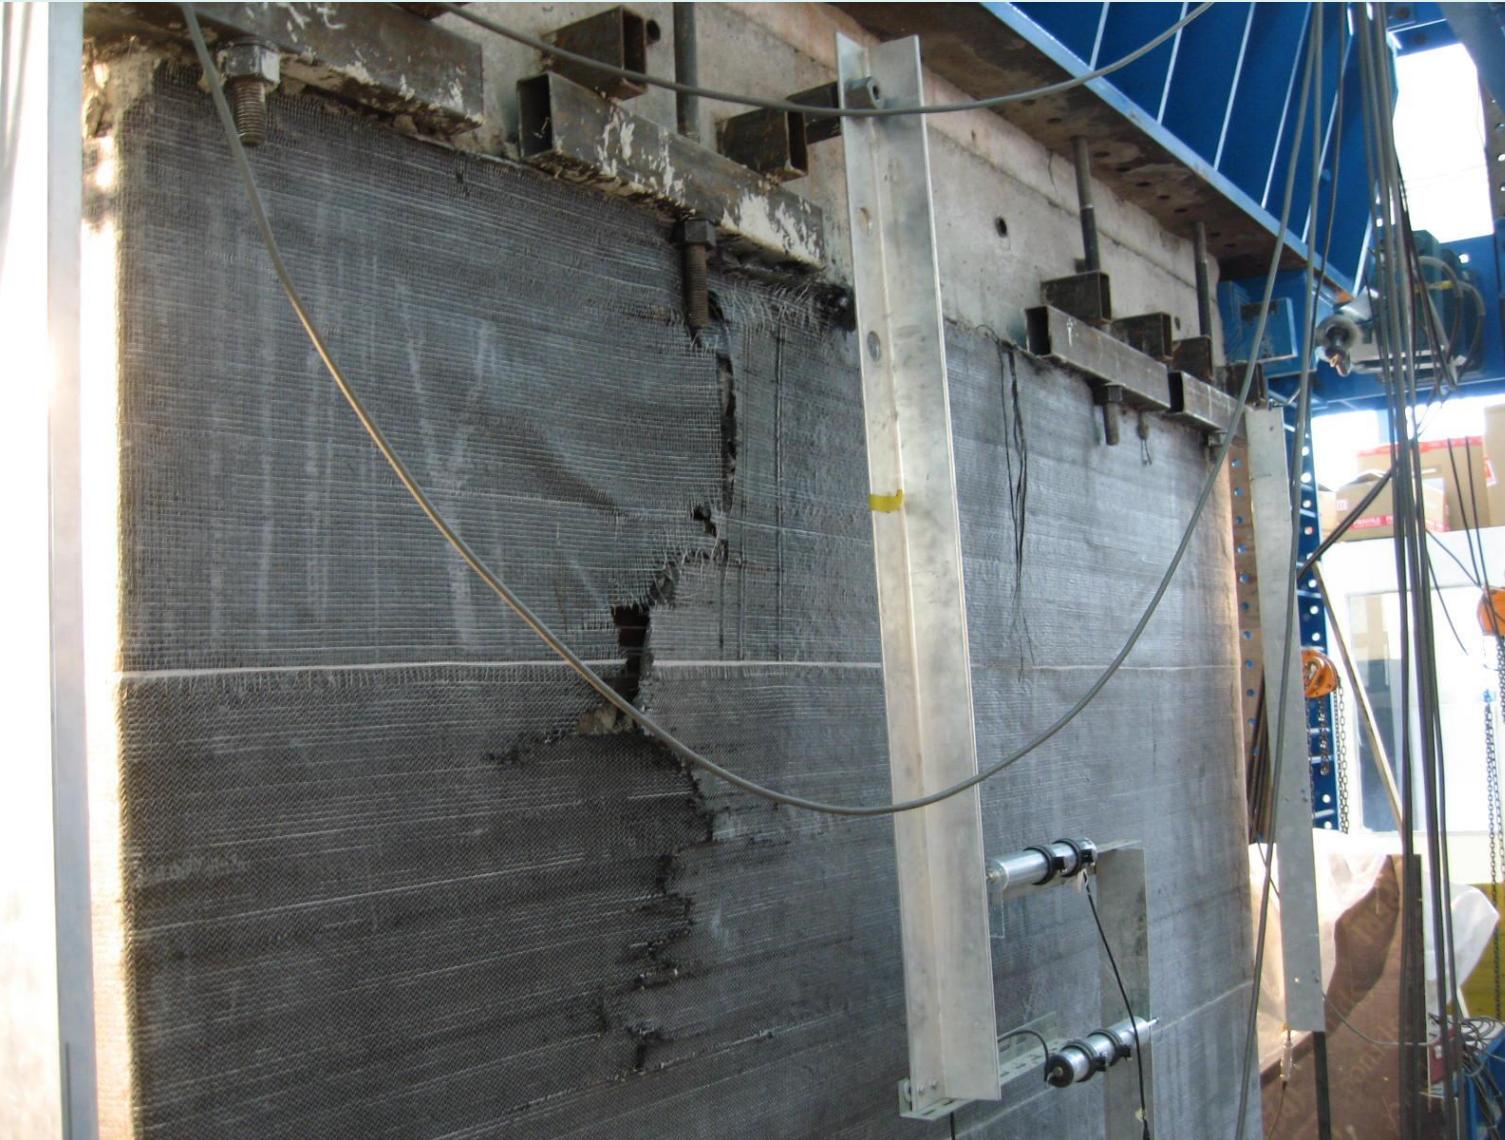
WBRI3-carbon fiber on both faces (B)

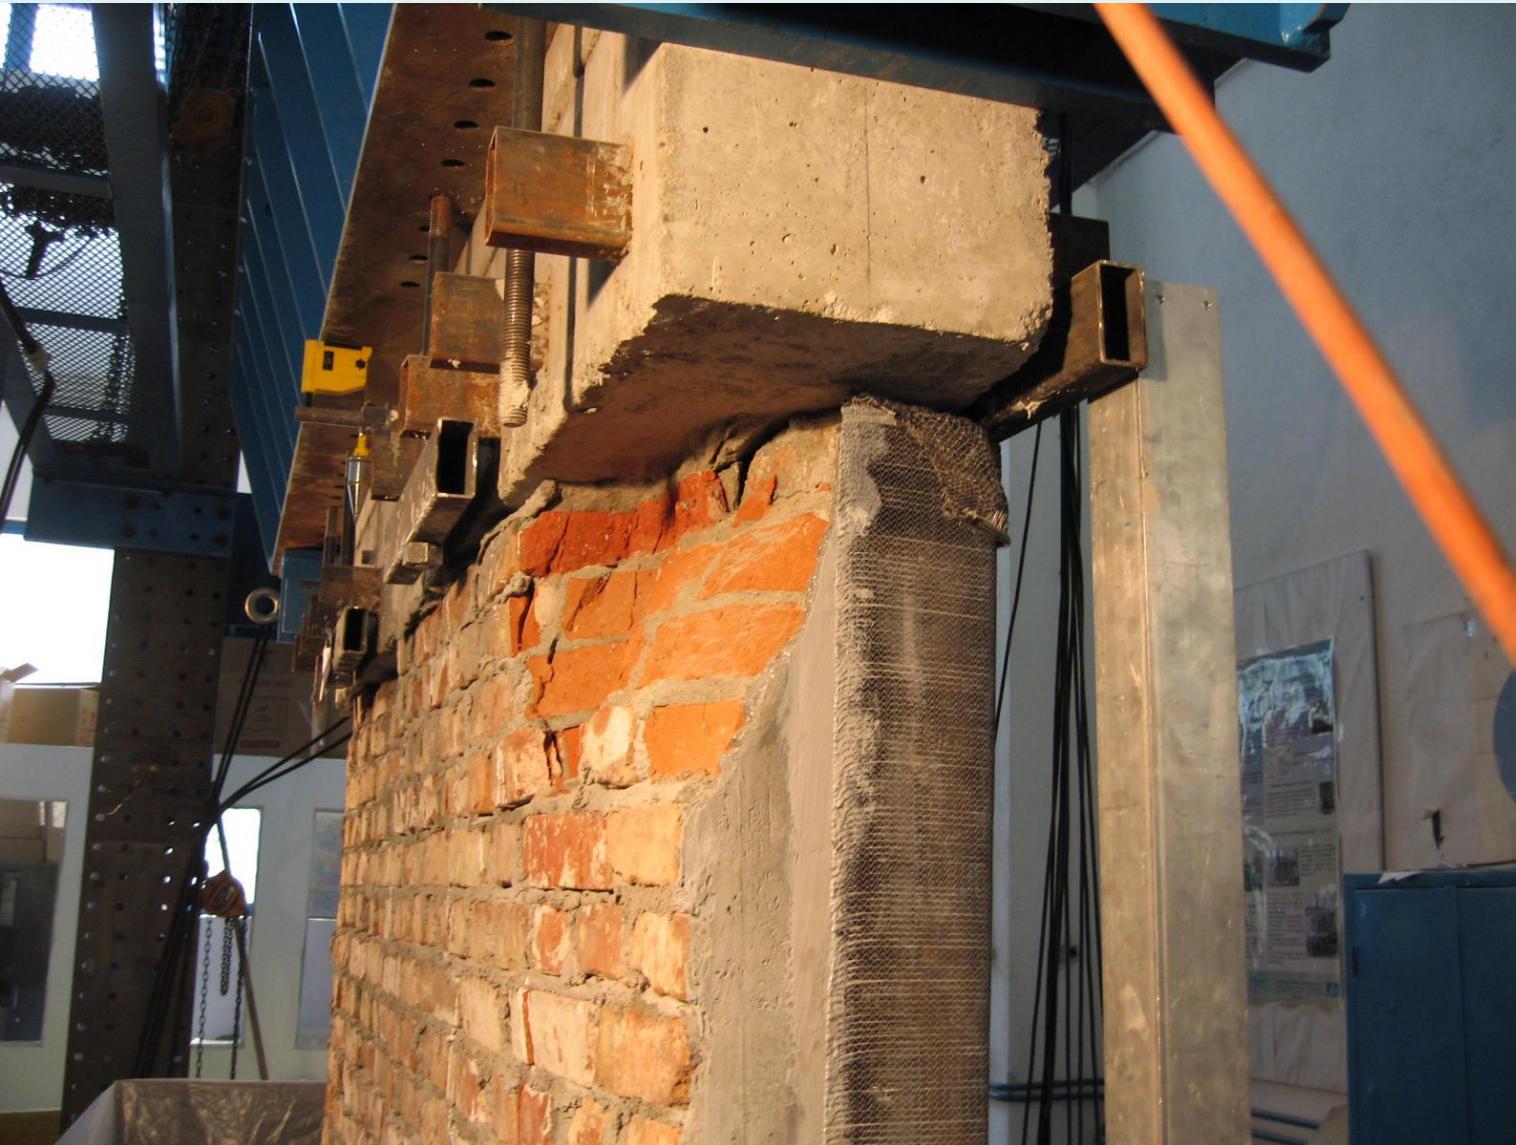
WBRI4 – carbon fiber on one face(C)

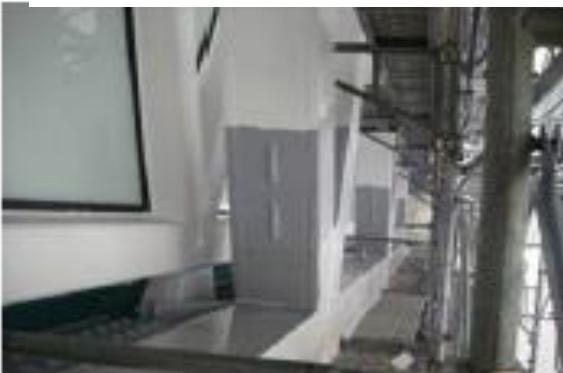
⑫ Welding of joint part

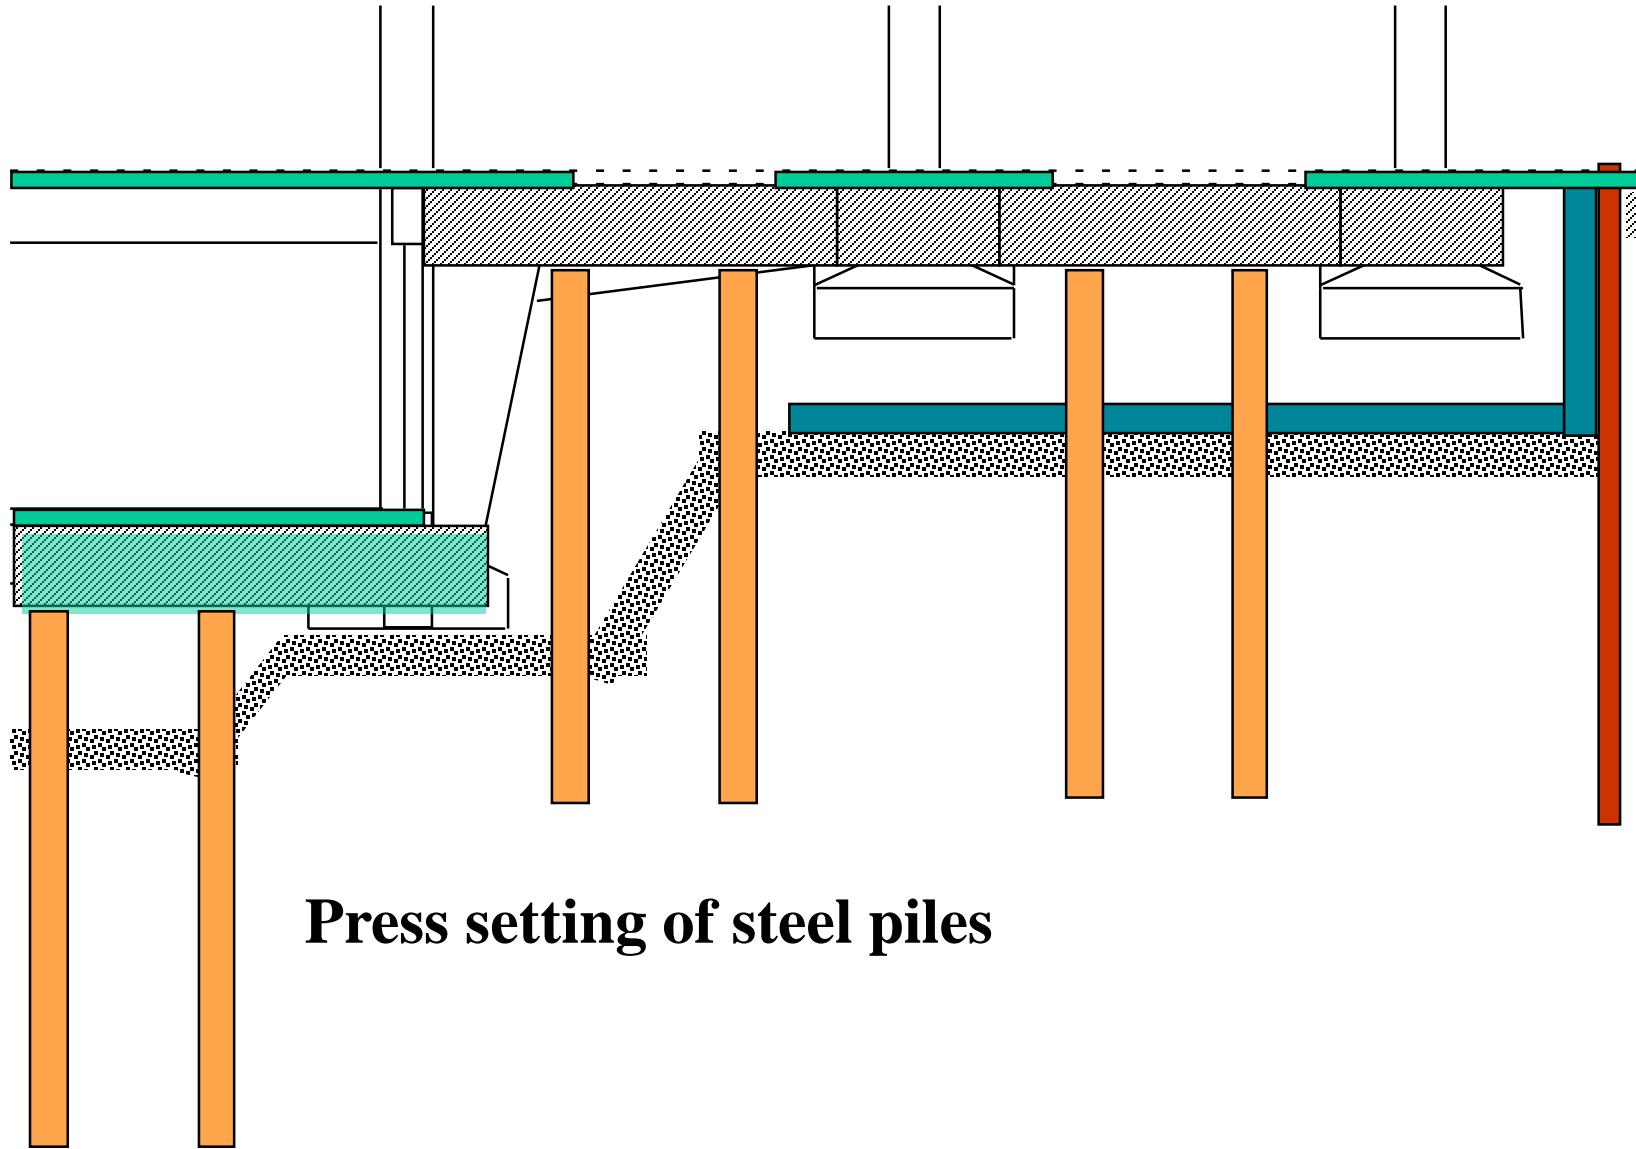
## Press setting of steel piles

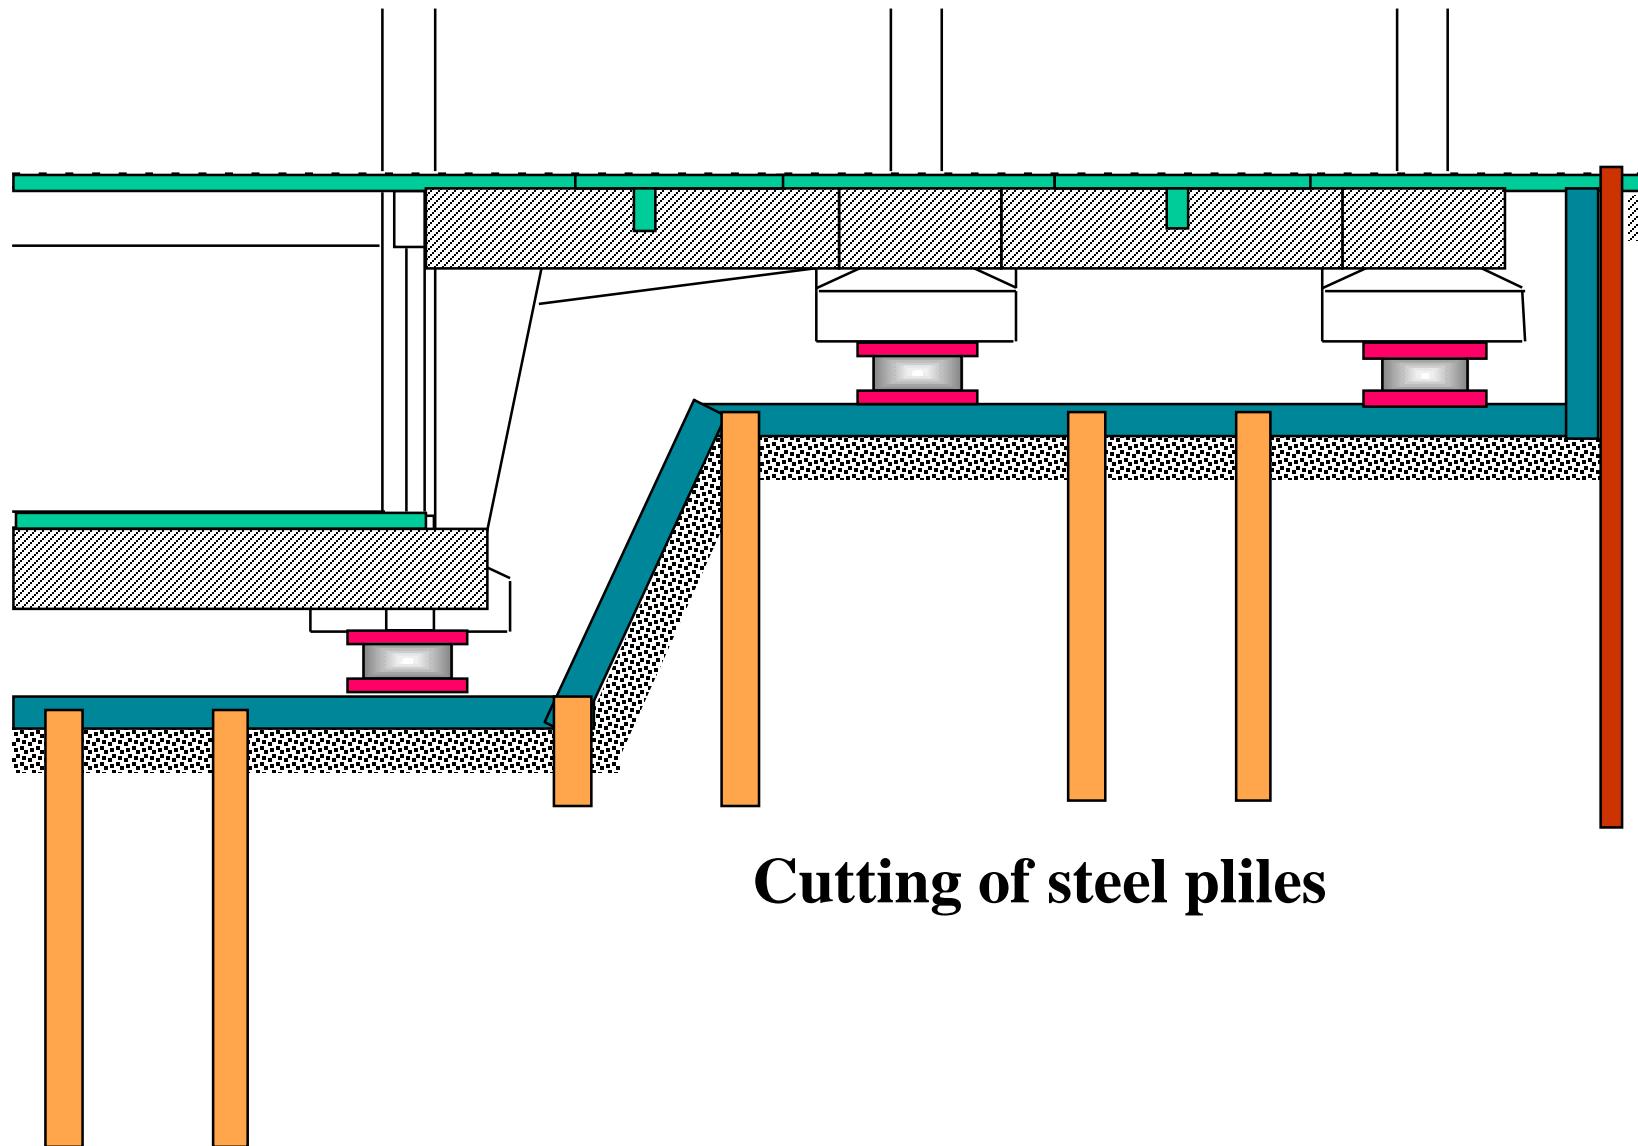
**Cutting of steel piles**

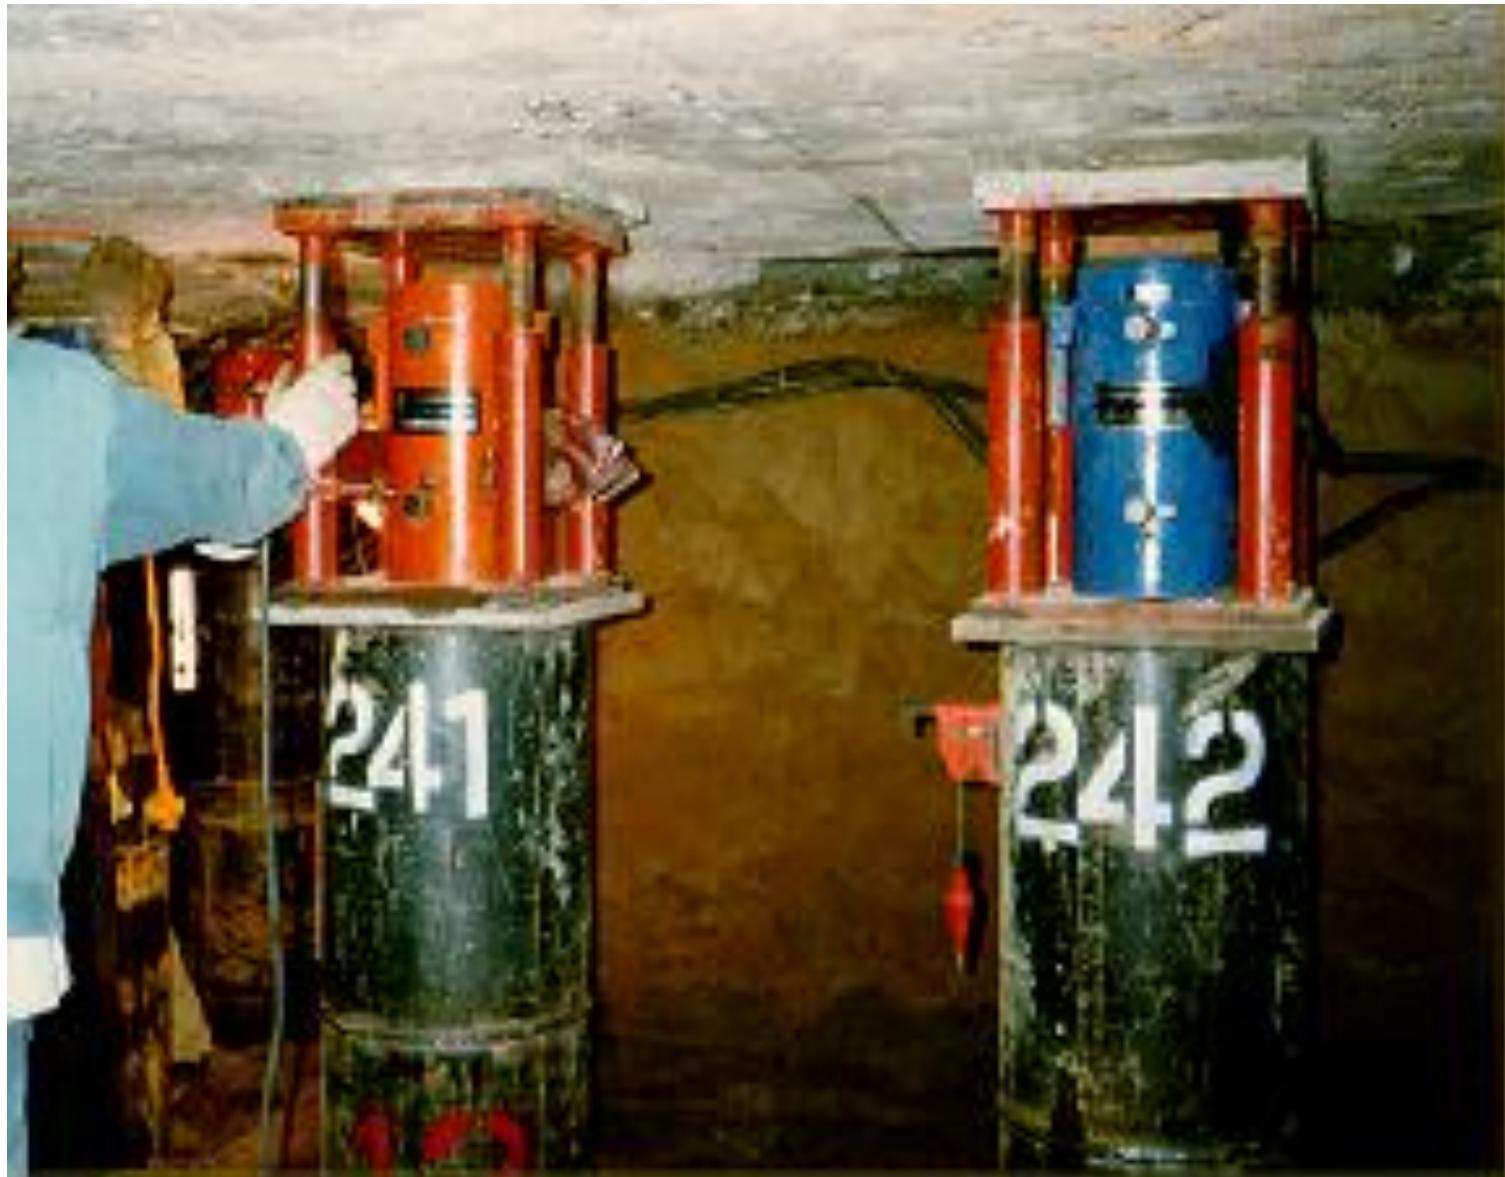
# Pressing of steel piles

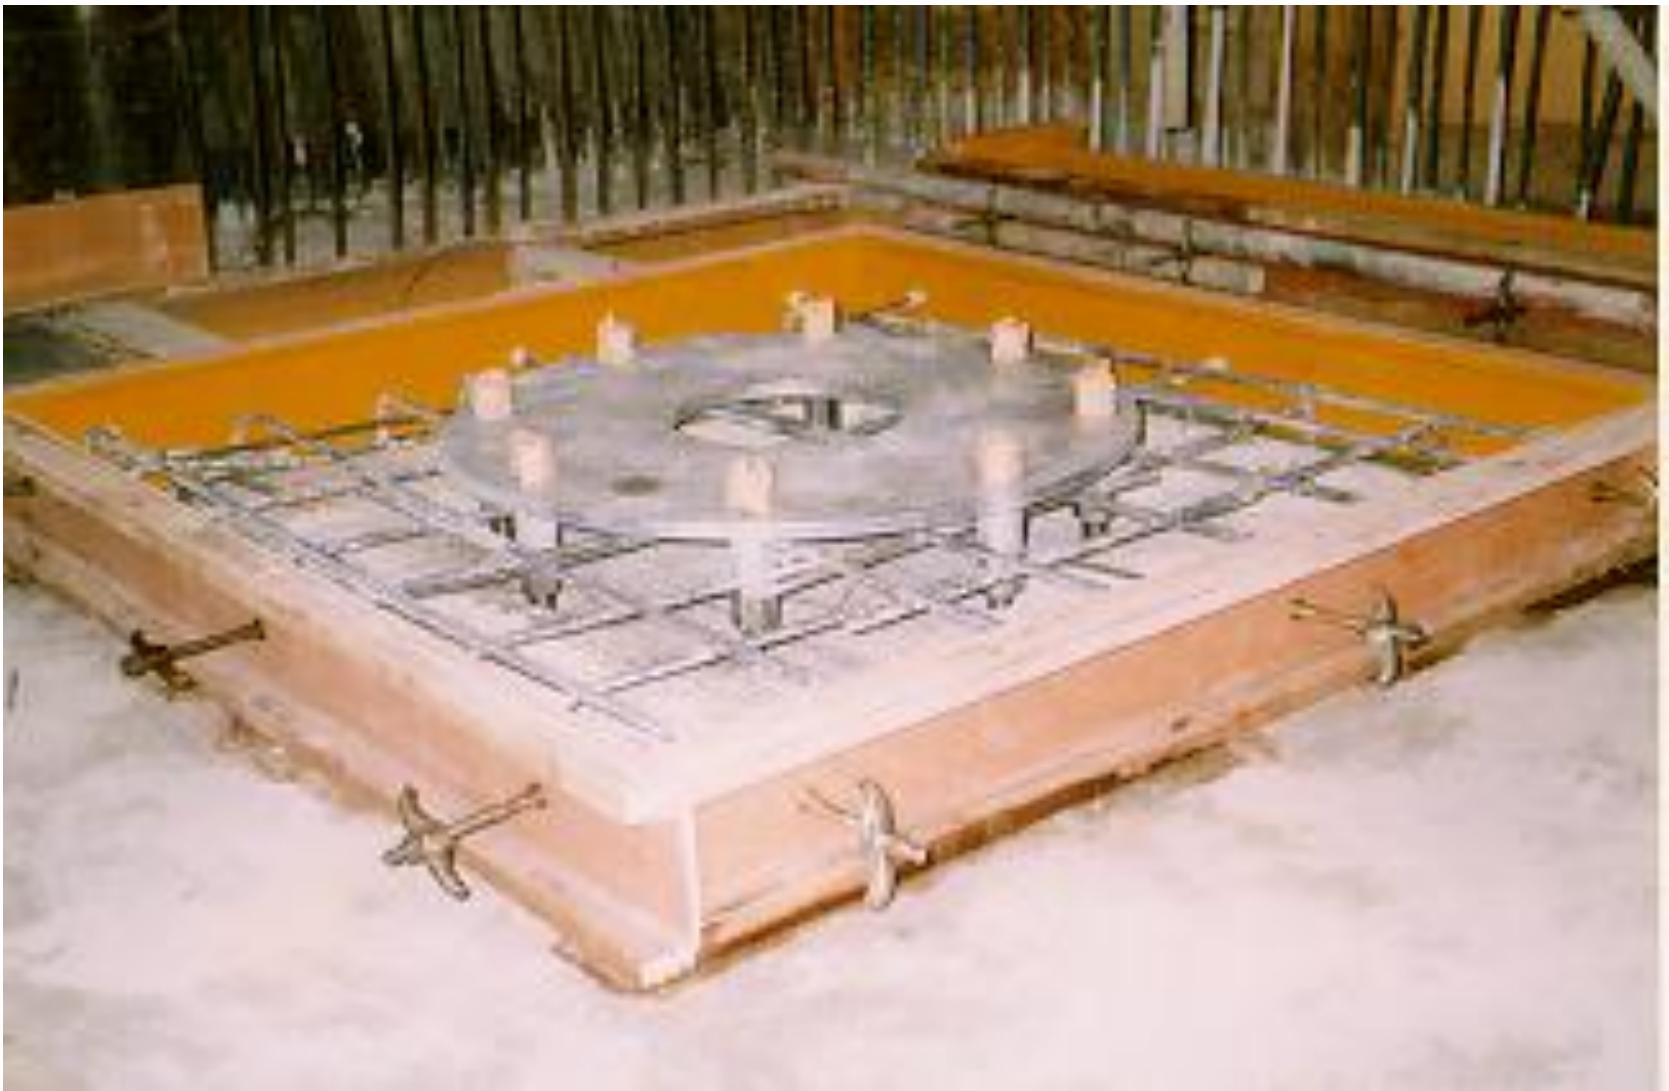
# Setting of seismic isolators

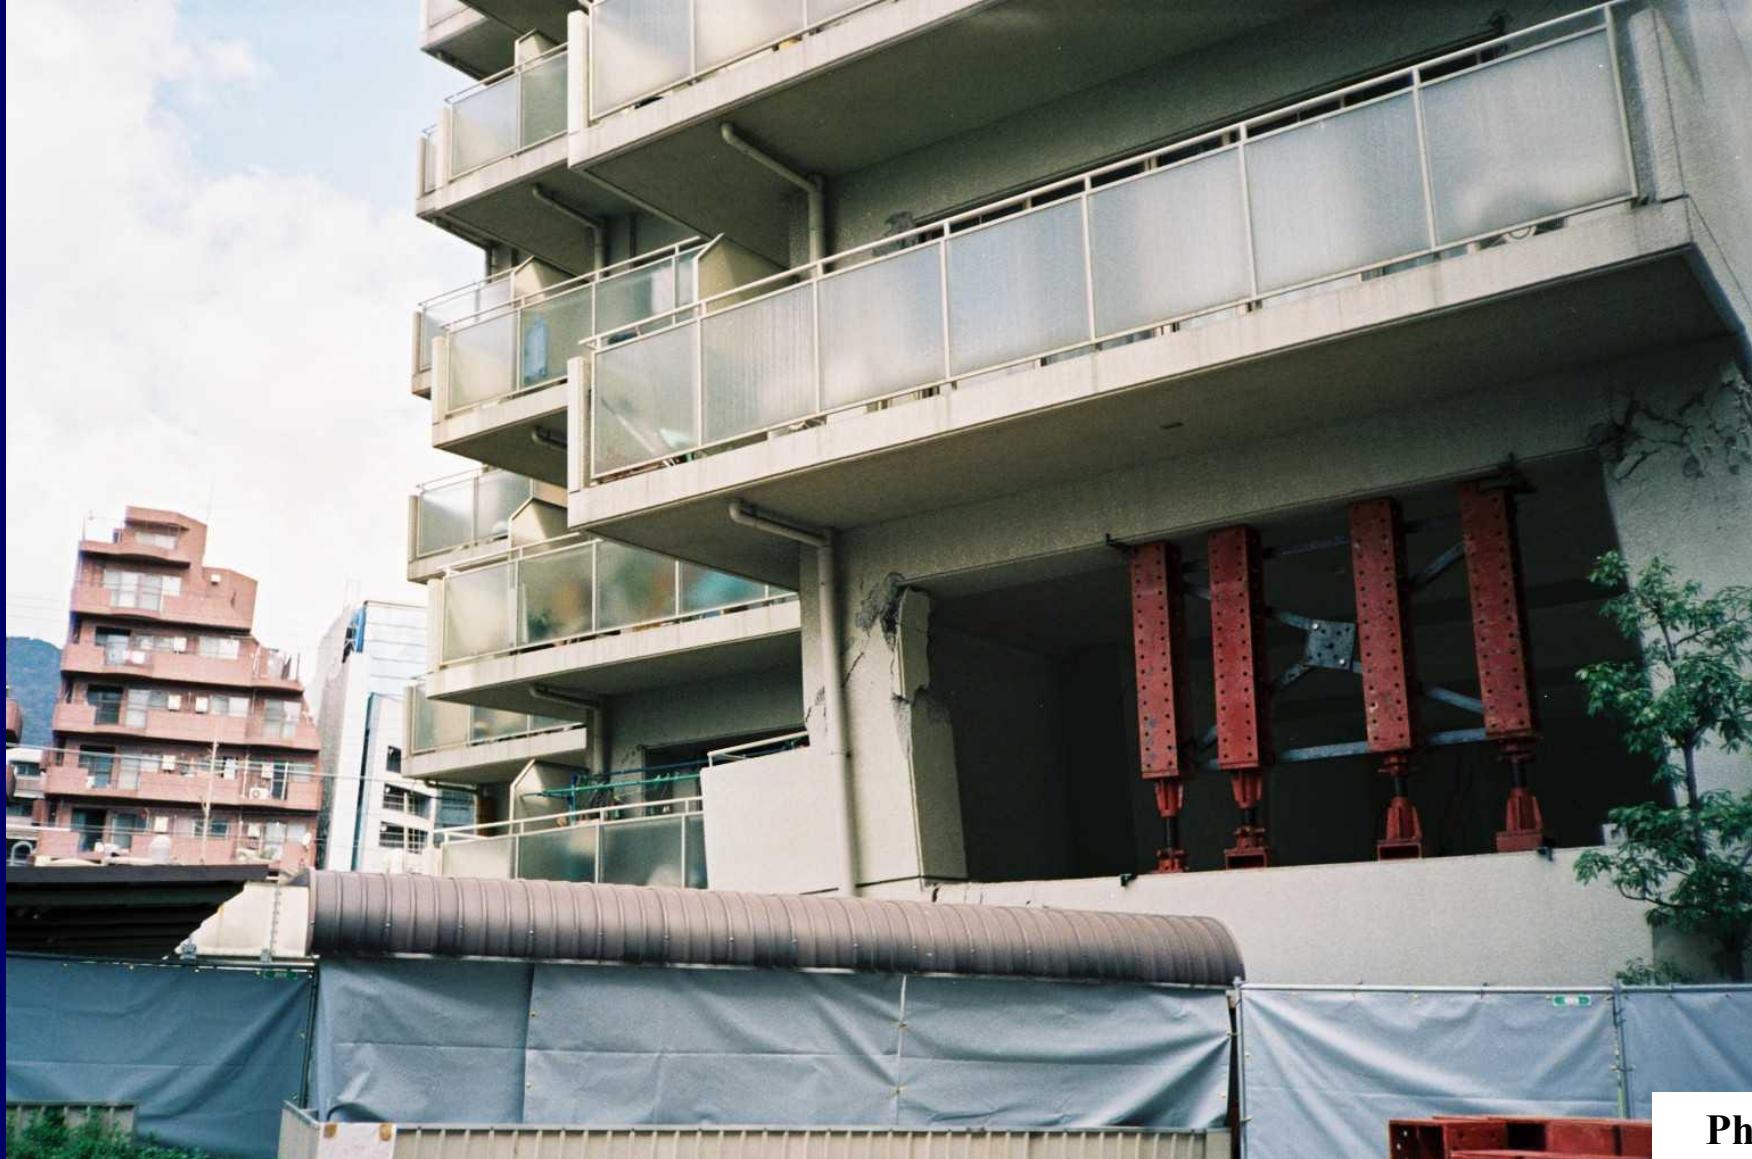
Steel post

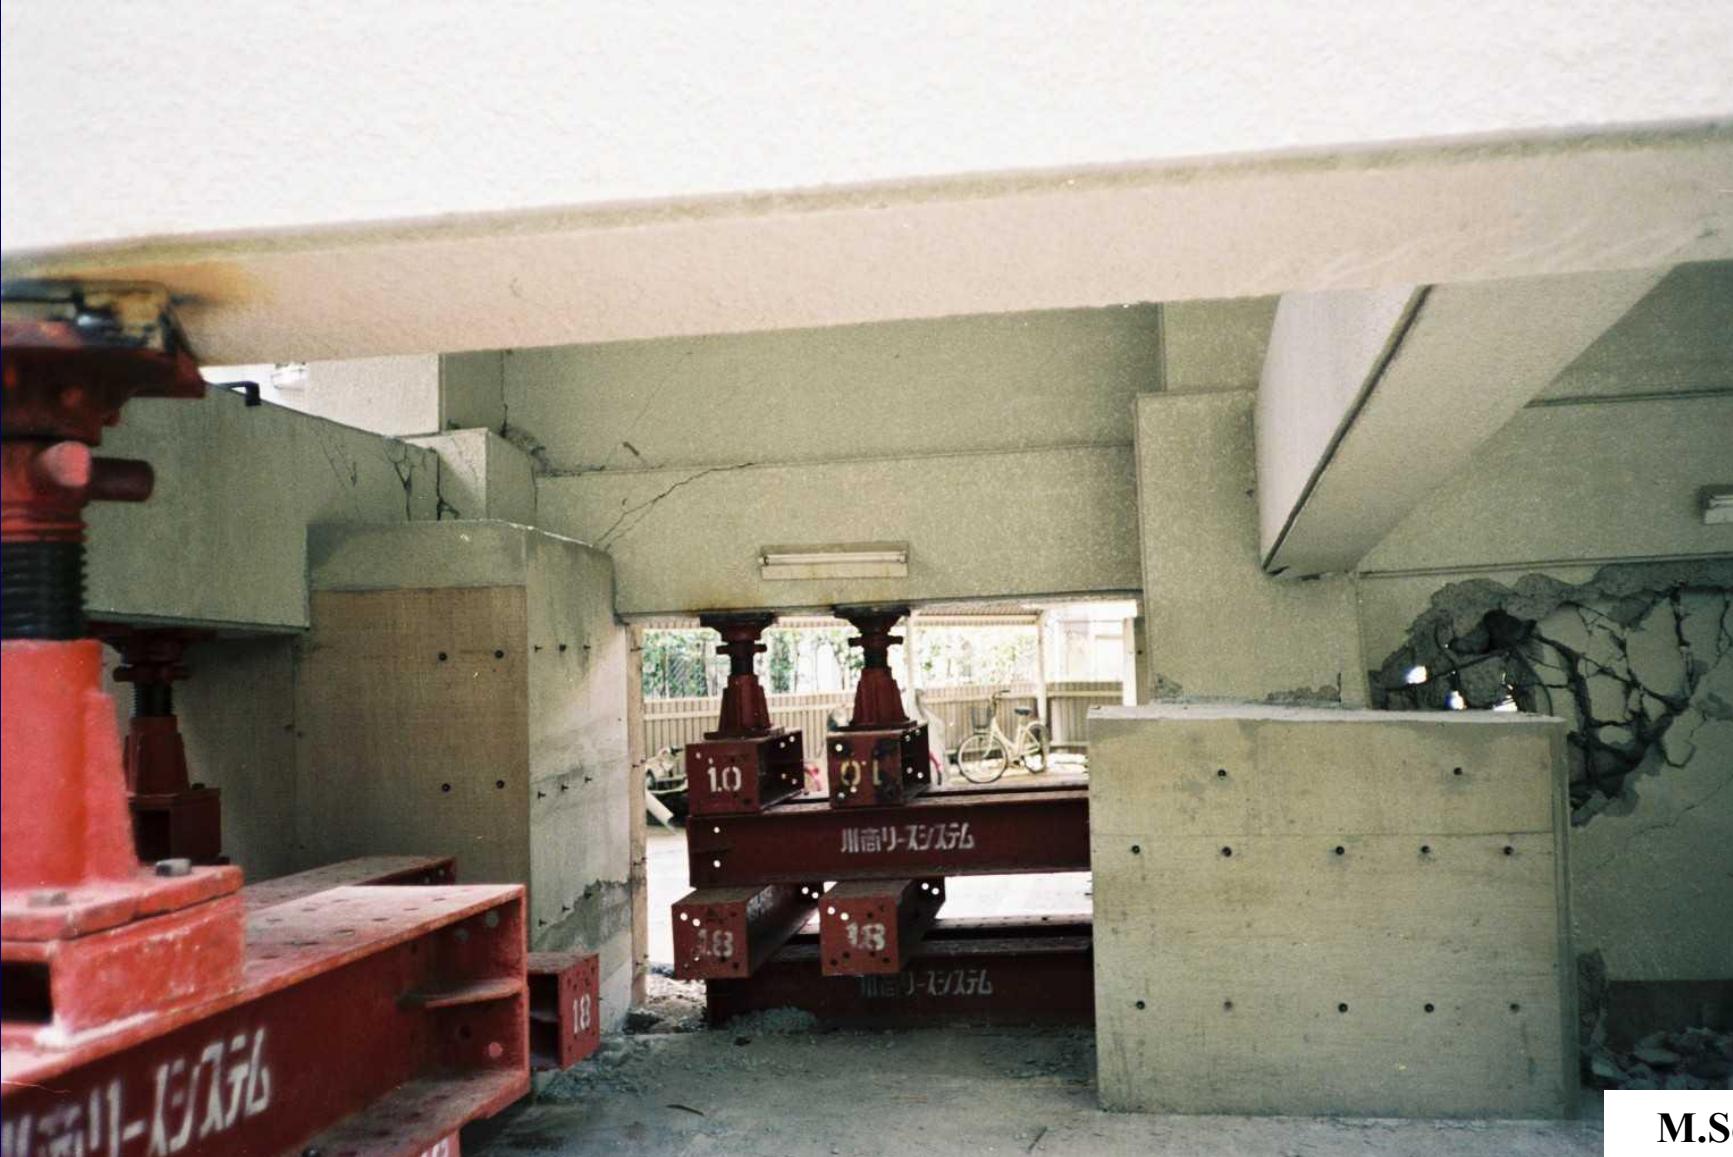
Steel post
