# **Seismic Retrofit of the Existing RC buildings in Japan**

June 2017

Building Research Institute,  
Japan

Matsutaro SEKI

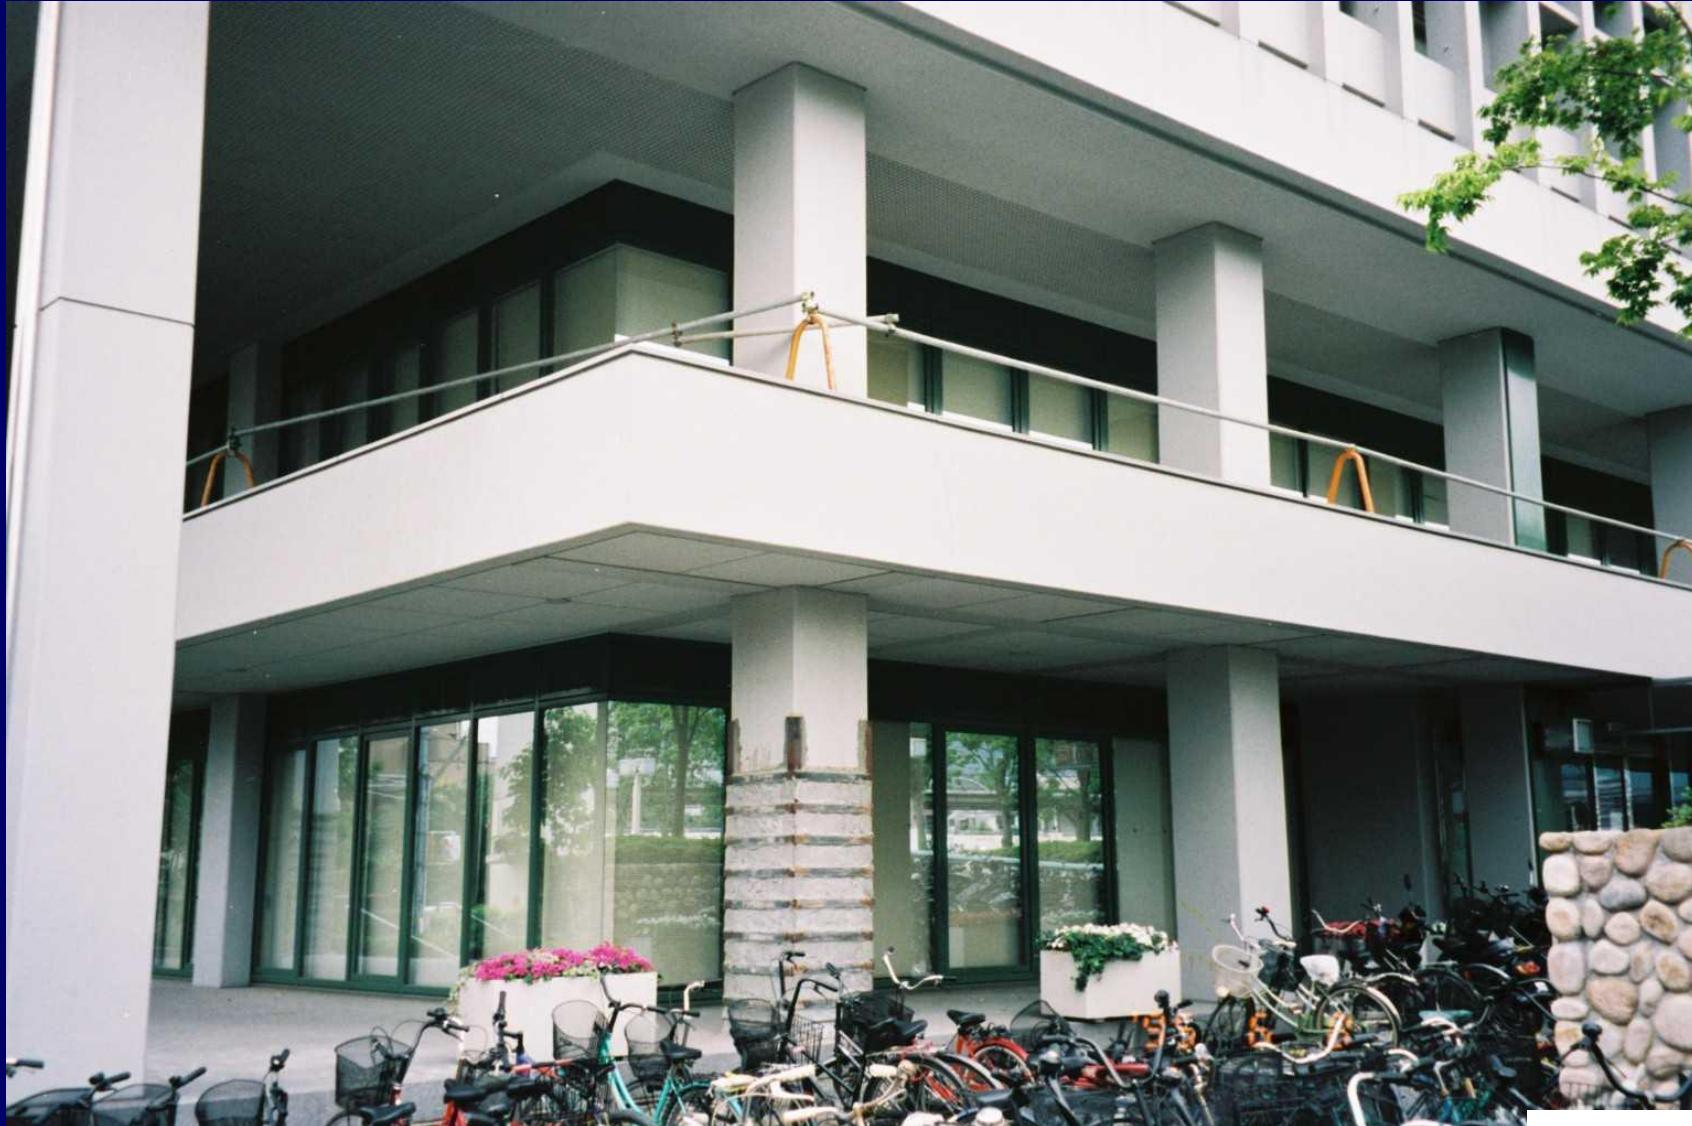
Steel band  
plate

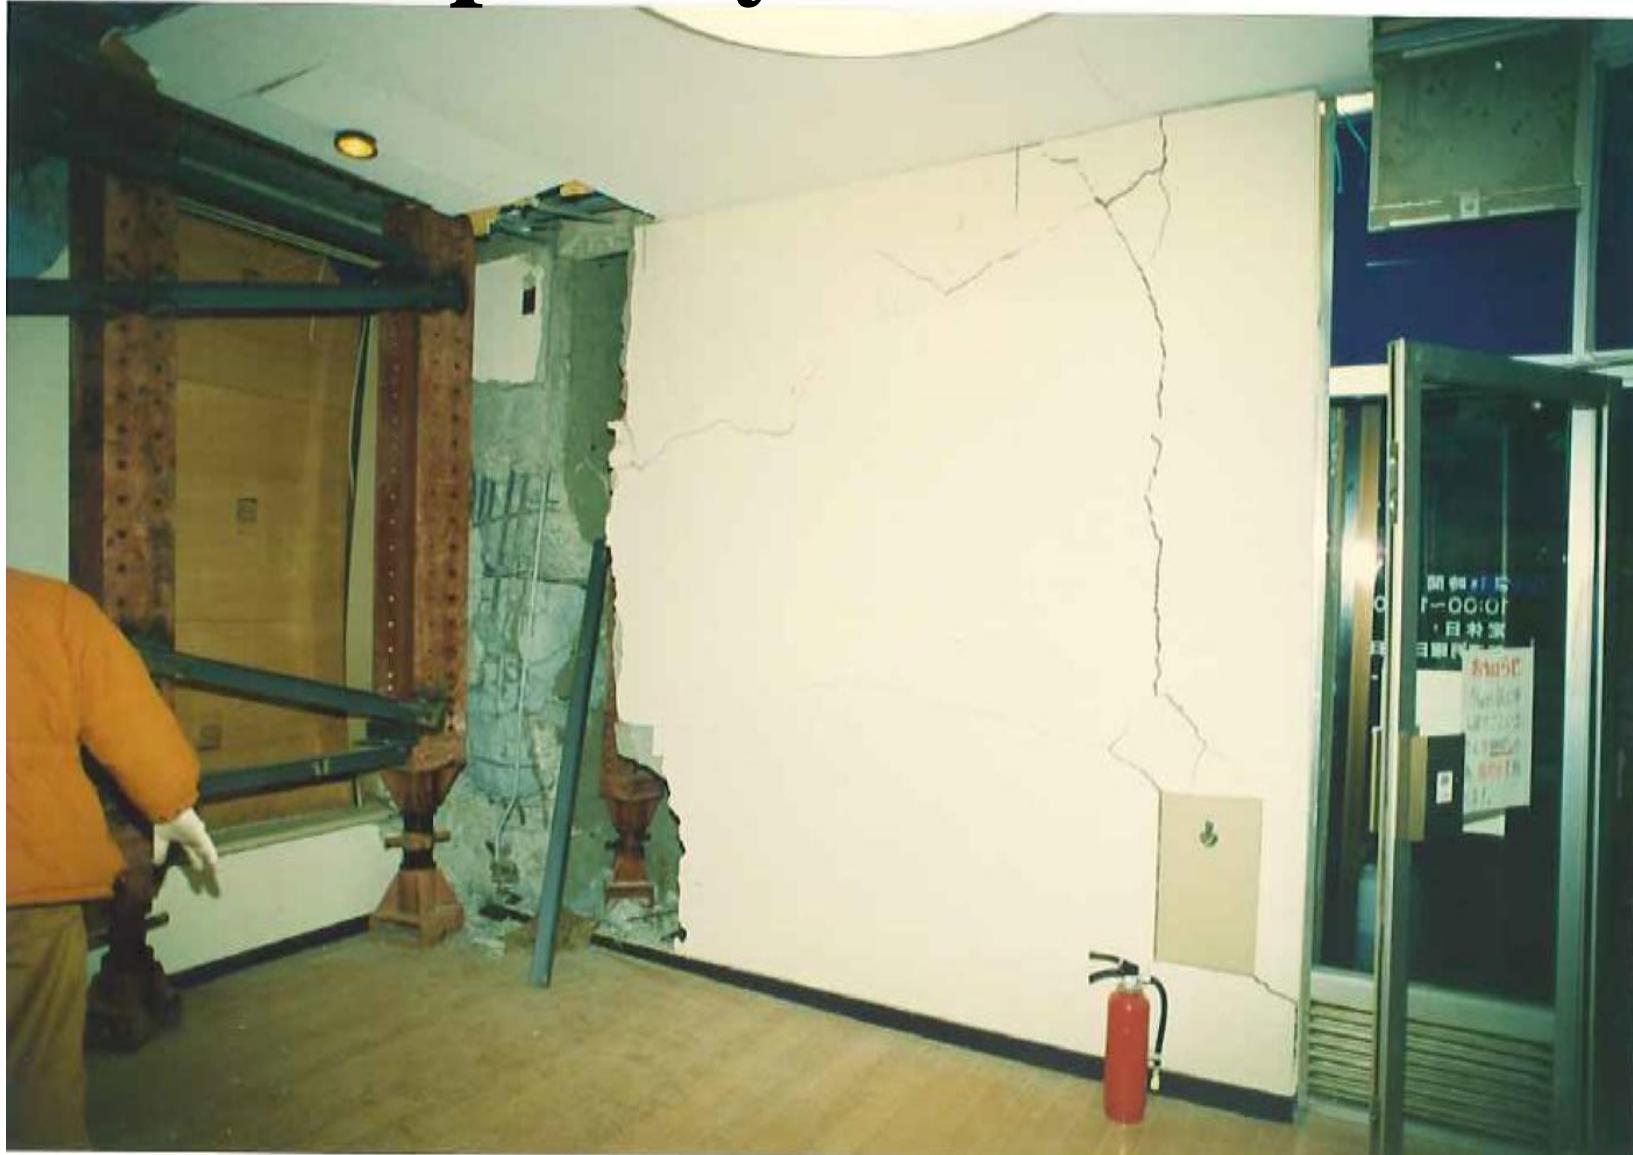
Severely  
damaged  
column  
(1994  
Sanriku EQ,  
Japan)

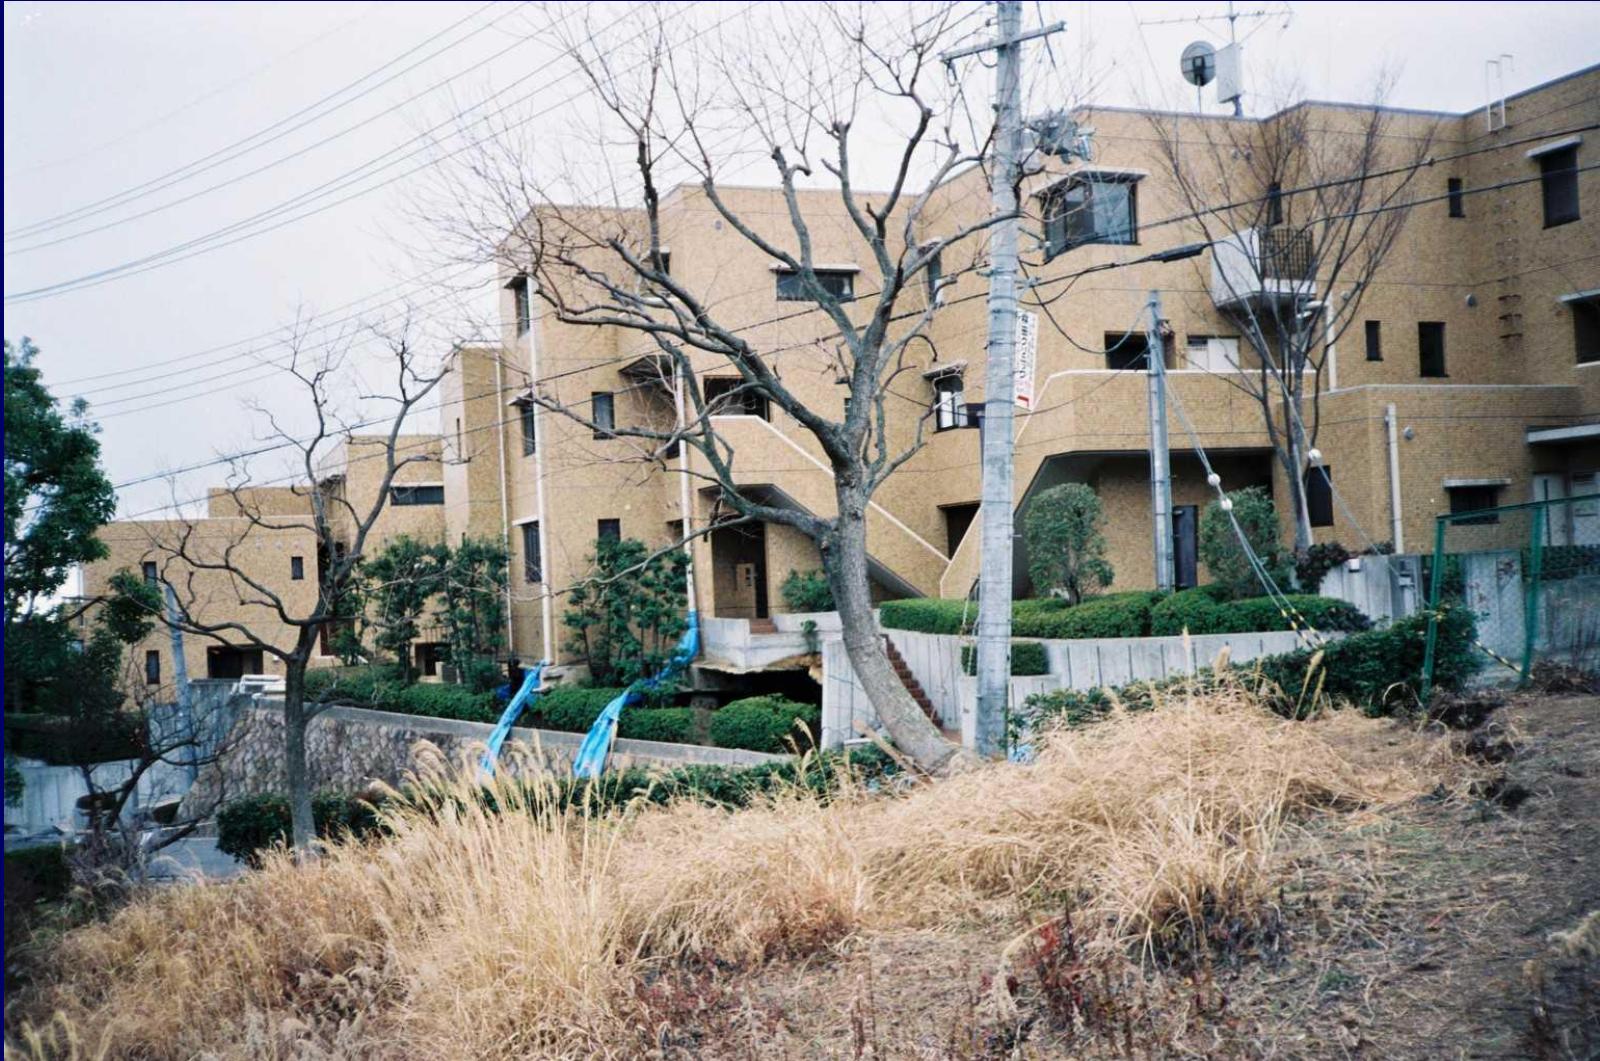
Residential  
building  
(Superstructure:  
no damage)

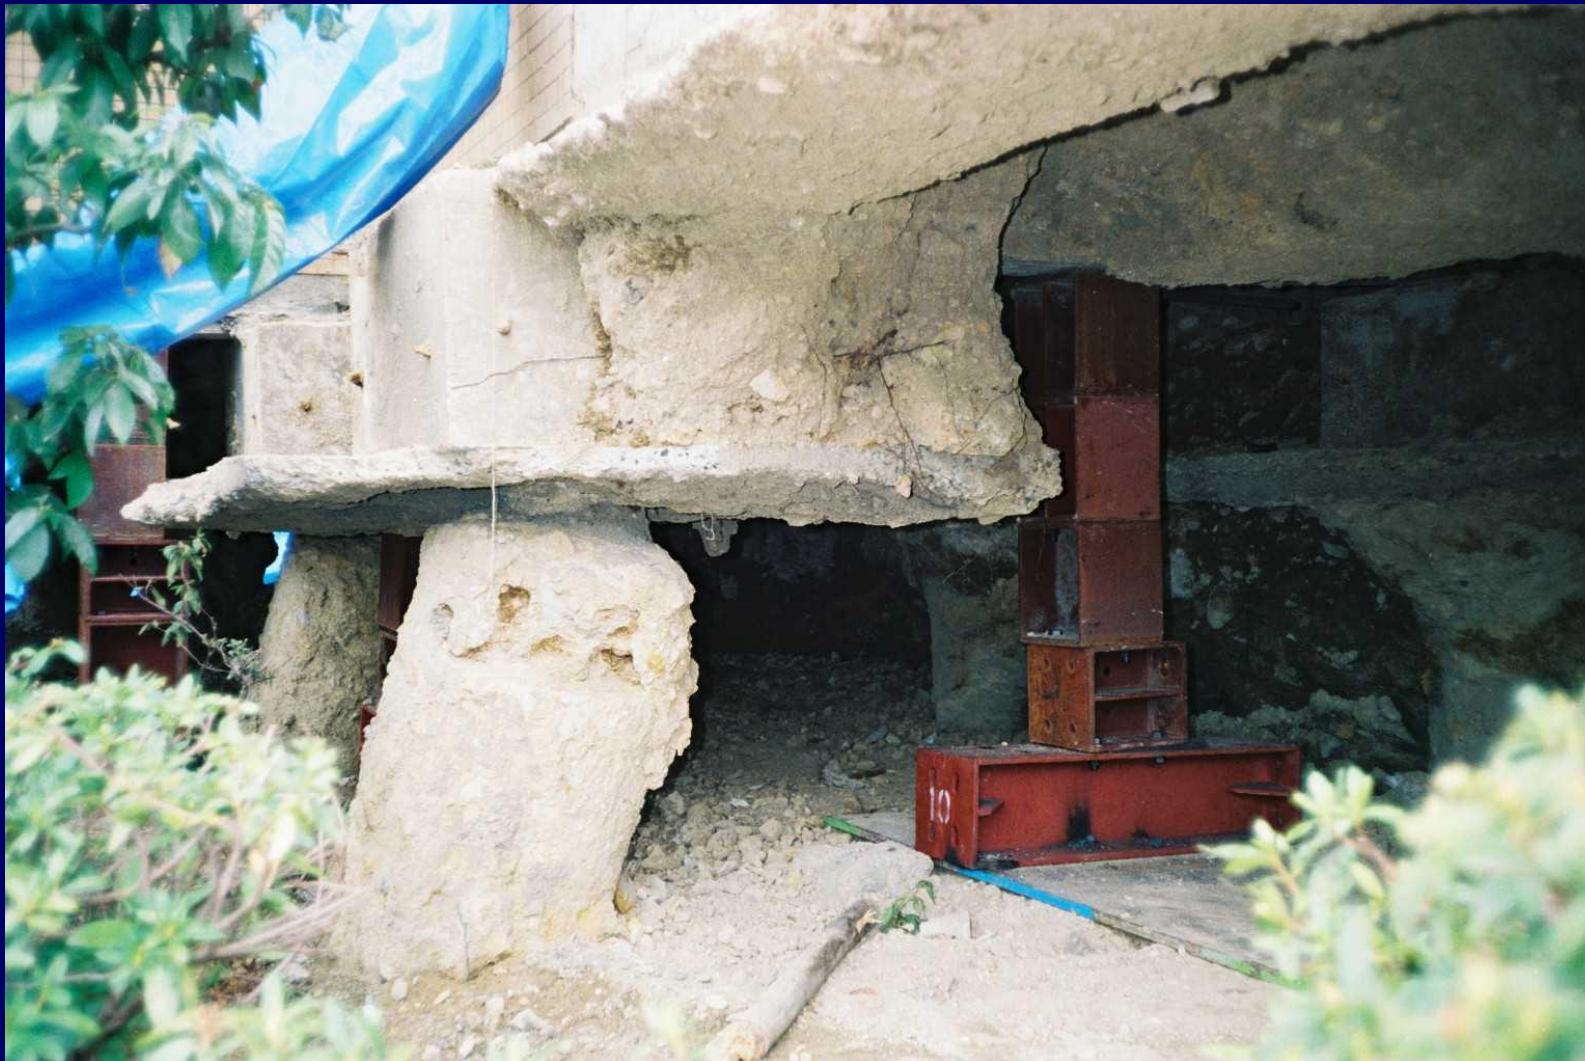
Residential  
building  
(Piles: damage)

Steel post

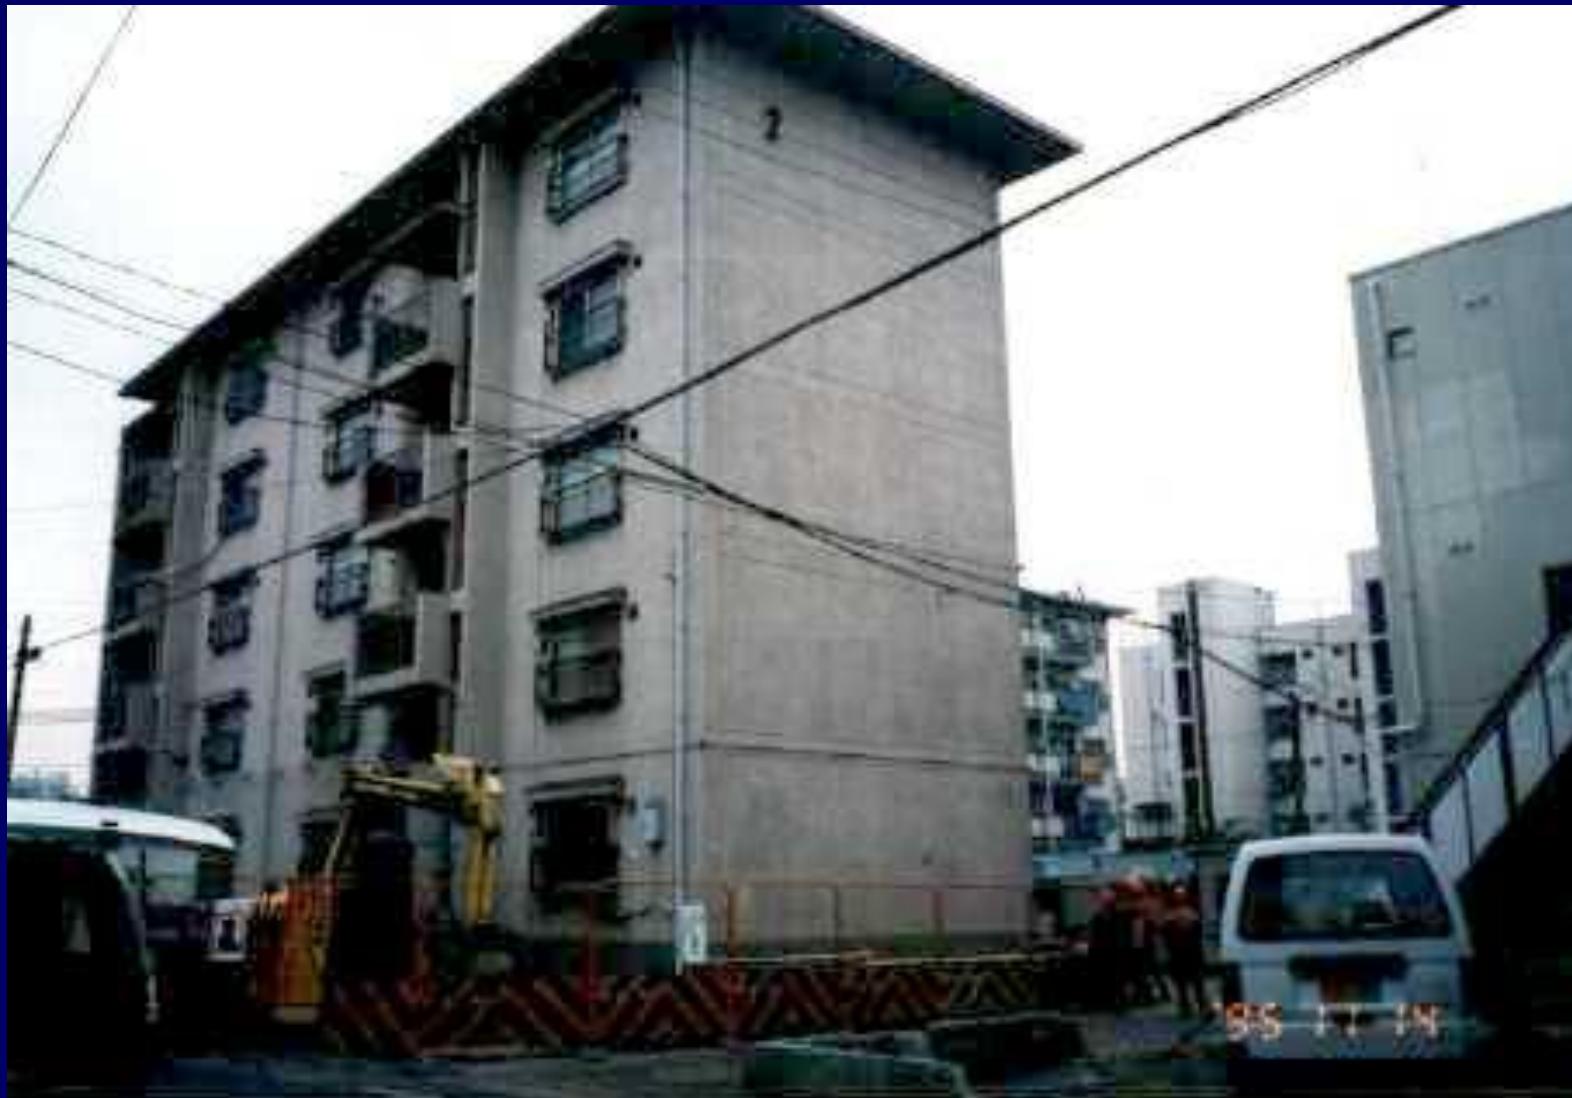
Residential  
building  
(Superstructure:  
no damage)

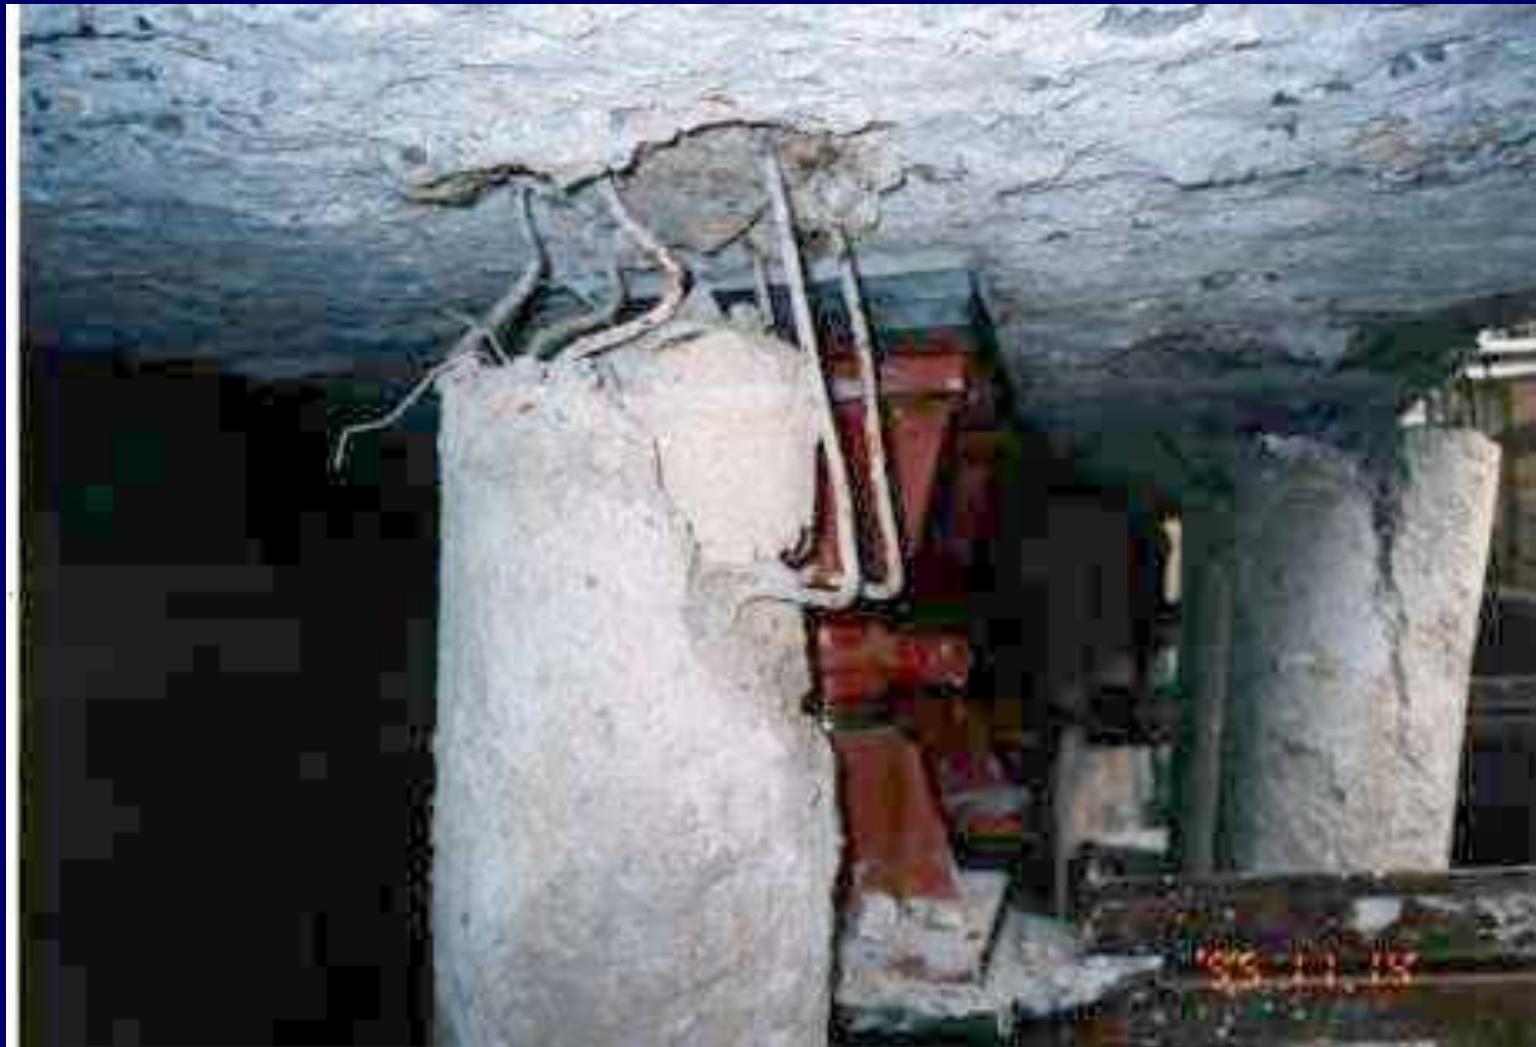
Residential  
building  
(Piles: damage)

Steel post and  
jack

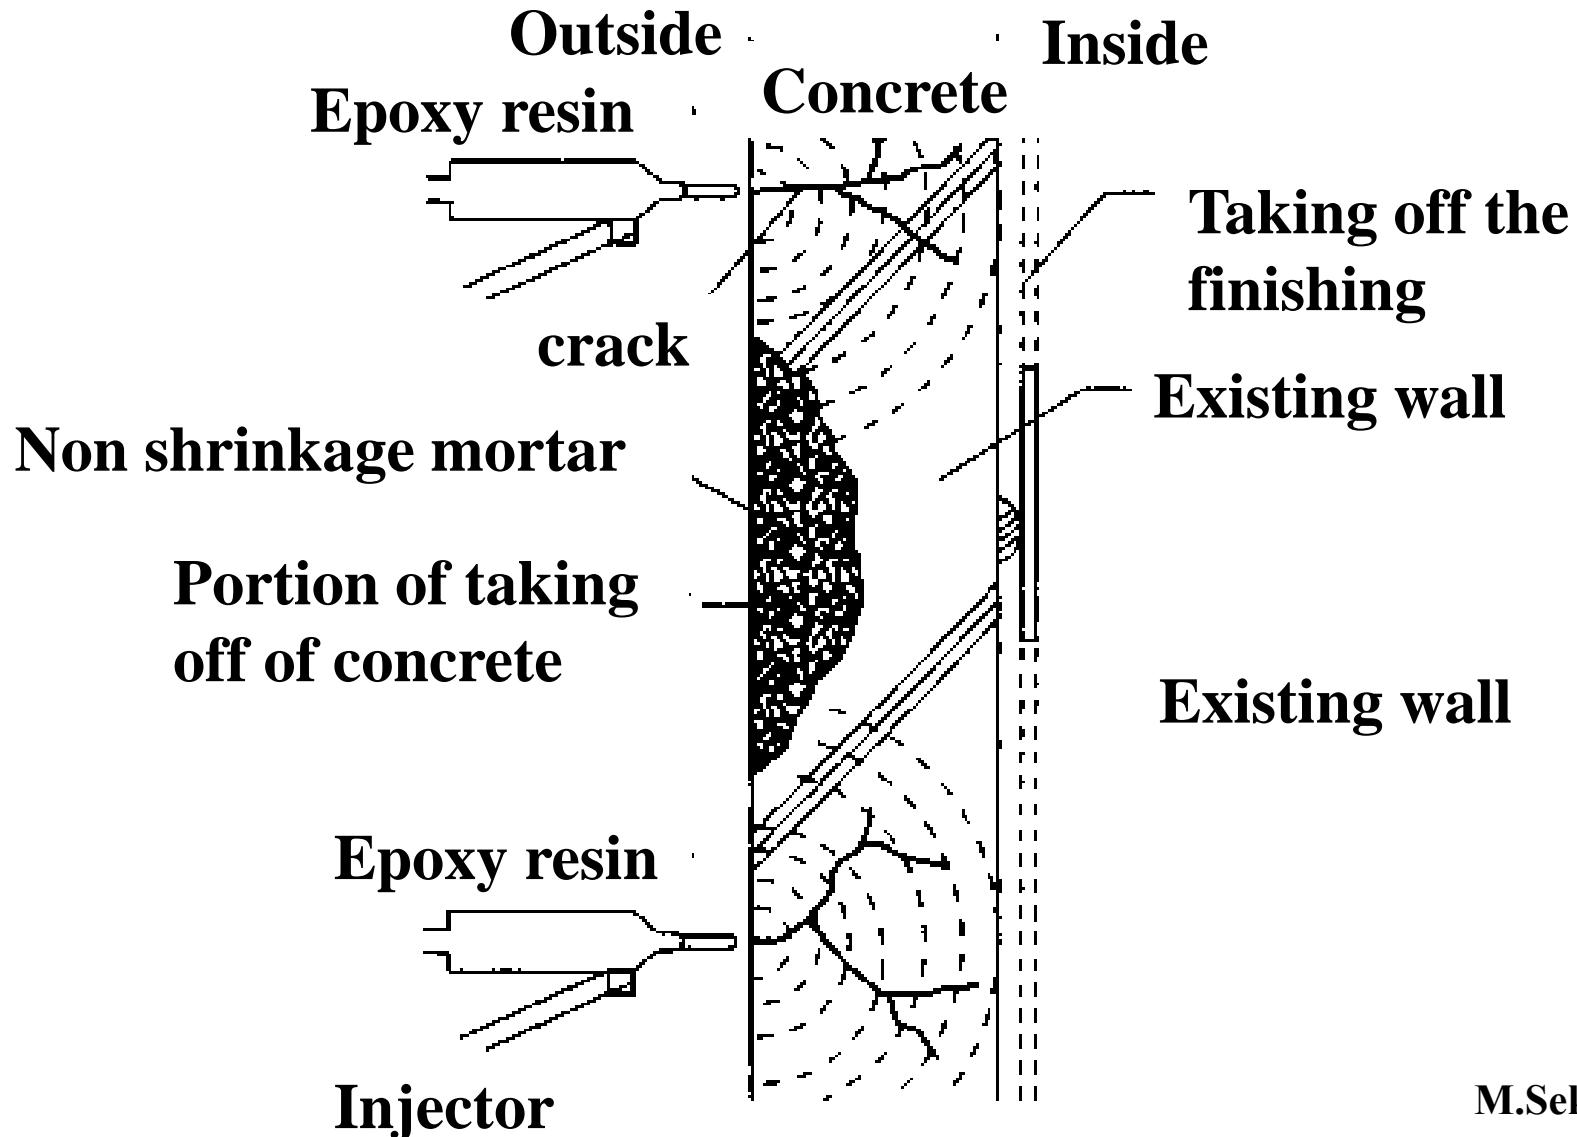
## Epoxy resin injection

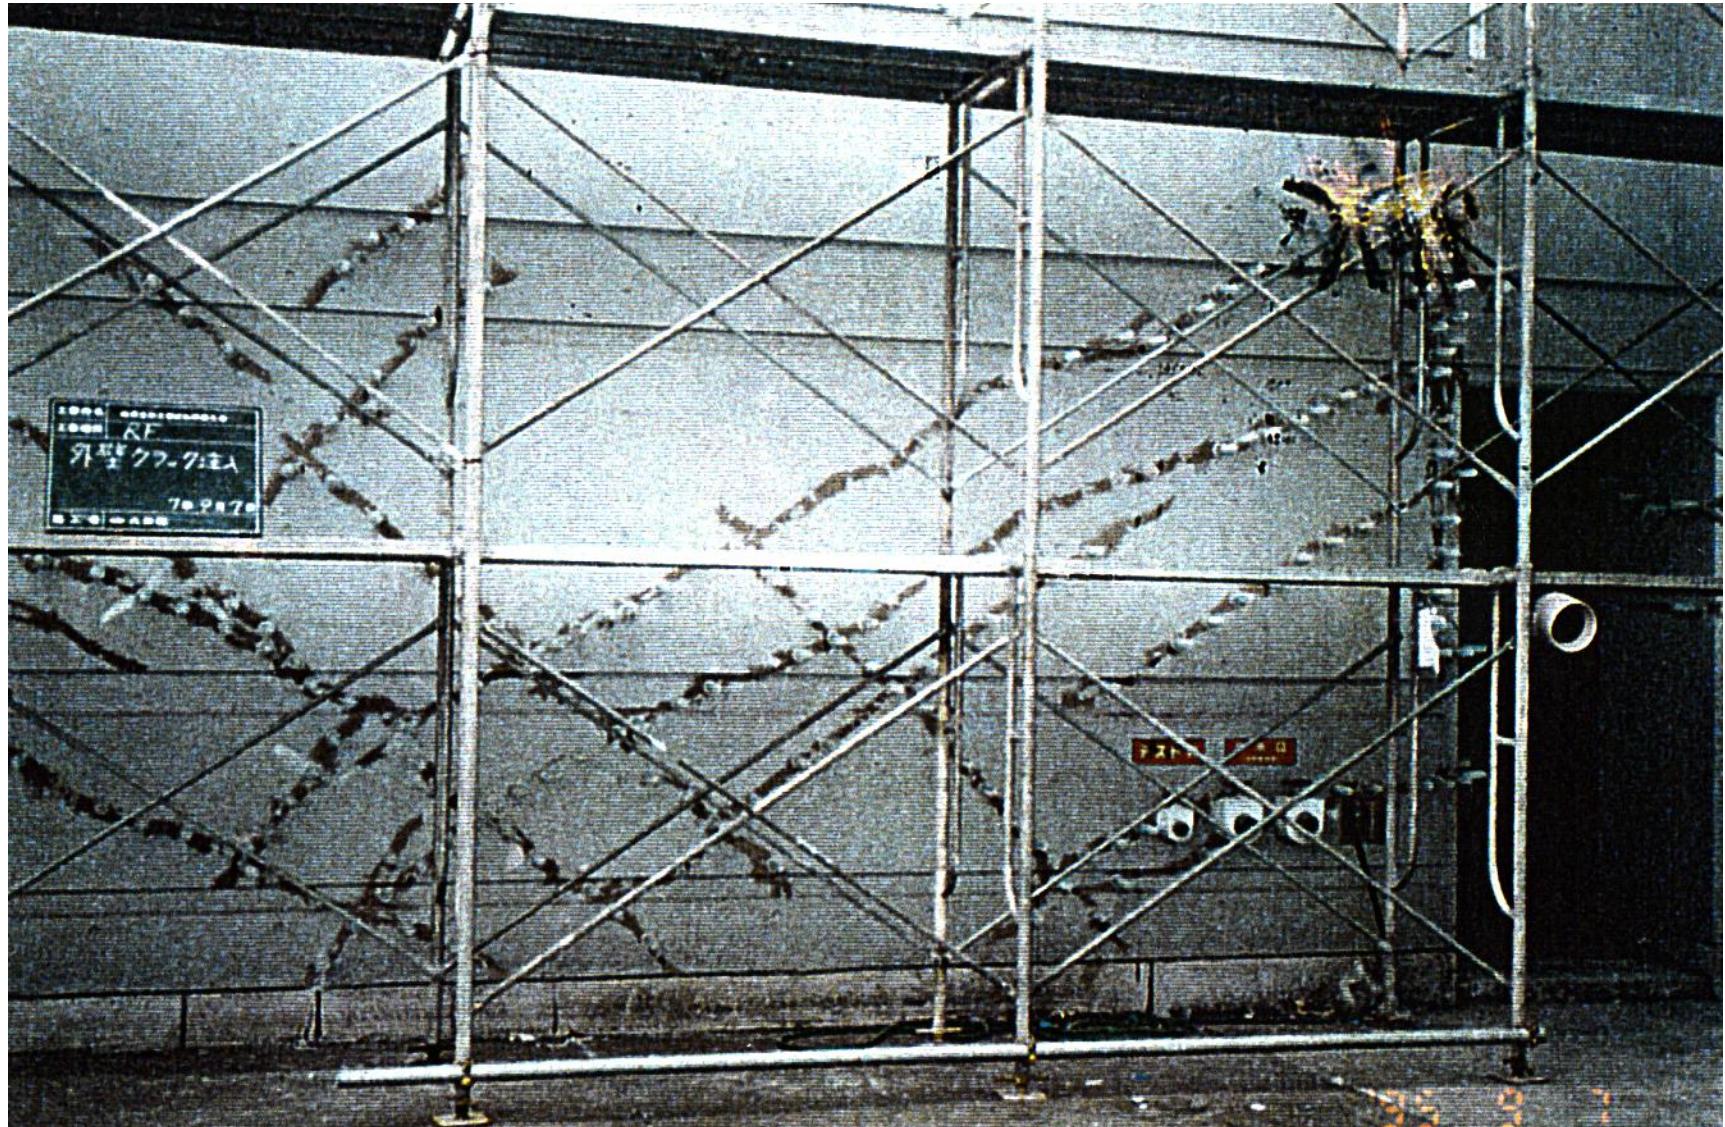
*Epoxy resin (wall)*

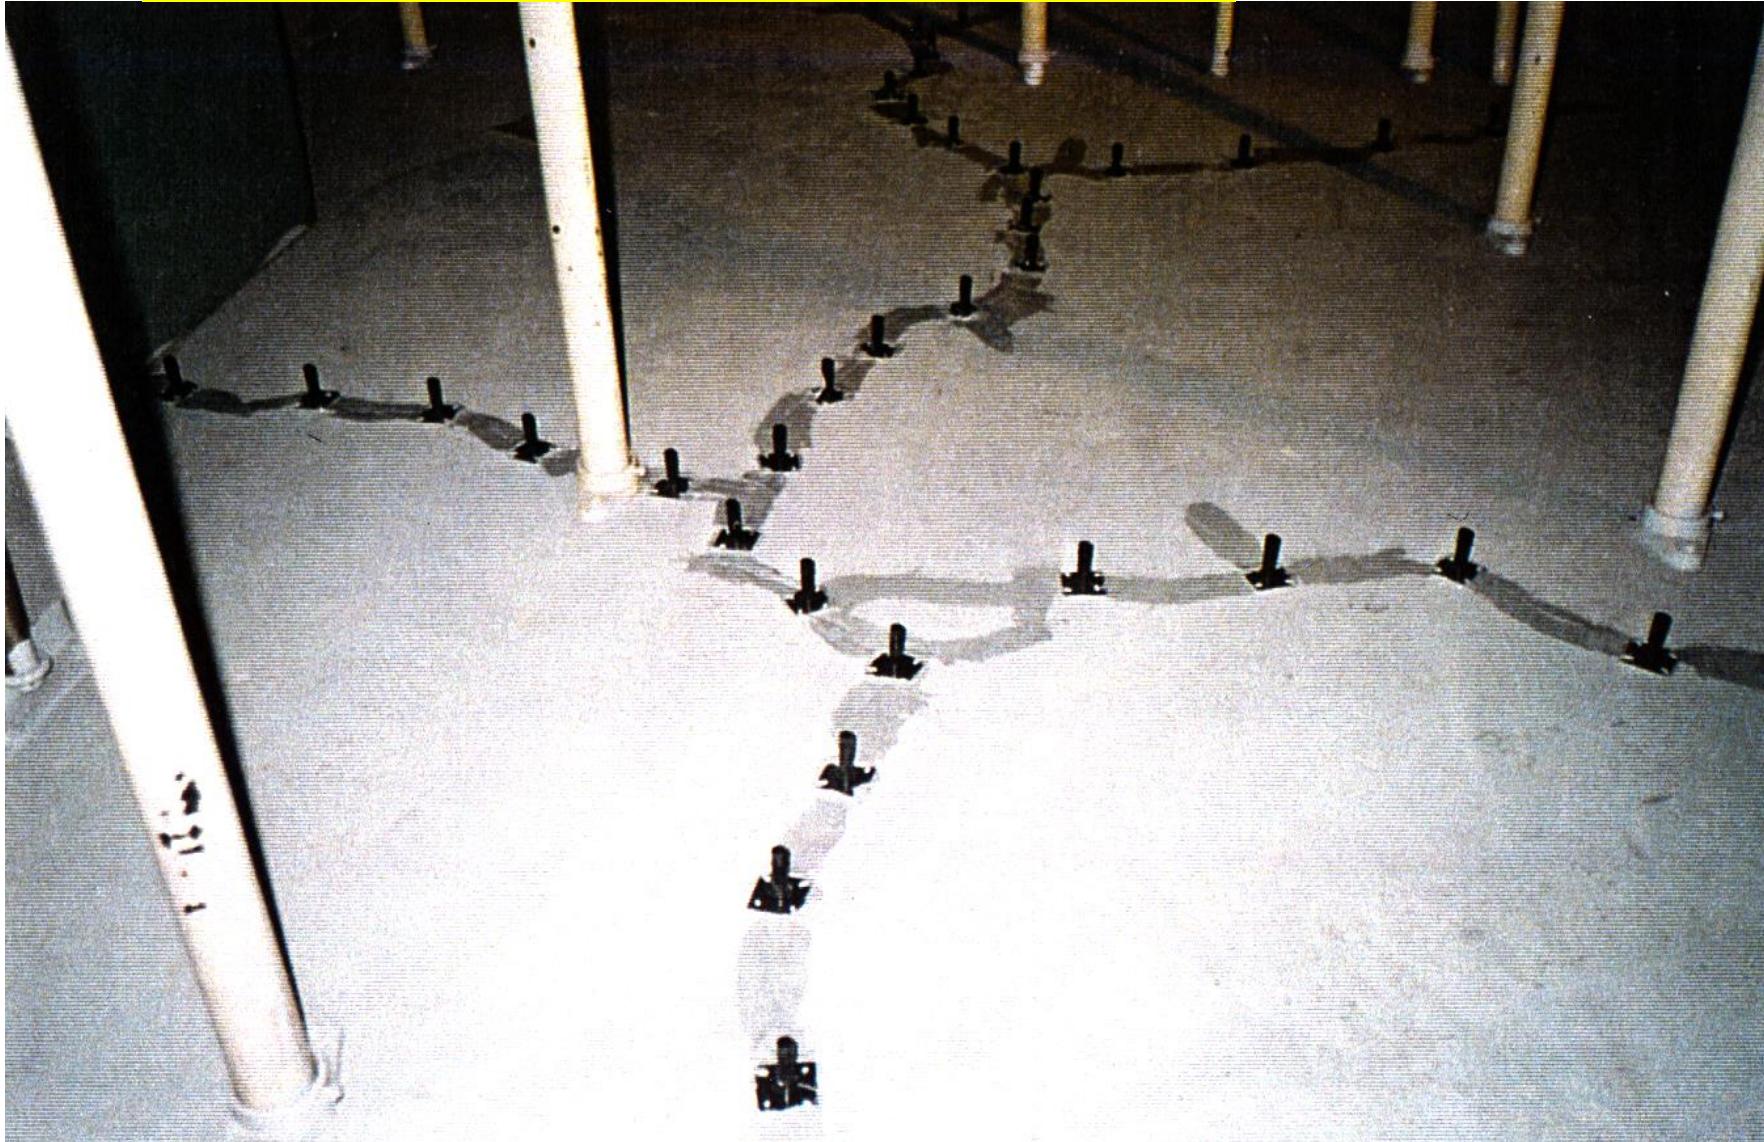
*Epoxy resin  
(floor slab)*

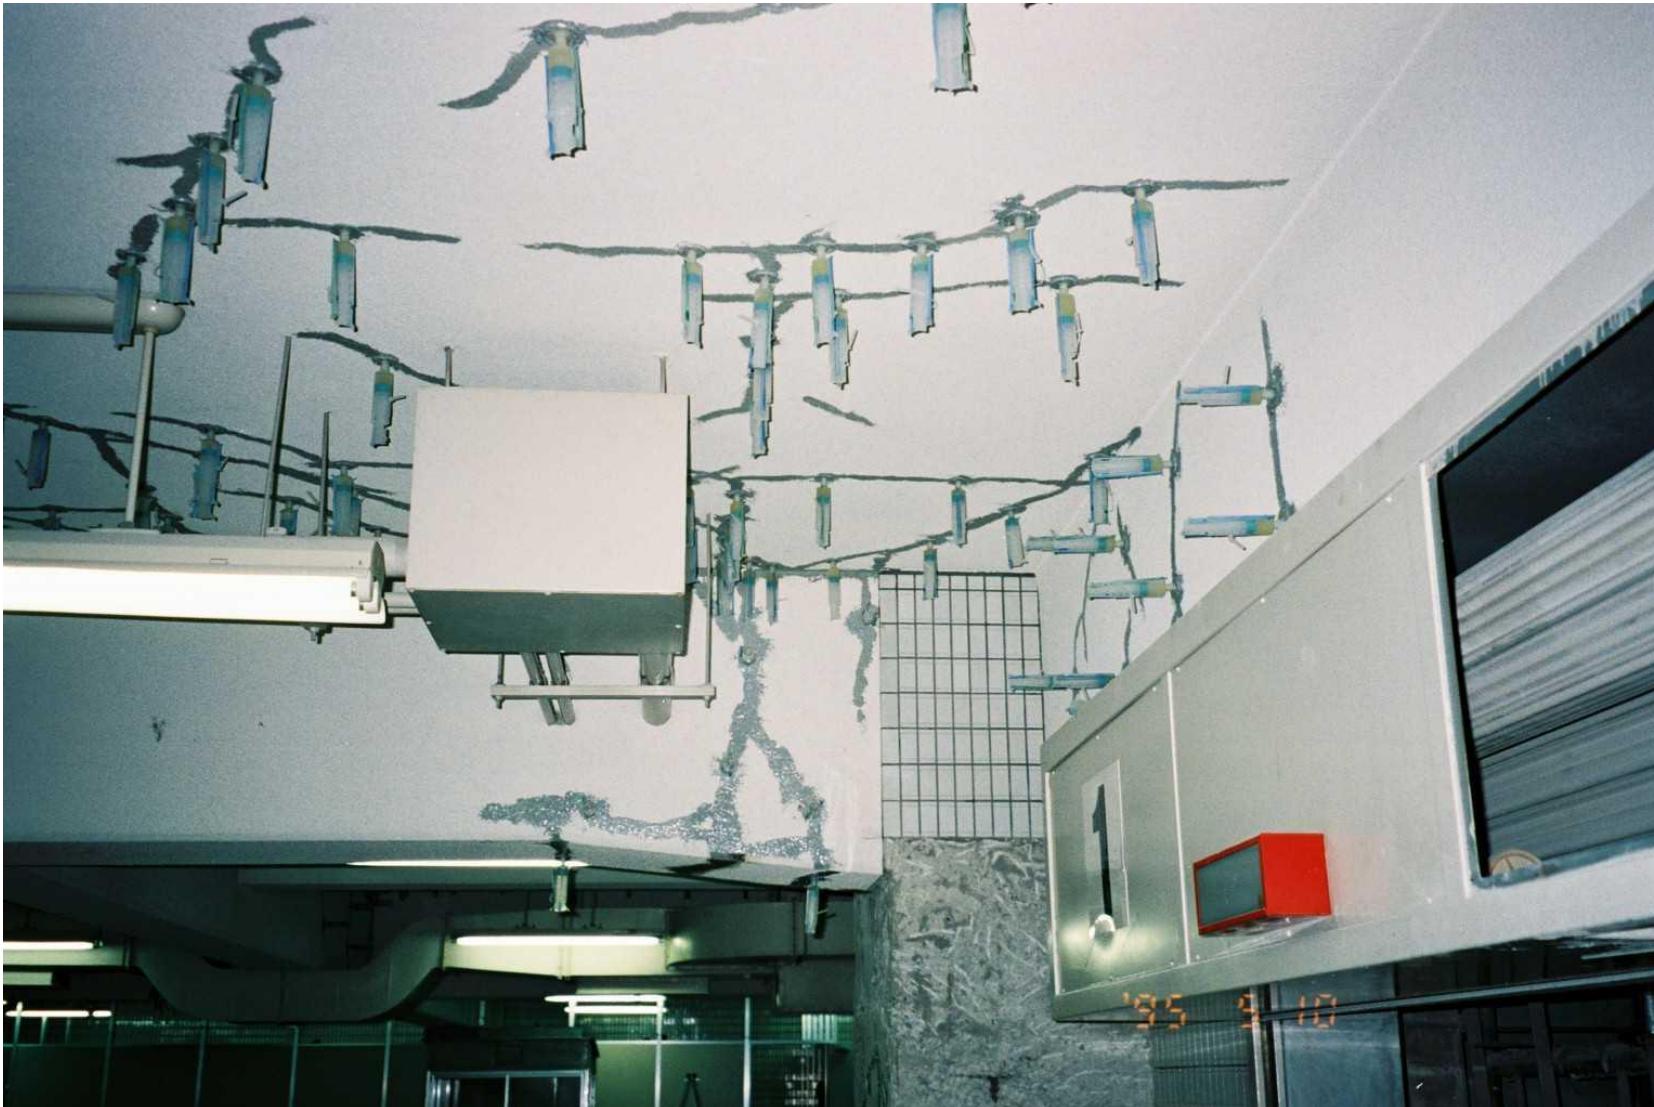
Epoxy resin  
(ceiling)

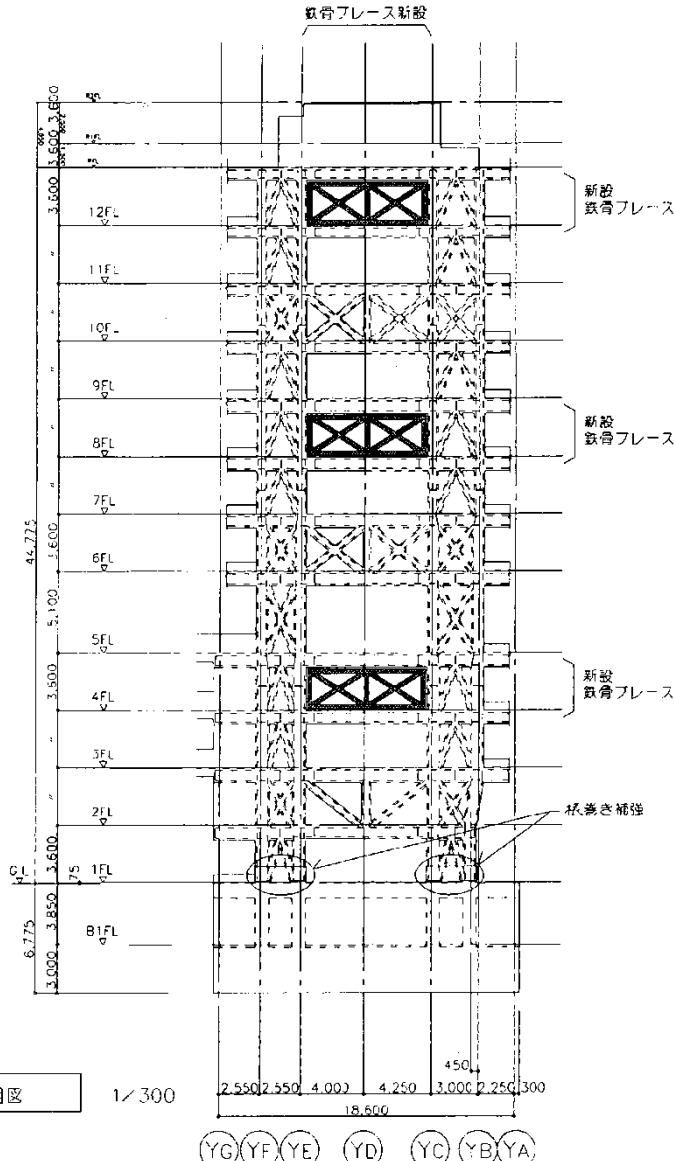
*Elevation of  
damaged  
building*

Steel and  
ceinforced  
concrete building  
(SRC)

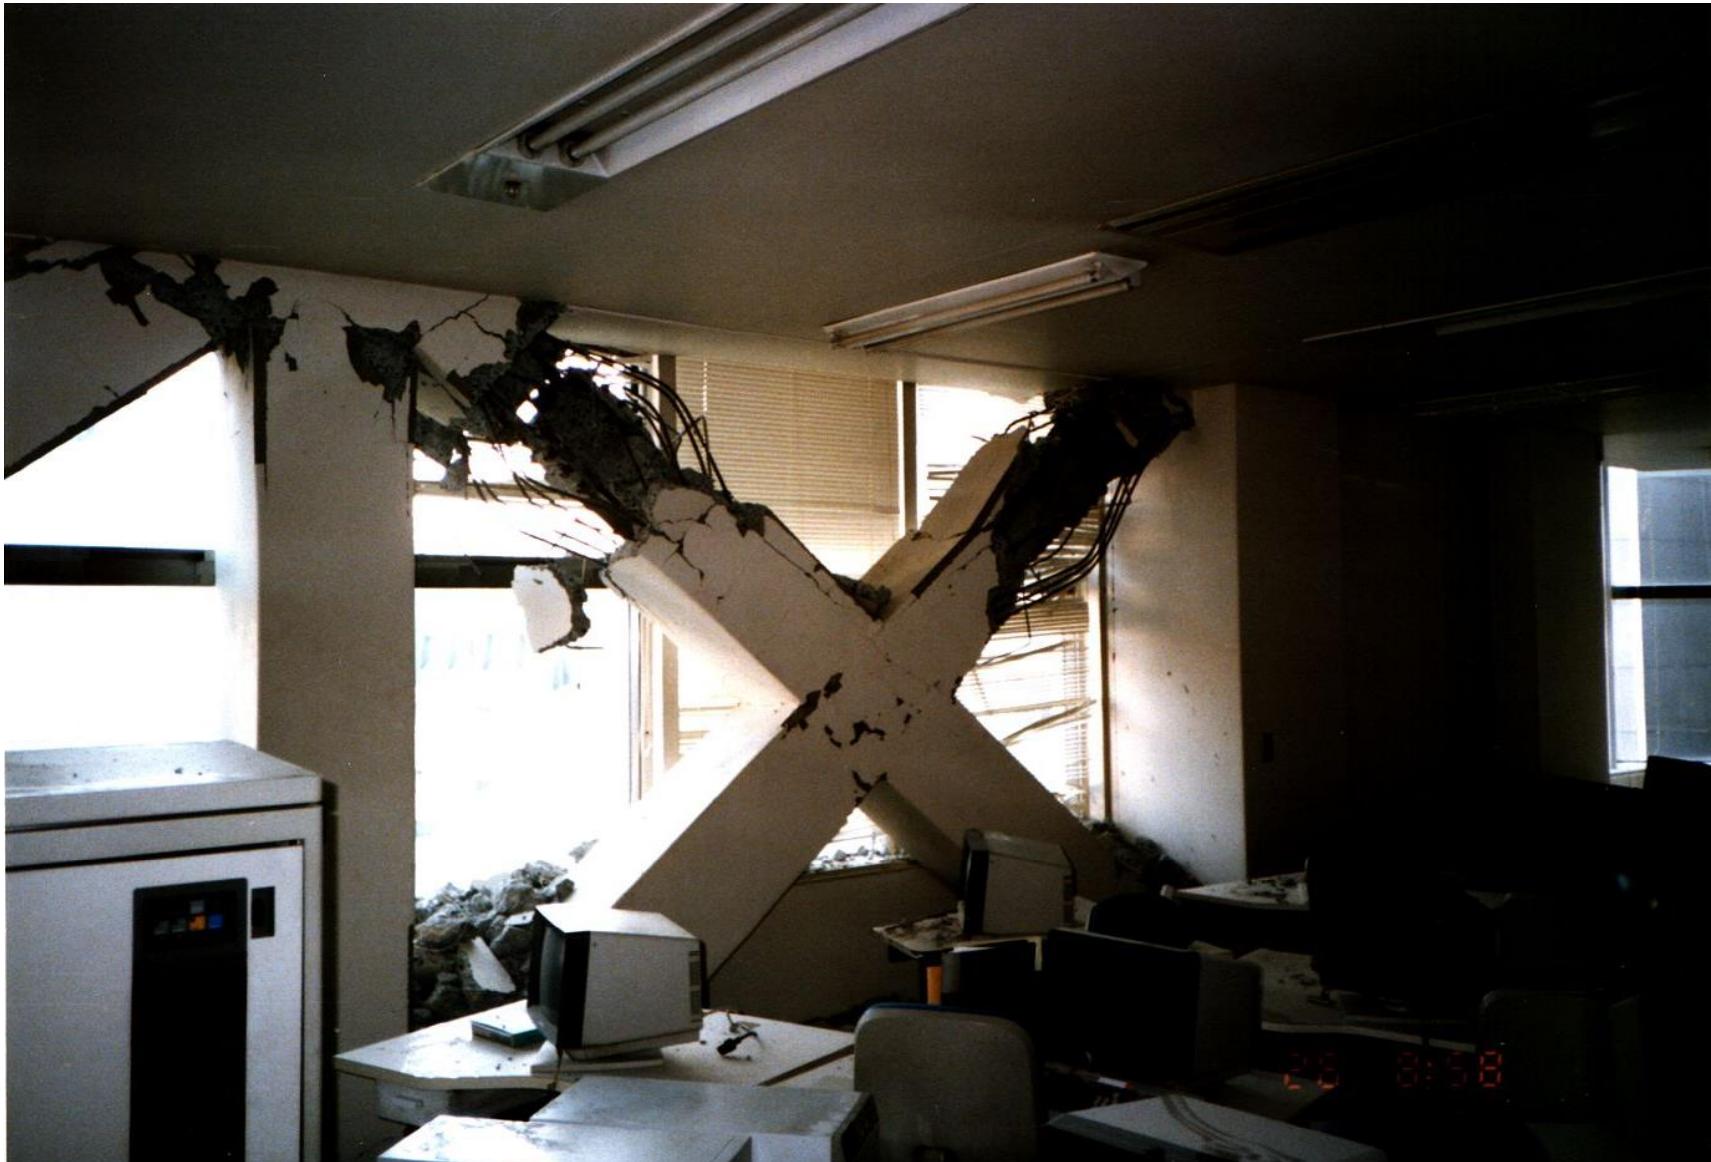
*Damage of  
SRC brace*

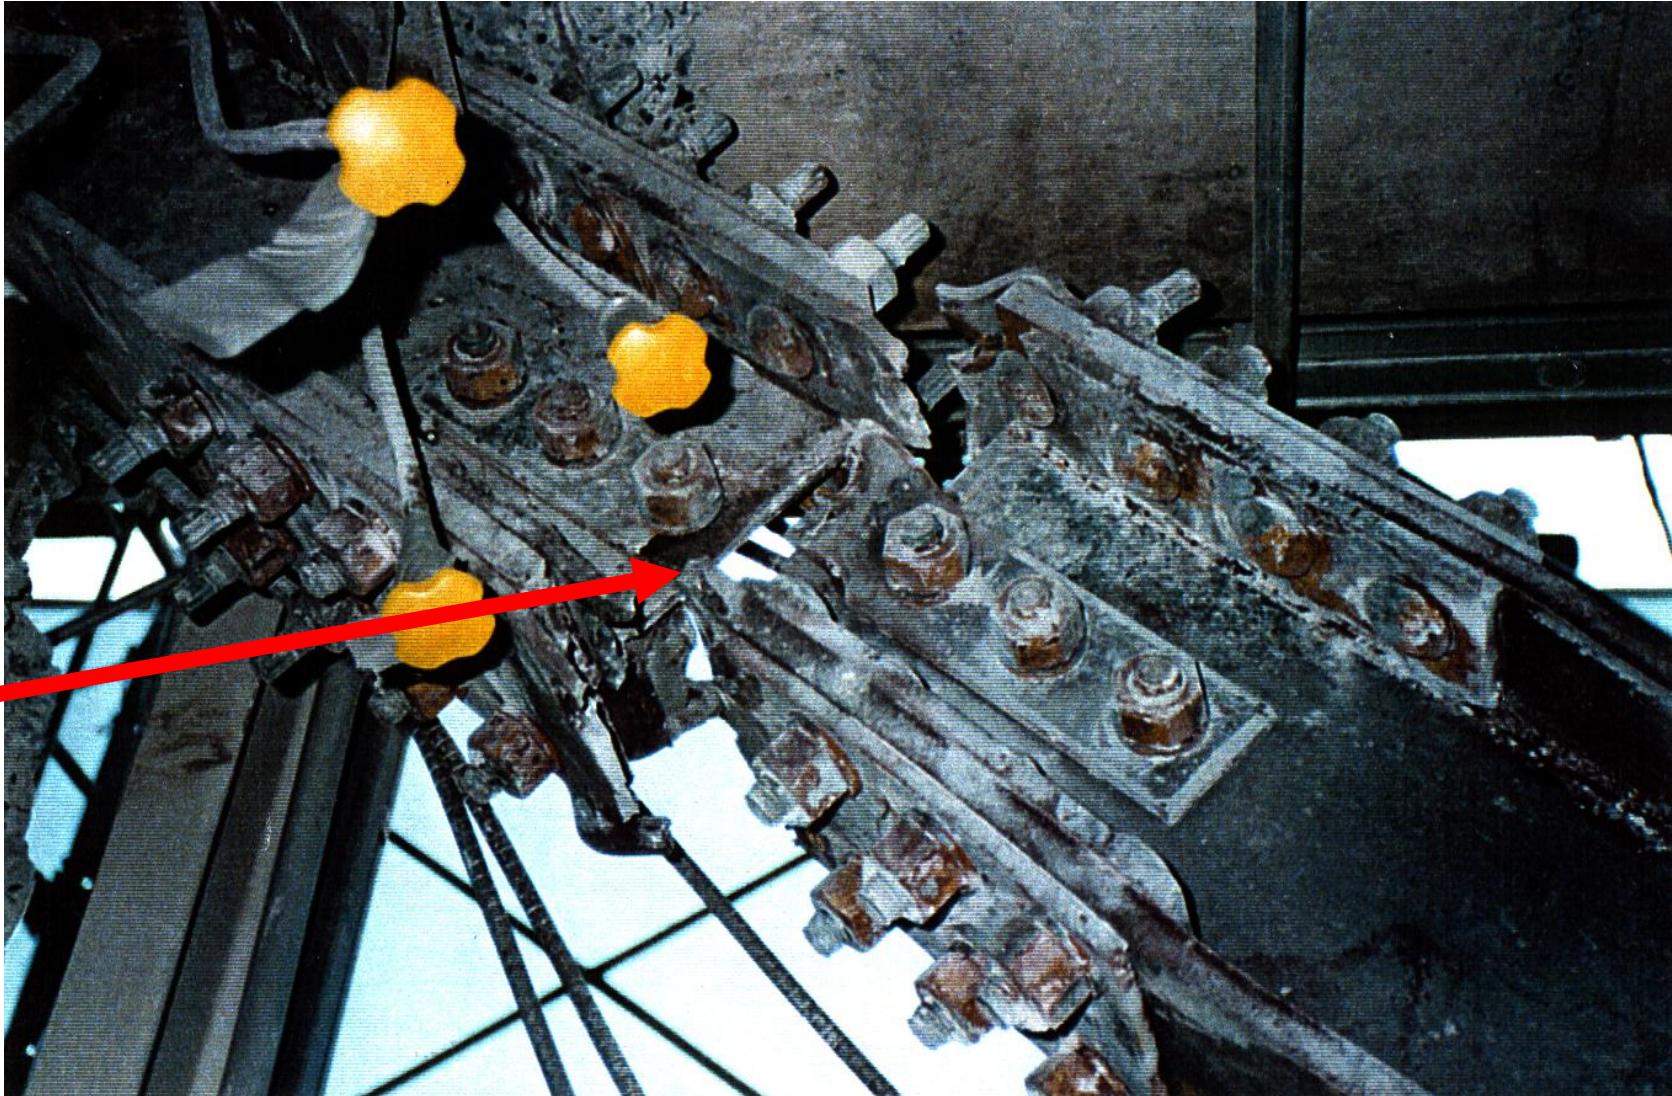
*Damage of  
SRC brace*

*Damage detail  
of joint plate*
