# **Seismic Retrofit of the Existing RC buildings in Japan**

June 2017

Building Research Institute,  
Japan

Matsutaro SEKI

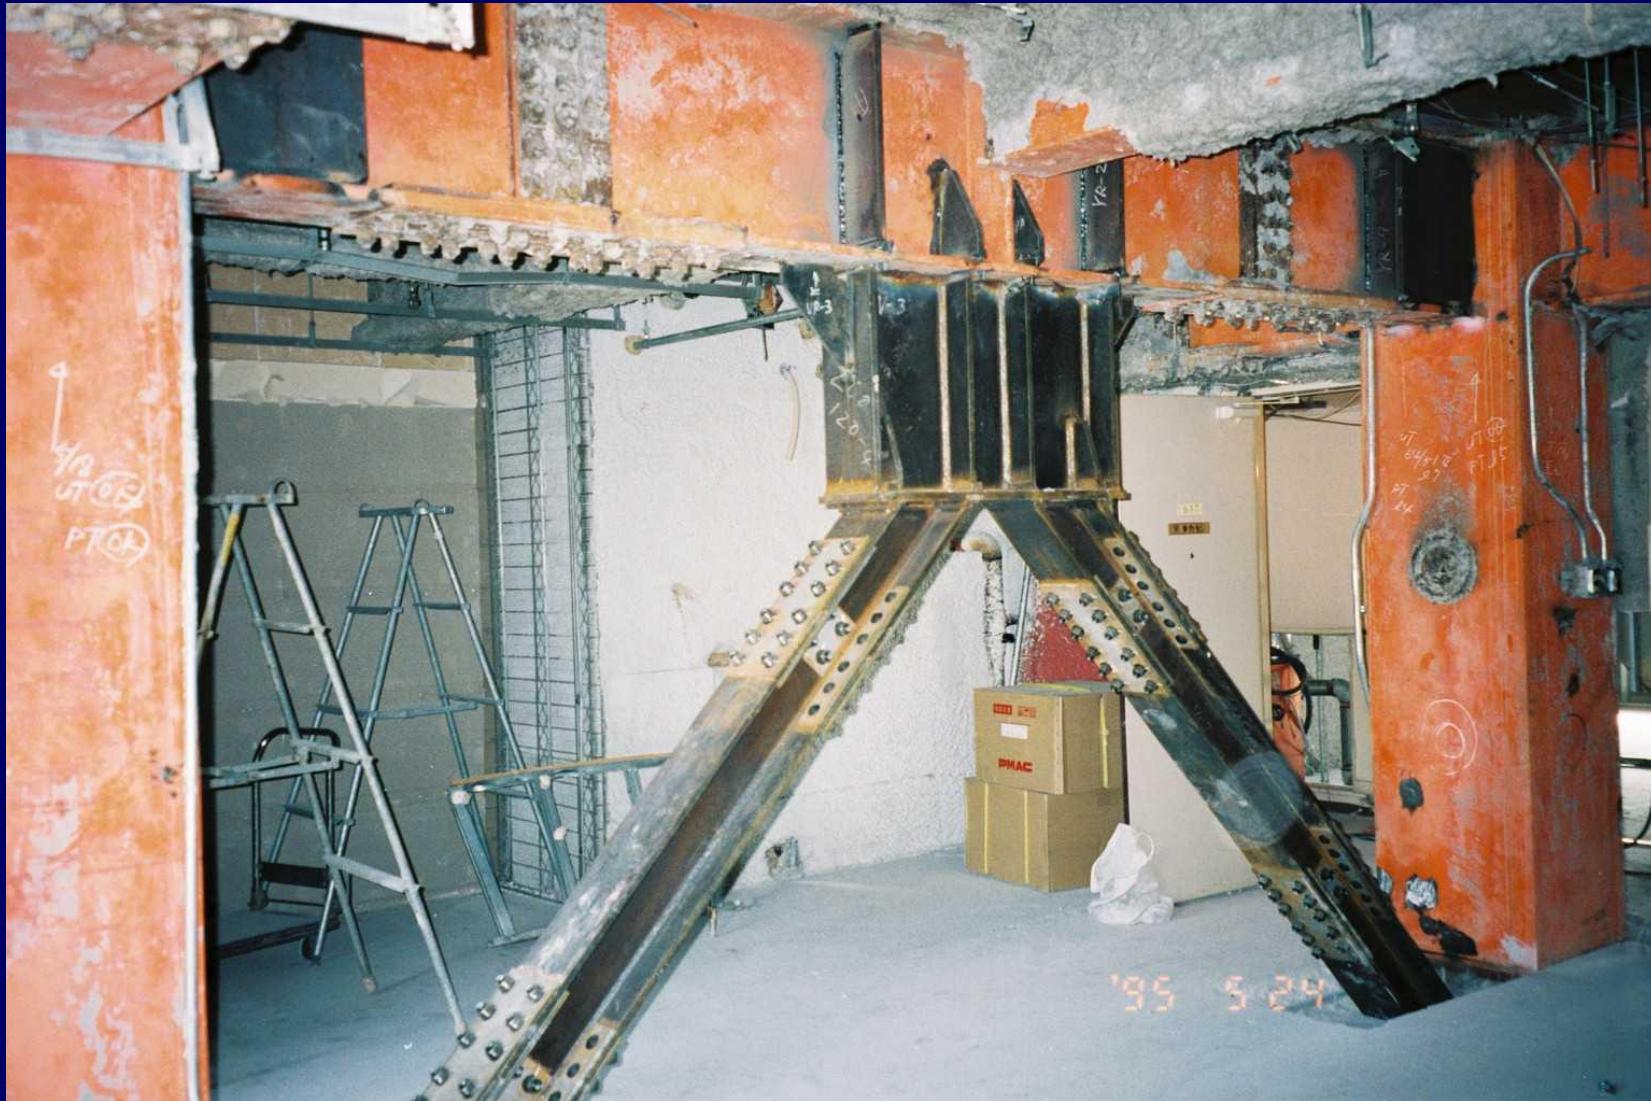
New steel brace

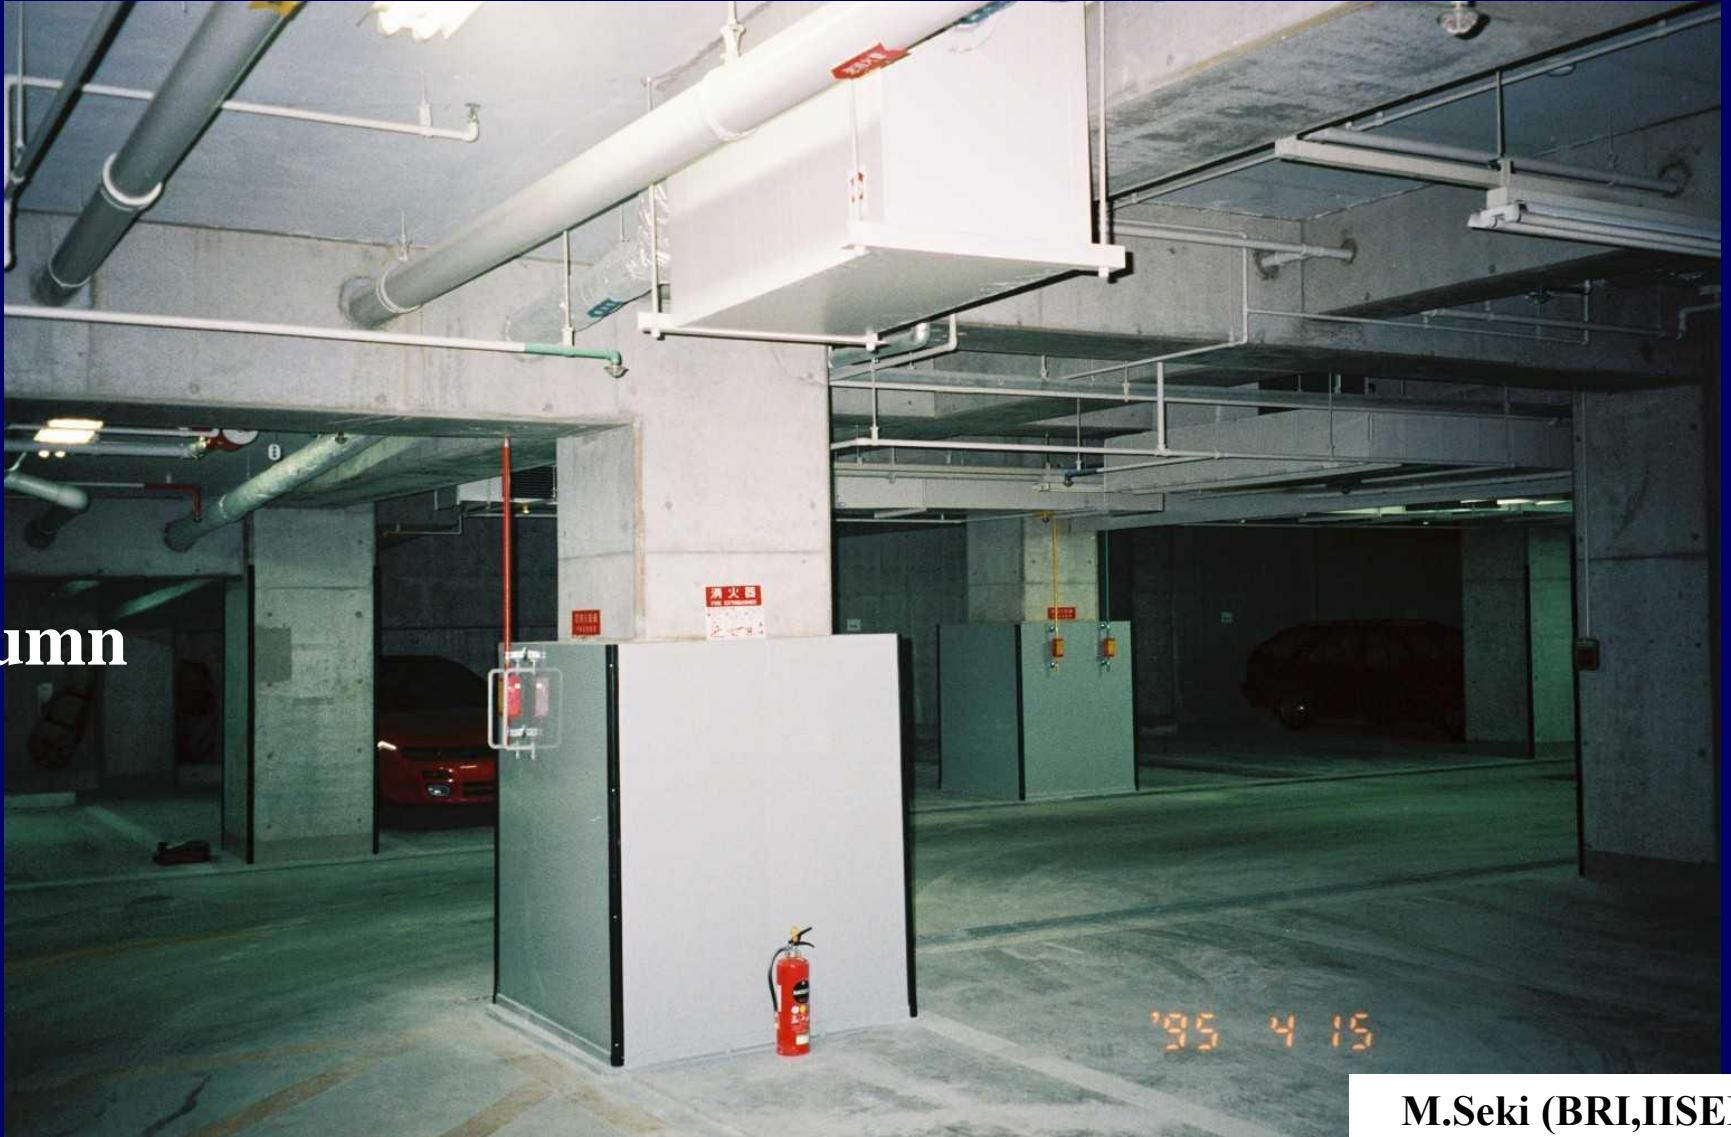
Increasing of section  
at the bottom of column

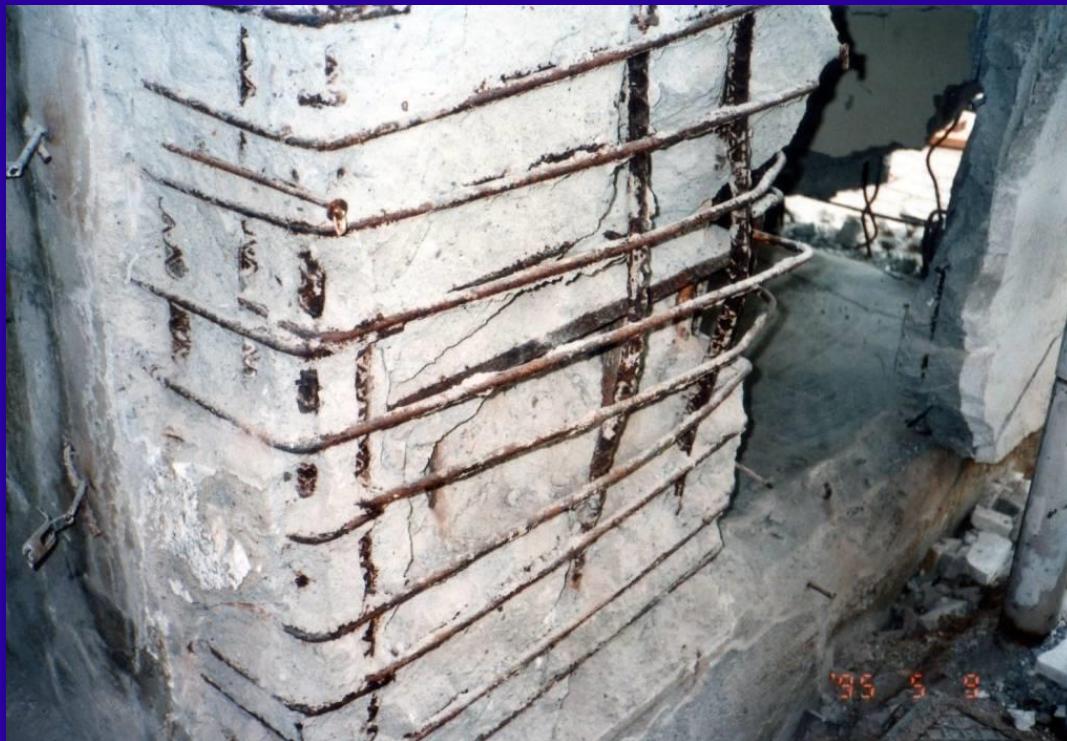
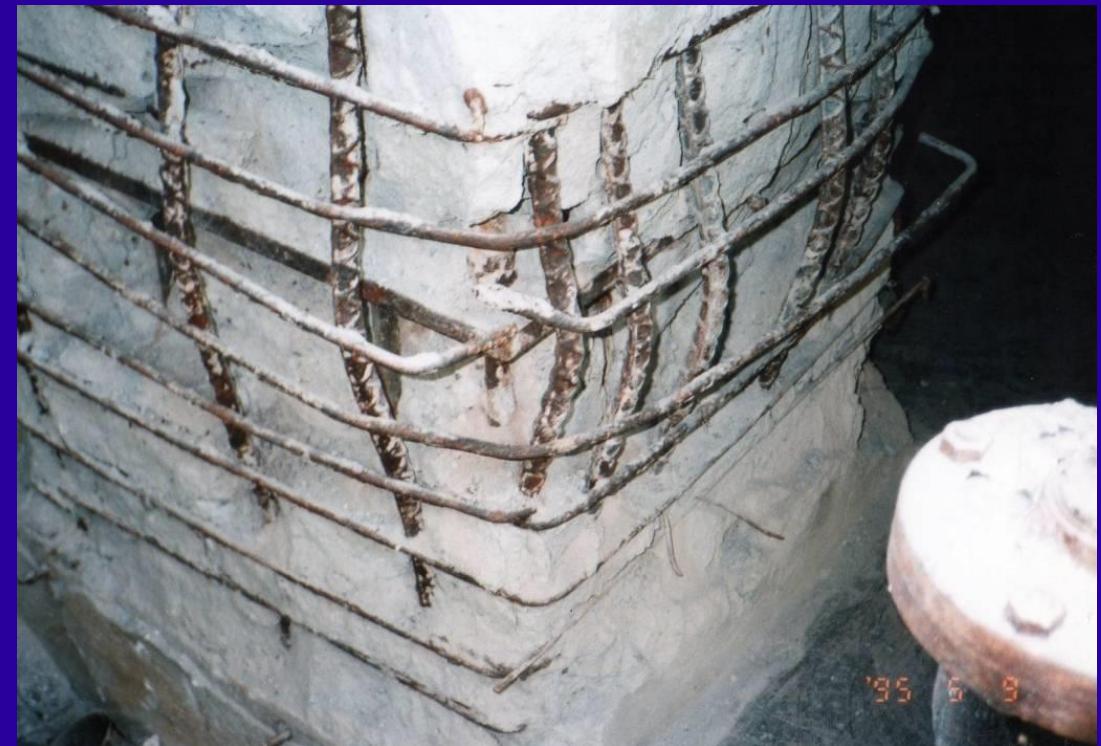
## Steel plate jacketing

Taking off of damaged concrete portion

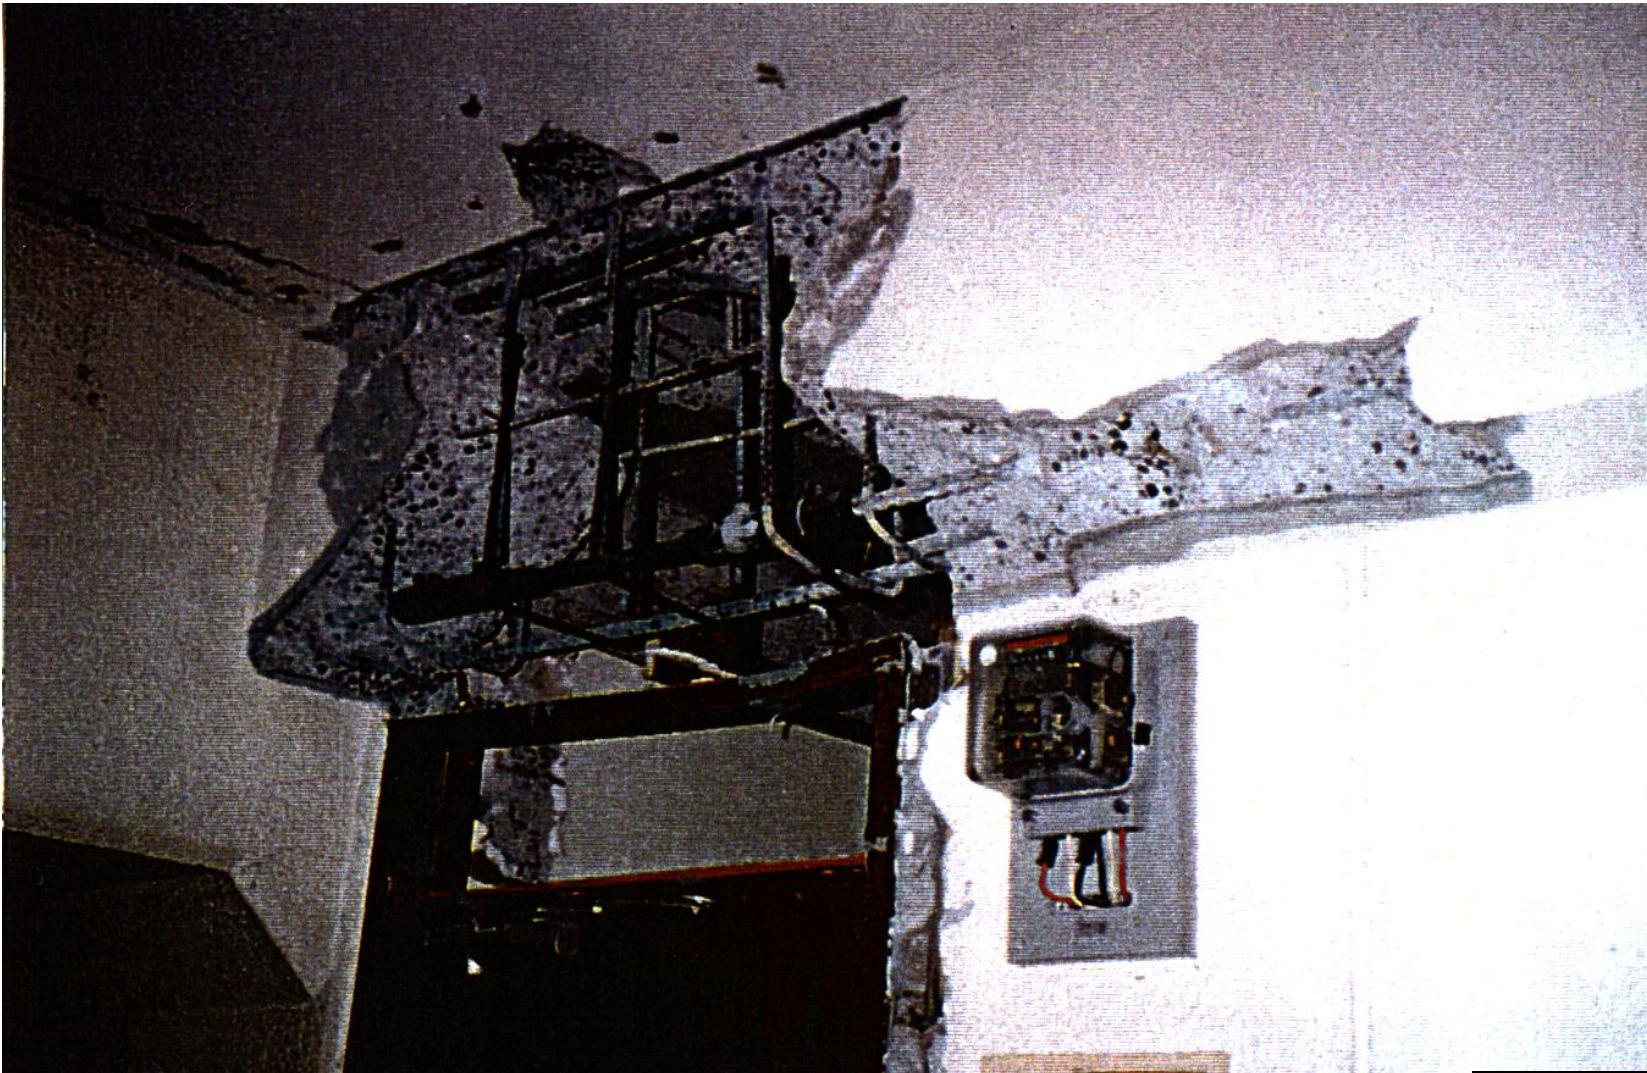
Repair of  
beam bars

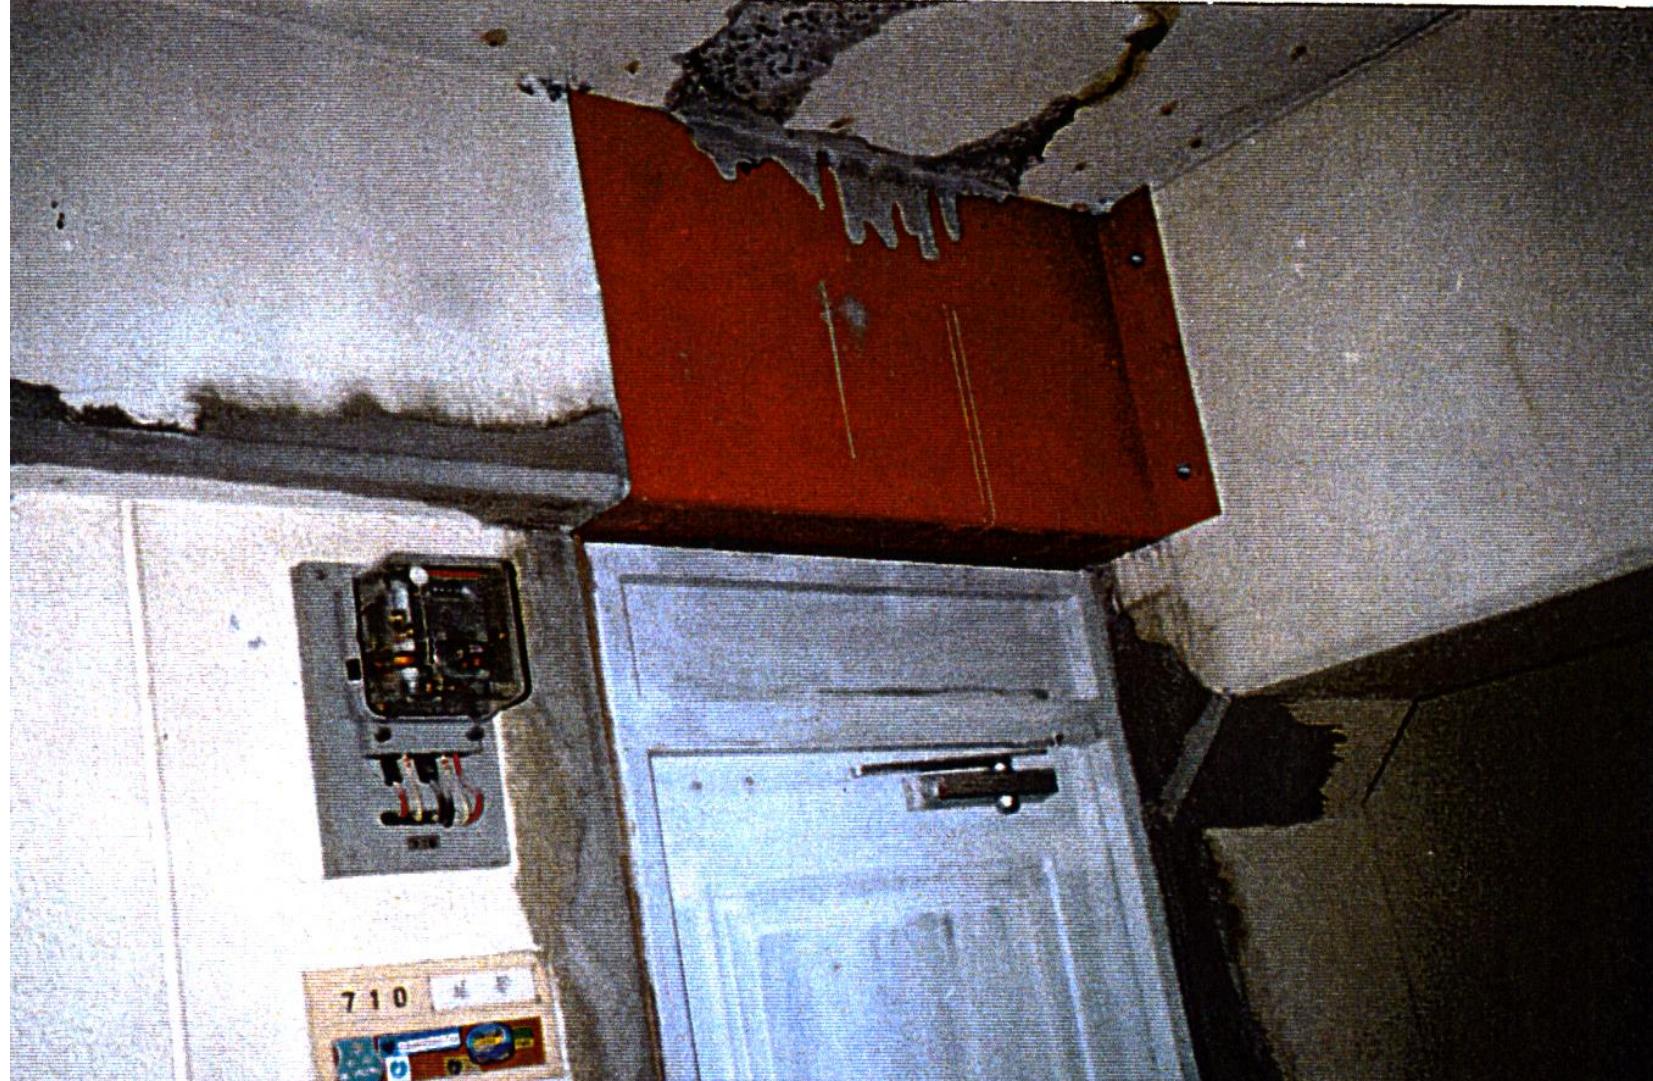
*After jacketing  
by steel plate  
(Beam)*

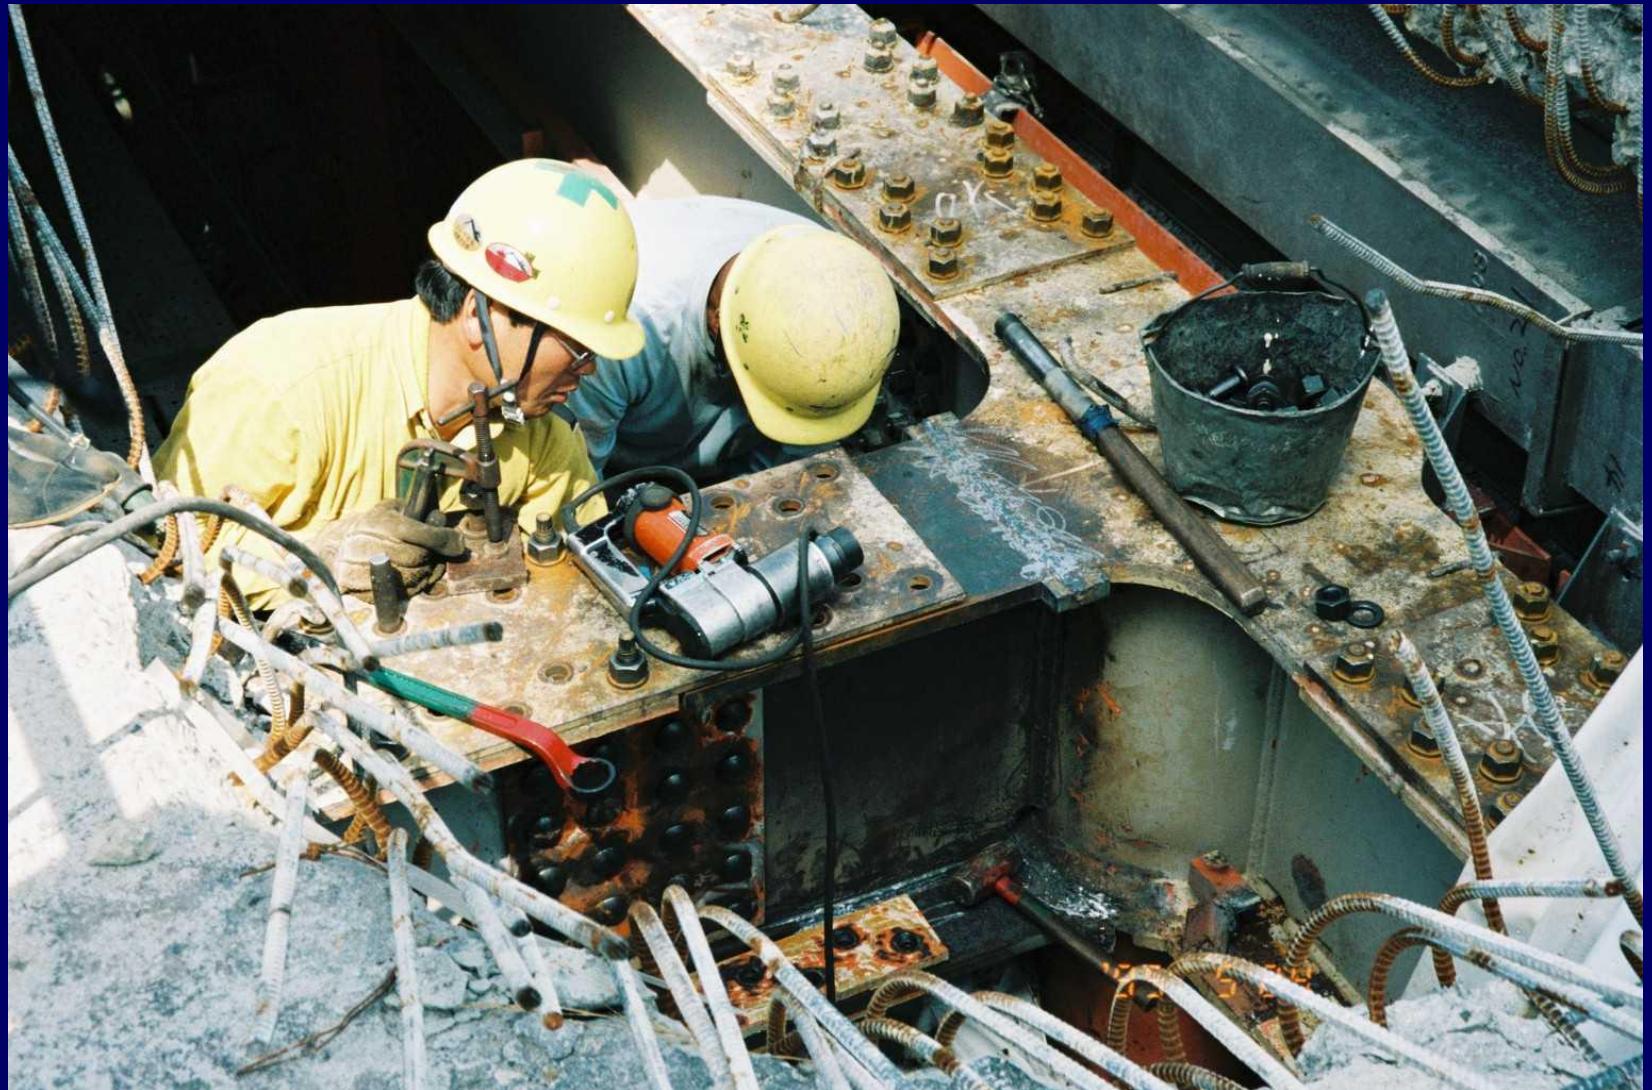
Welding retrofit of  
damaged beam plate

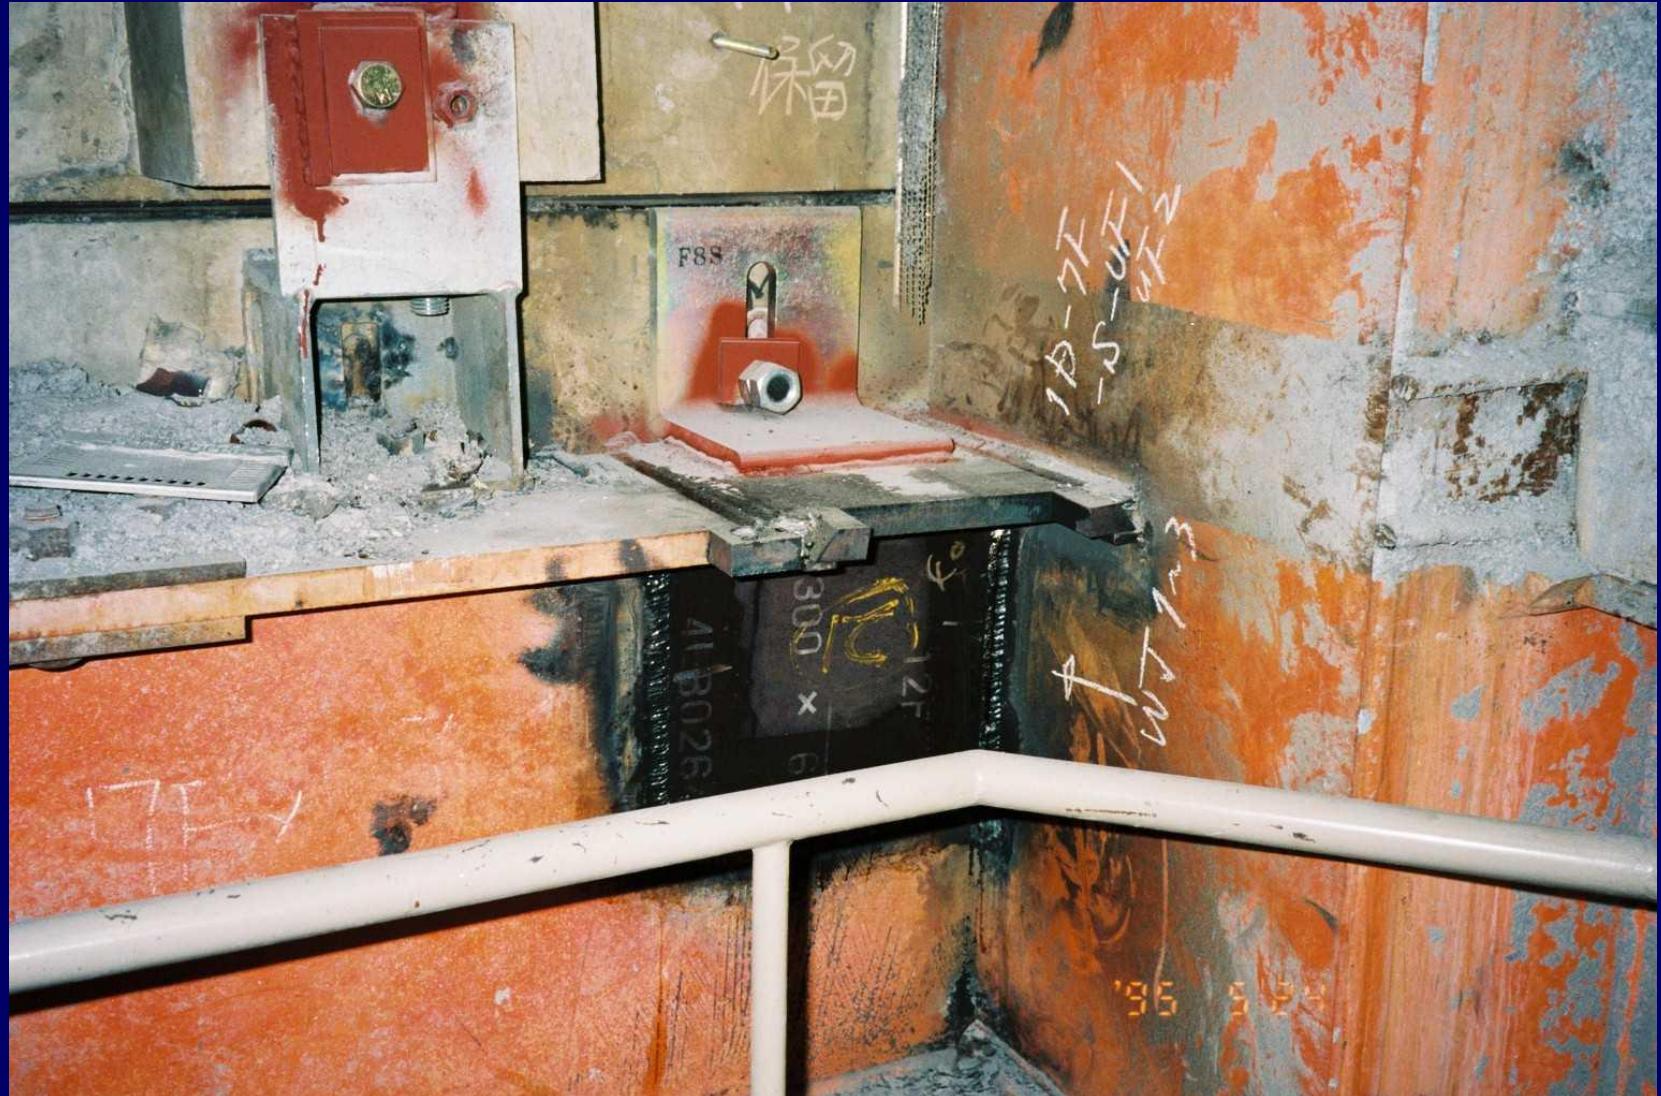
After welding of  
beam plates

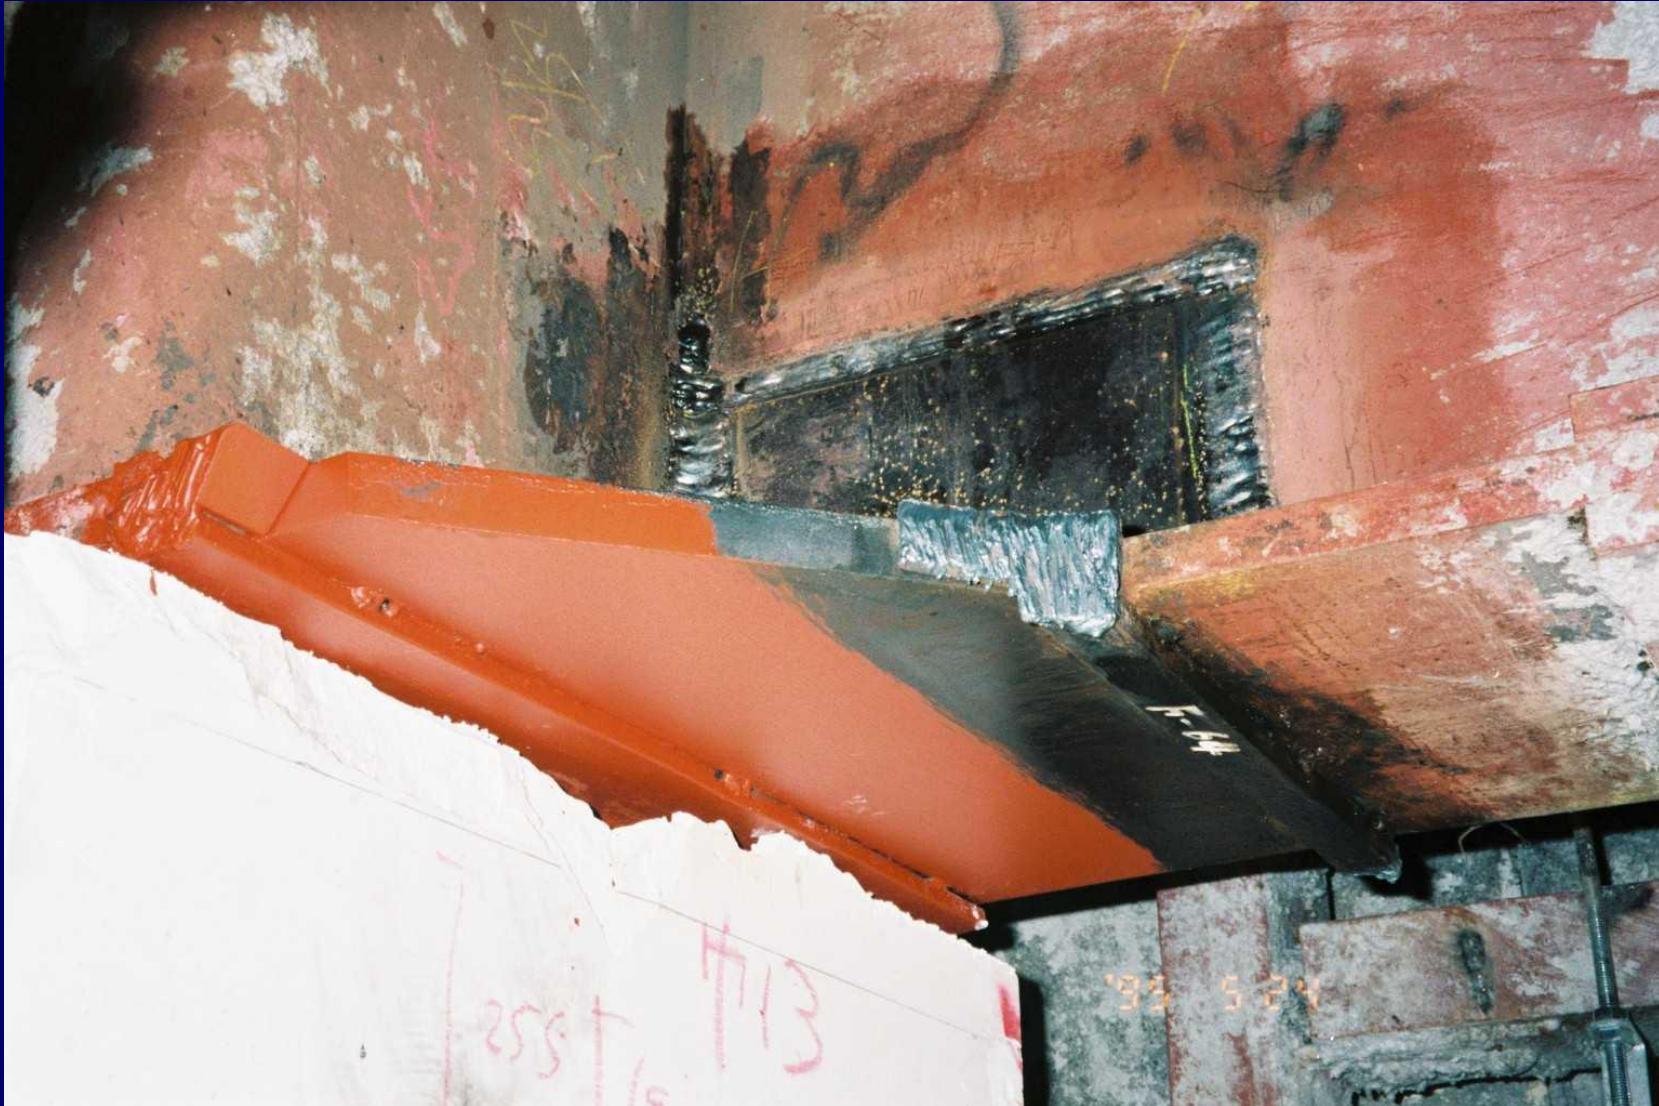
After welding of  
beam plates

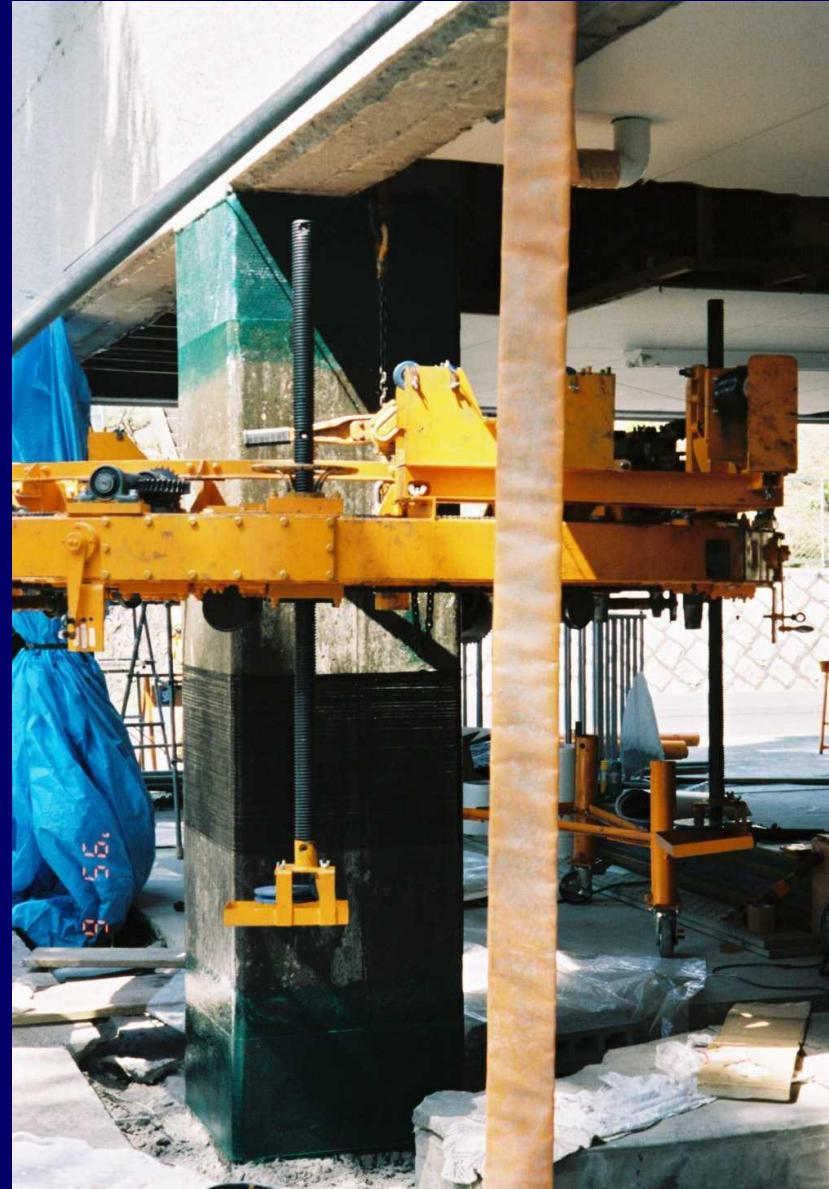
Binding the carbon  
fiber strand around  
the damaged  
column
