Seismic evaluation of the existing RC buildings in Japan

**Building Research Institute,
Japan**

Matsutaro SEKI

Post Earthquake Quick Inspection of Damaged Buildings (Reinforced concrete buildings)

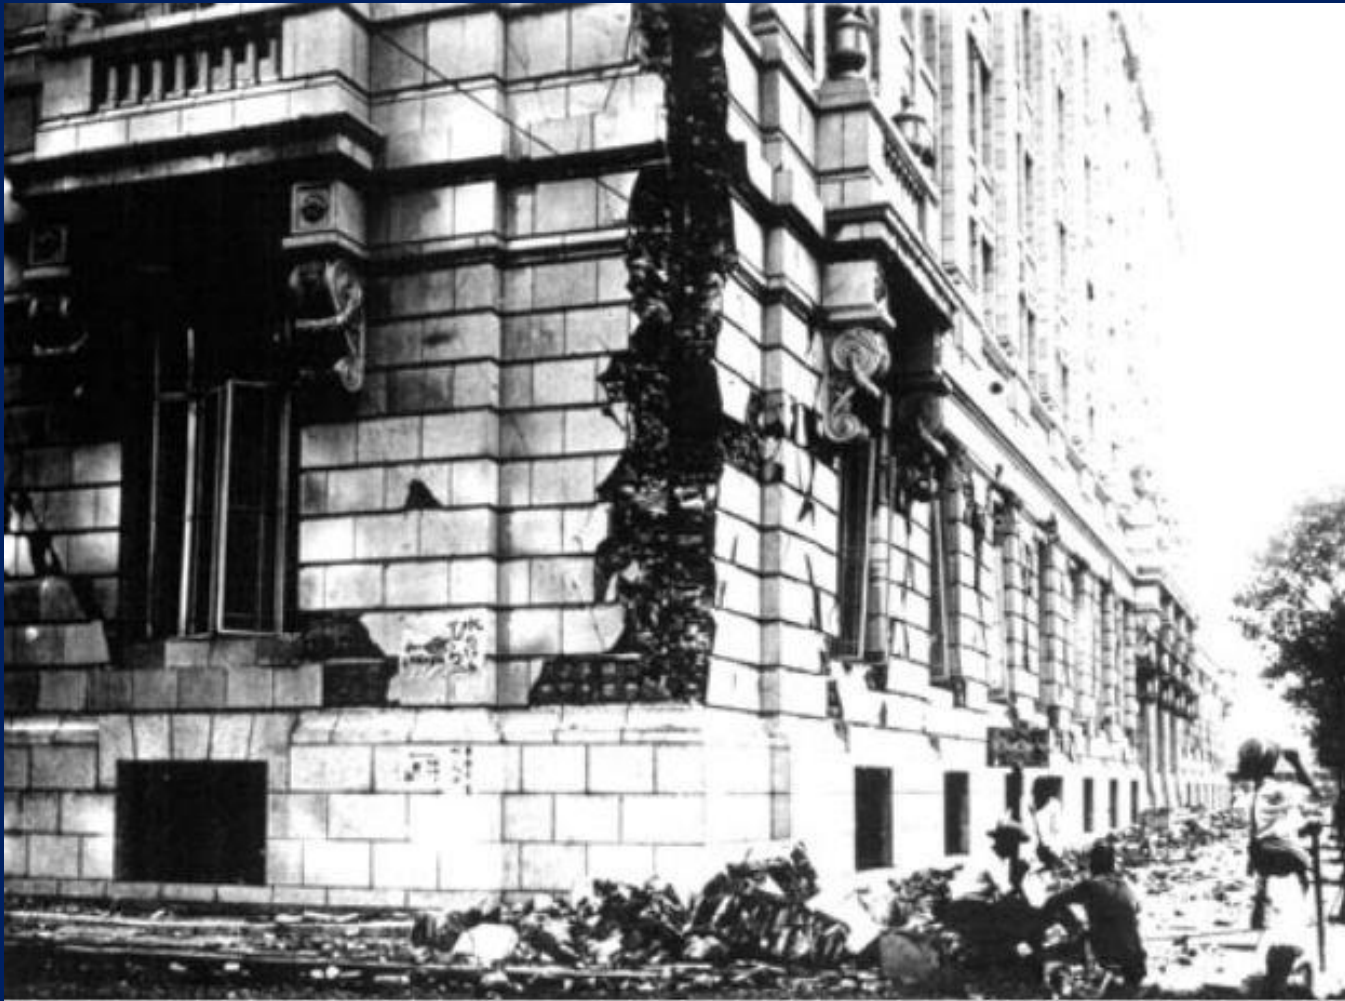
Damage of Masonry Building

1. Horizontal seismic intensity: 0.1 was adopted for seismic design.
2. Damage of reinforced concrete buildings was small.
3. Damage of masonry buildings was big.
4. Discussion on the benefit of rigid structure and flexible structure was done. From then, the rigid structure was recommended.

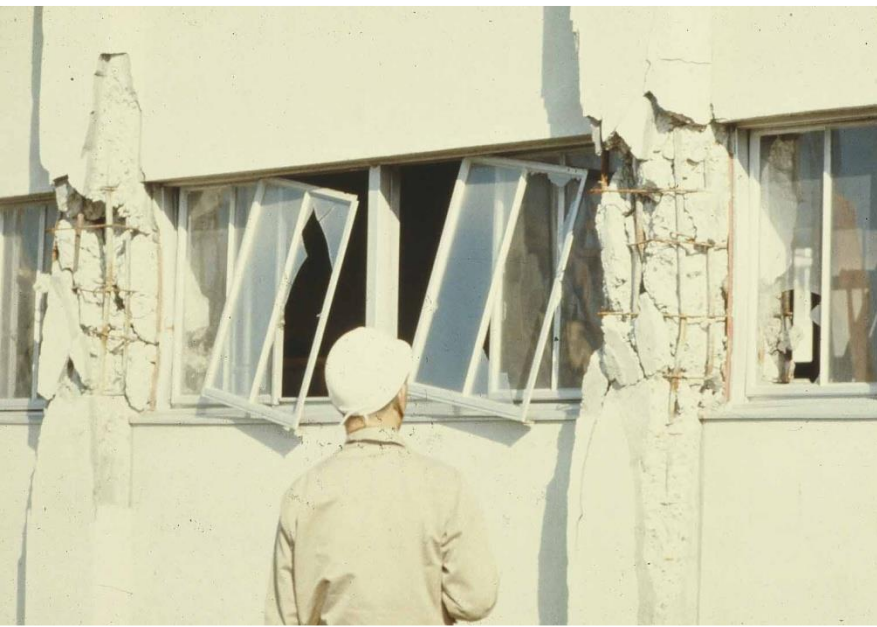
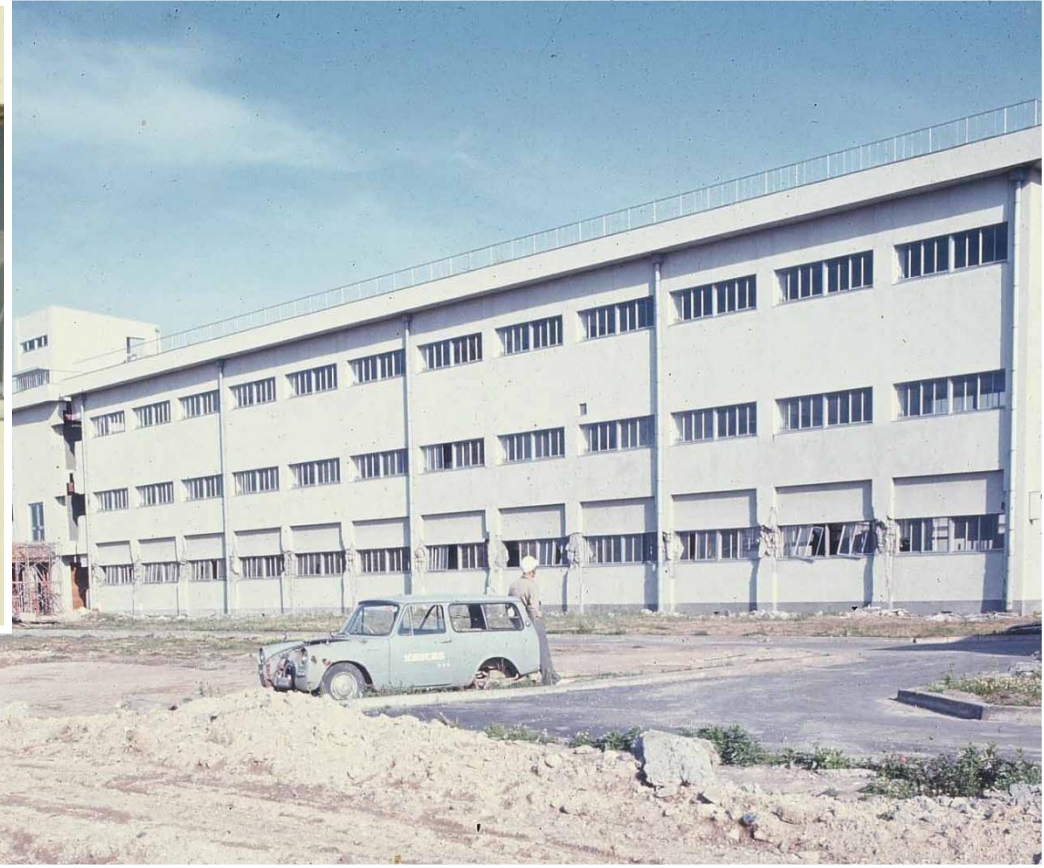
**Hachinohe
Technical High
School**

Shear Failure of Column (Brittle failure)

1. There are lots of Shear Failure of RC Column
2. Lots of research works on Shear Failure were done from then.
3. Japanese seismic code was revised in 1971.
4. Hoop space was changed from 30 cm to 10 cm.
5. Seismic design was changed from shear failure to flexural failure.

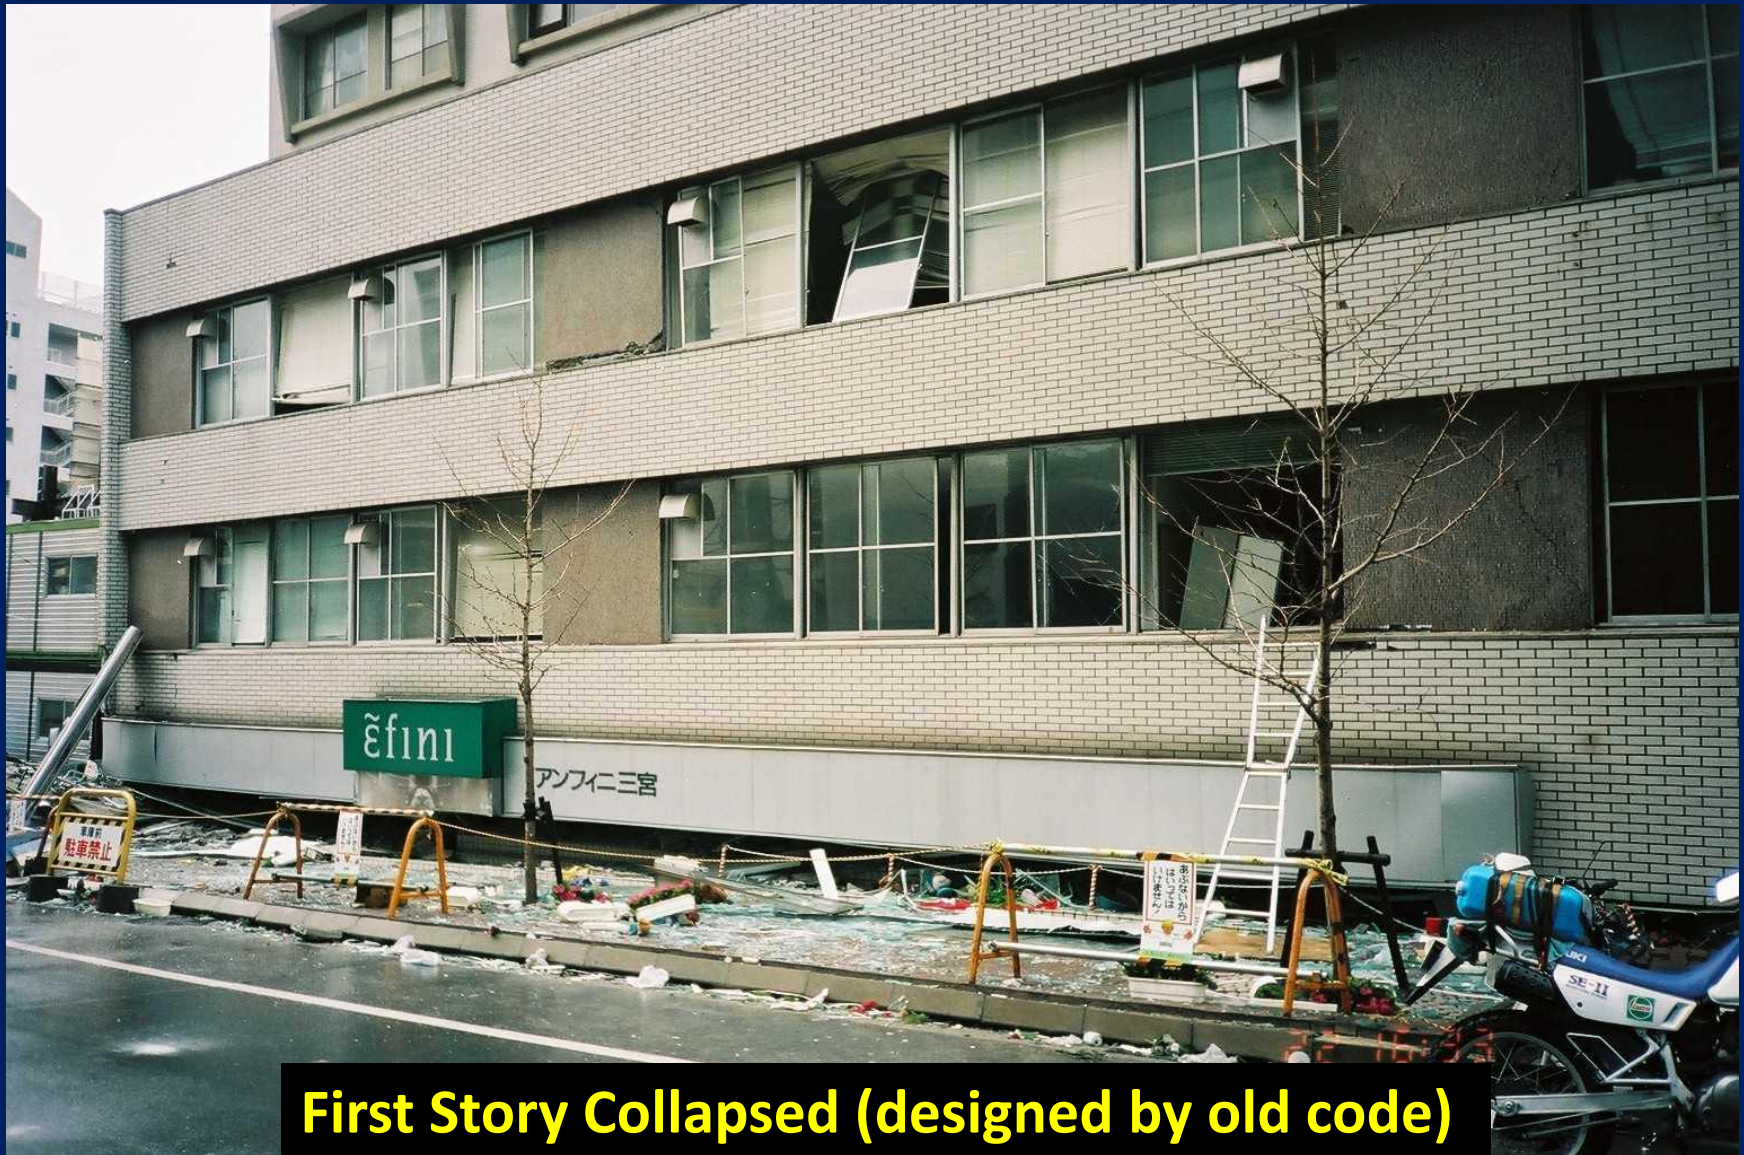
First Story Collapsed (designed by old code)

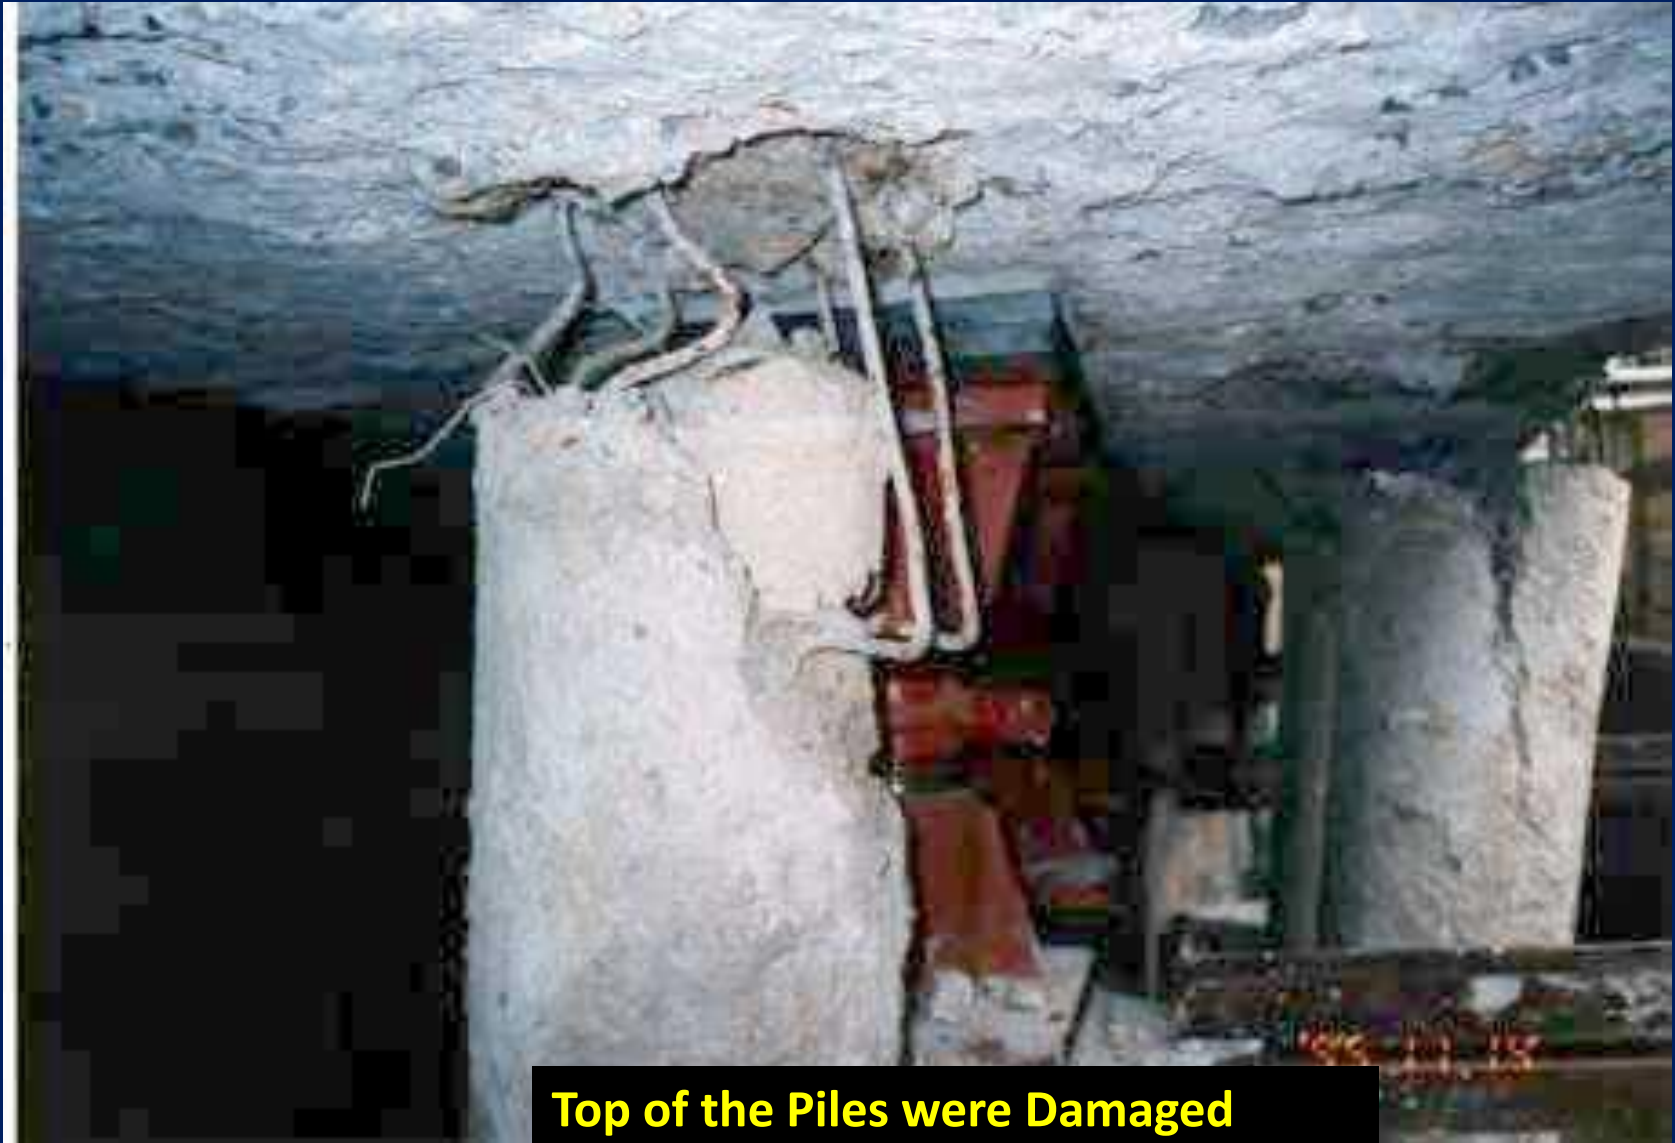
Top of the Piles were Damaged

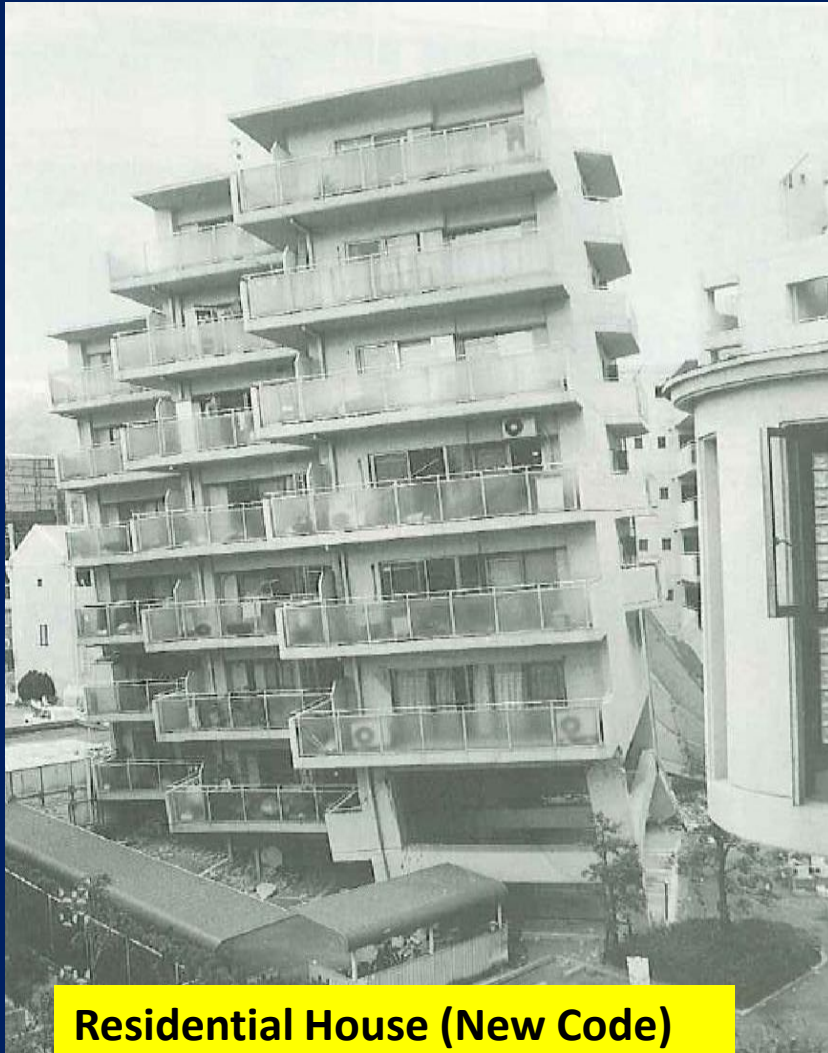
Residential House (New Code)

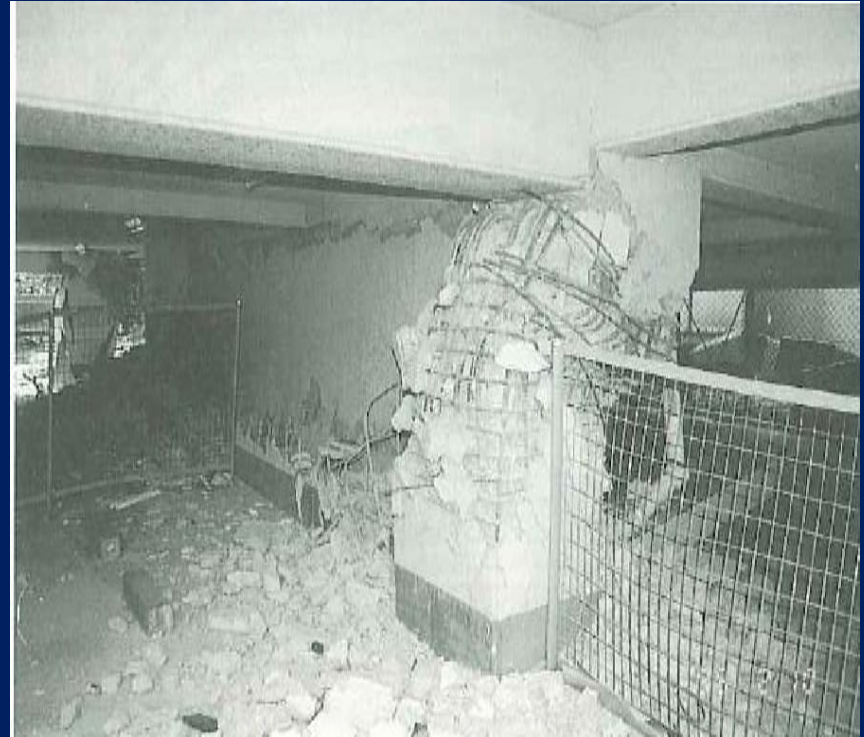
Failure of First Story (New Code)

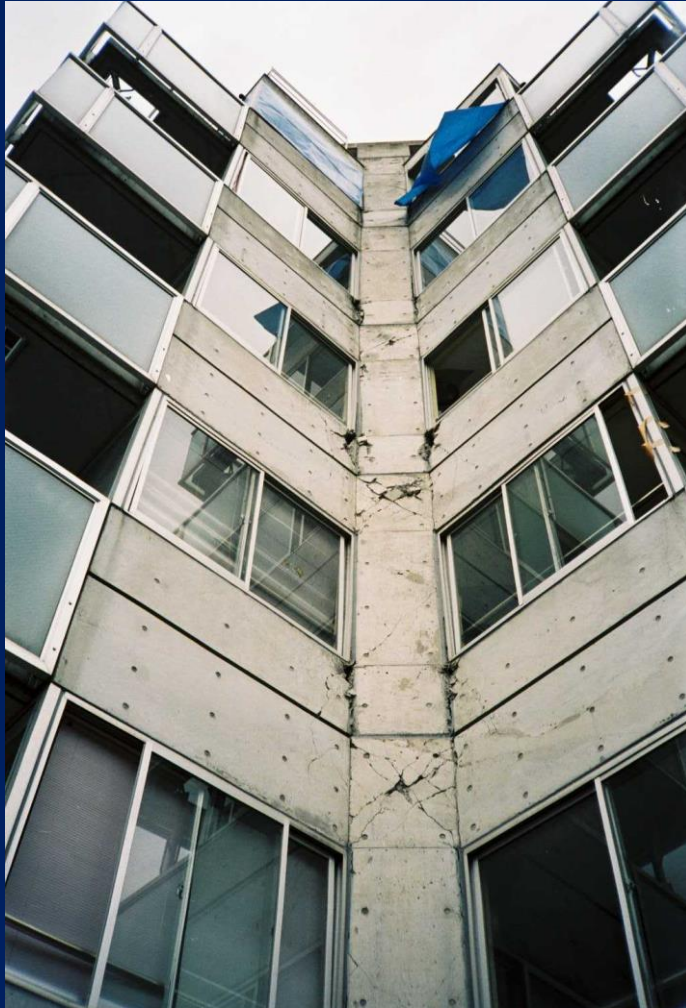
Cracks of Beam Column Joint (New Code)

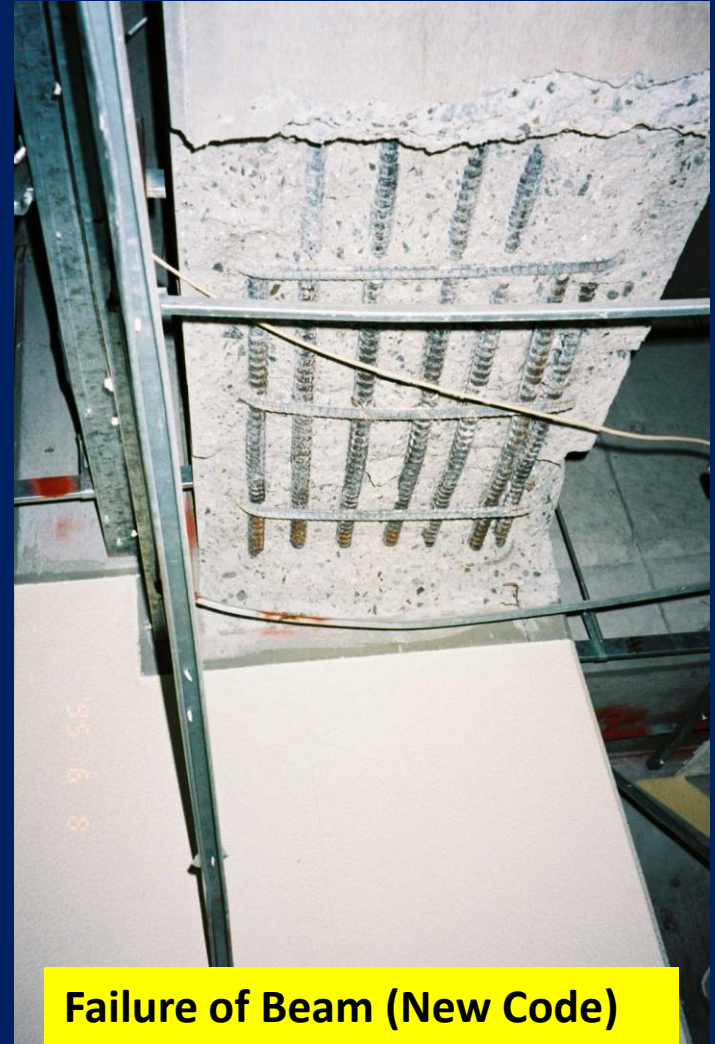
Failure of Beam (New Code)

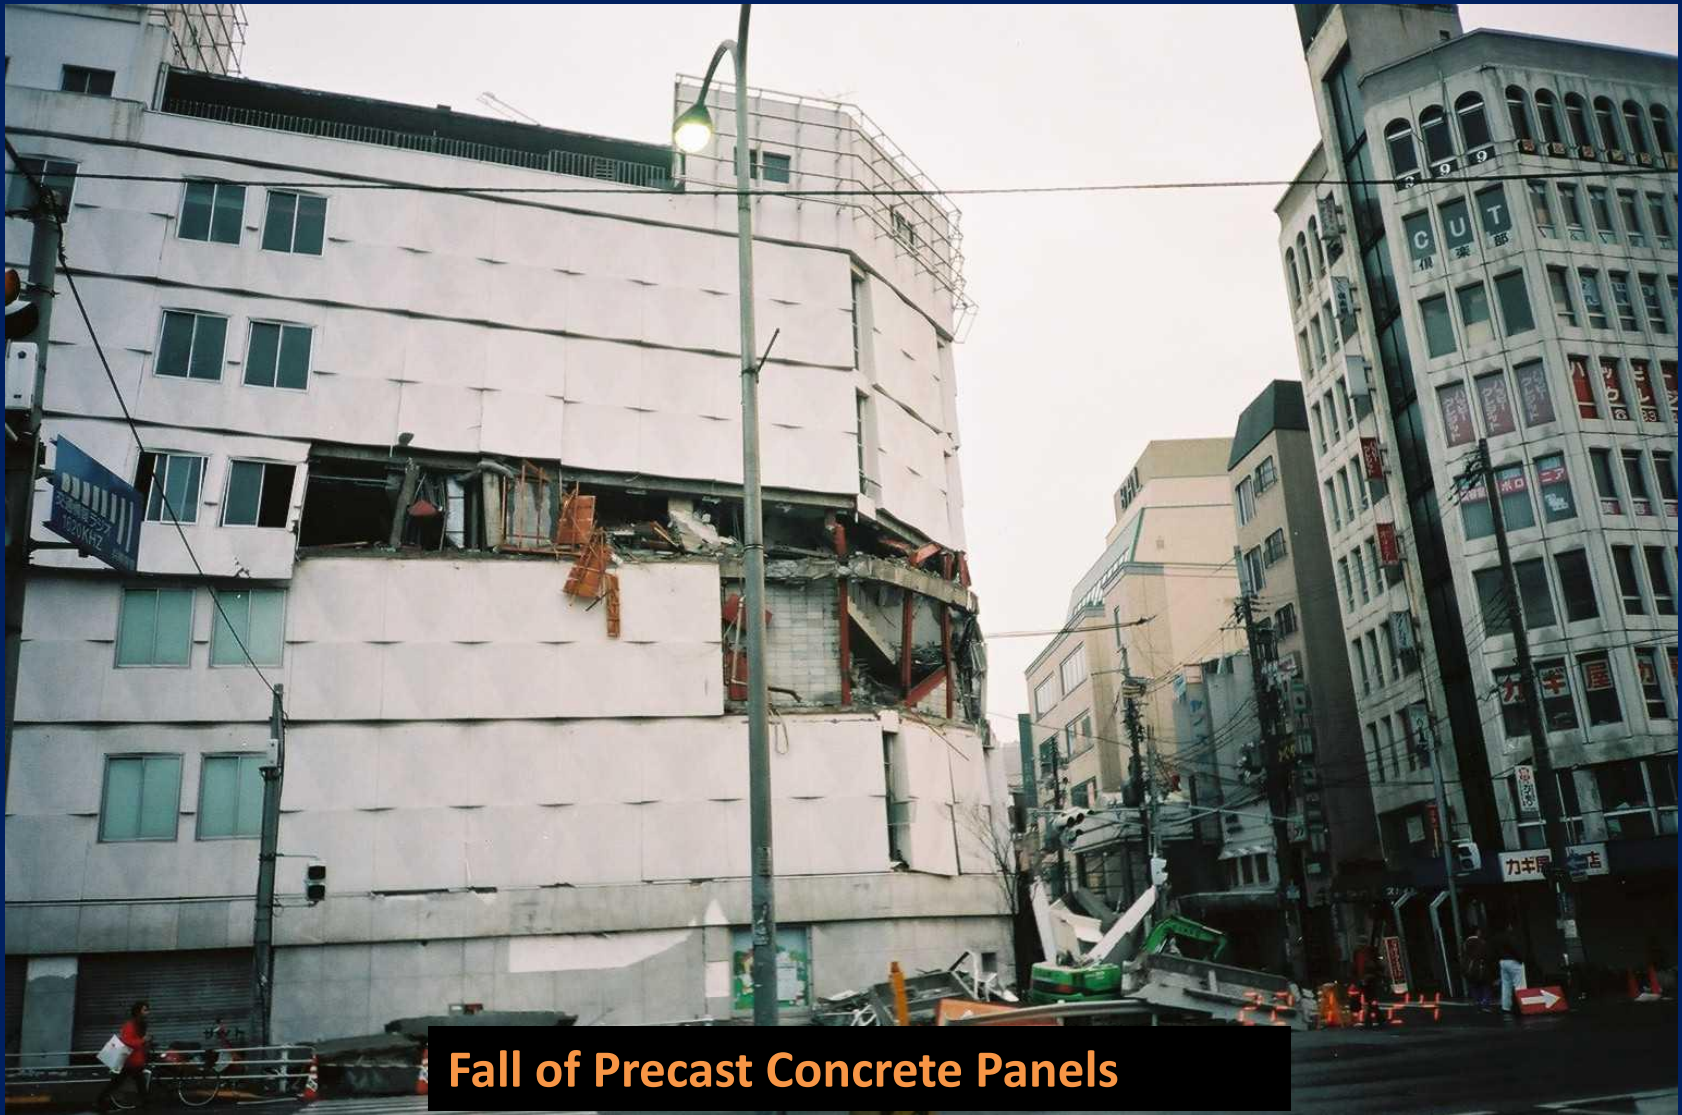
Fall of Precast Concrete Panels

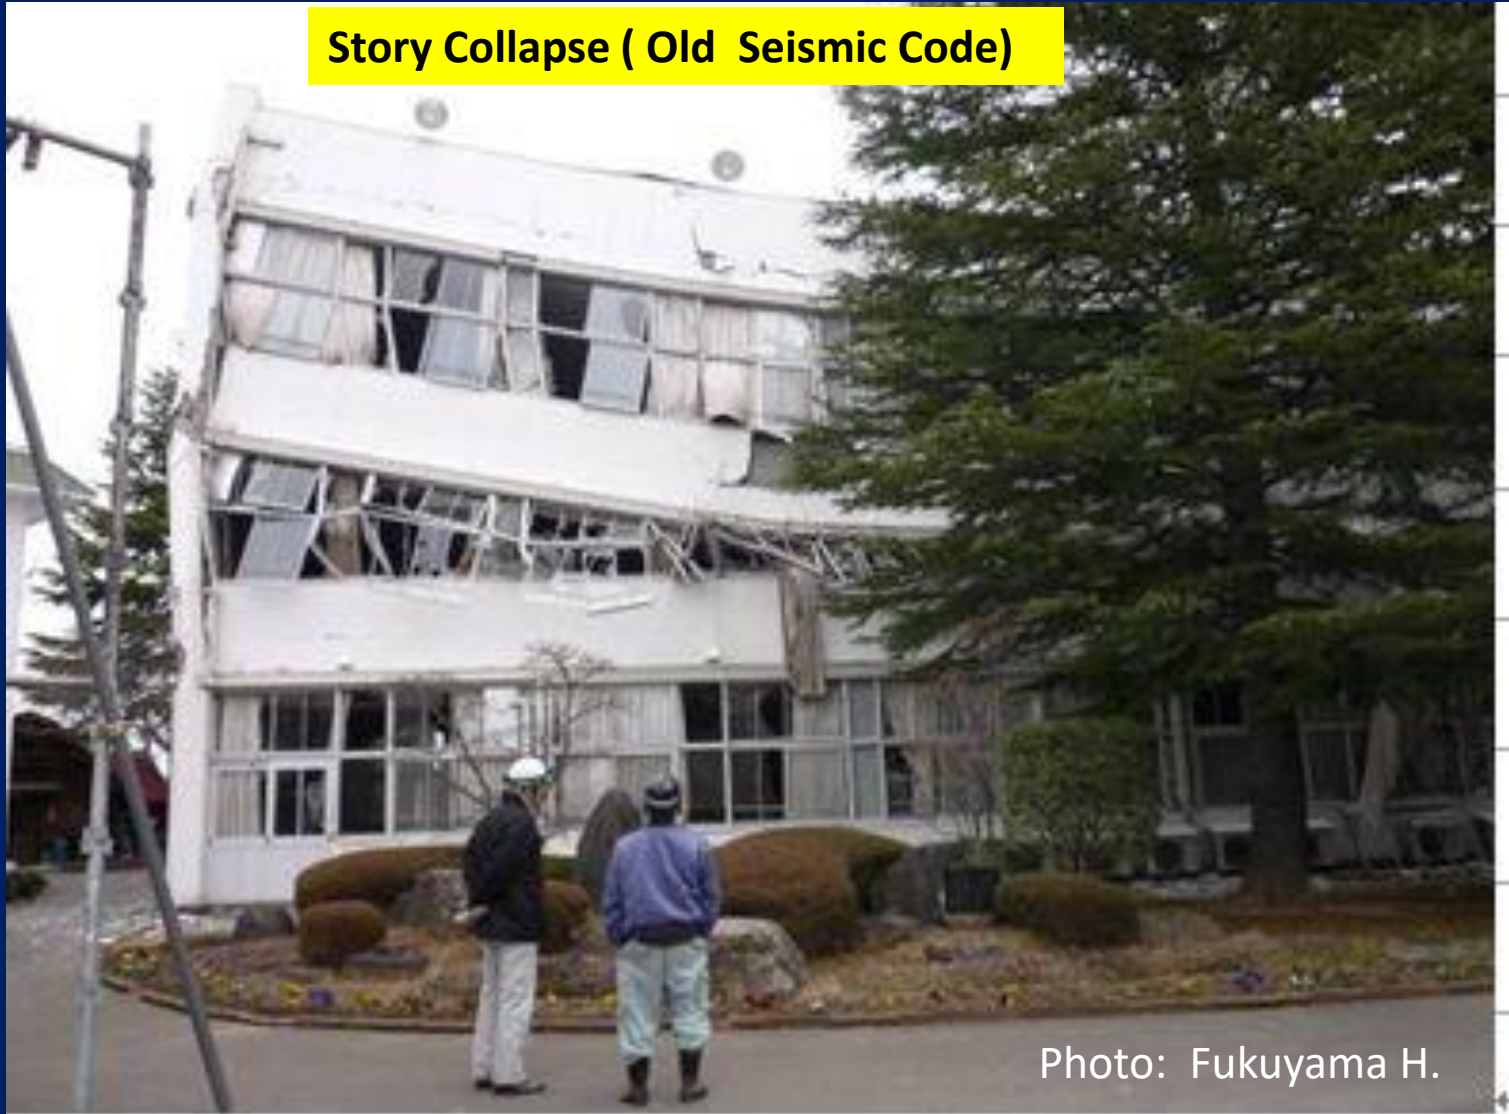
Story Collapse (Old Seismic Code)

- 1. The Buildings constructed by 1980 old code were severely damaged but not so many buildings.**
- 2. The retrofitted buildings showed the good performance.**
- 3. The buildings constructed by 1981 new code were almost safe but small modification was performed.**

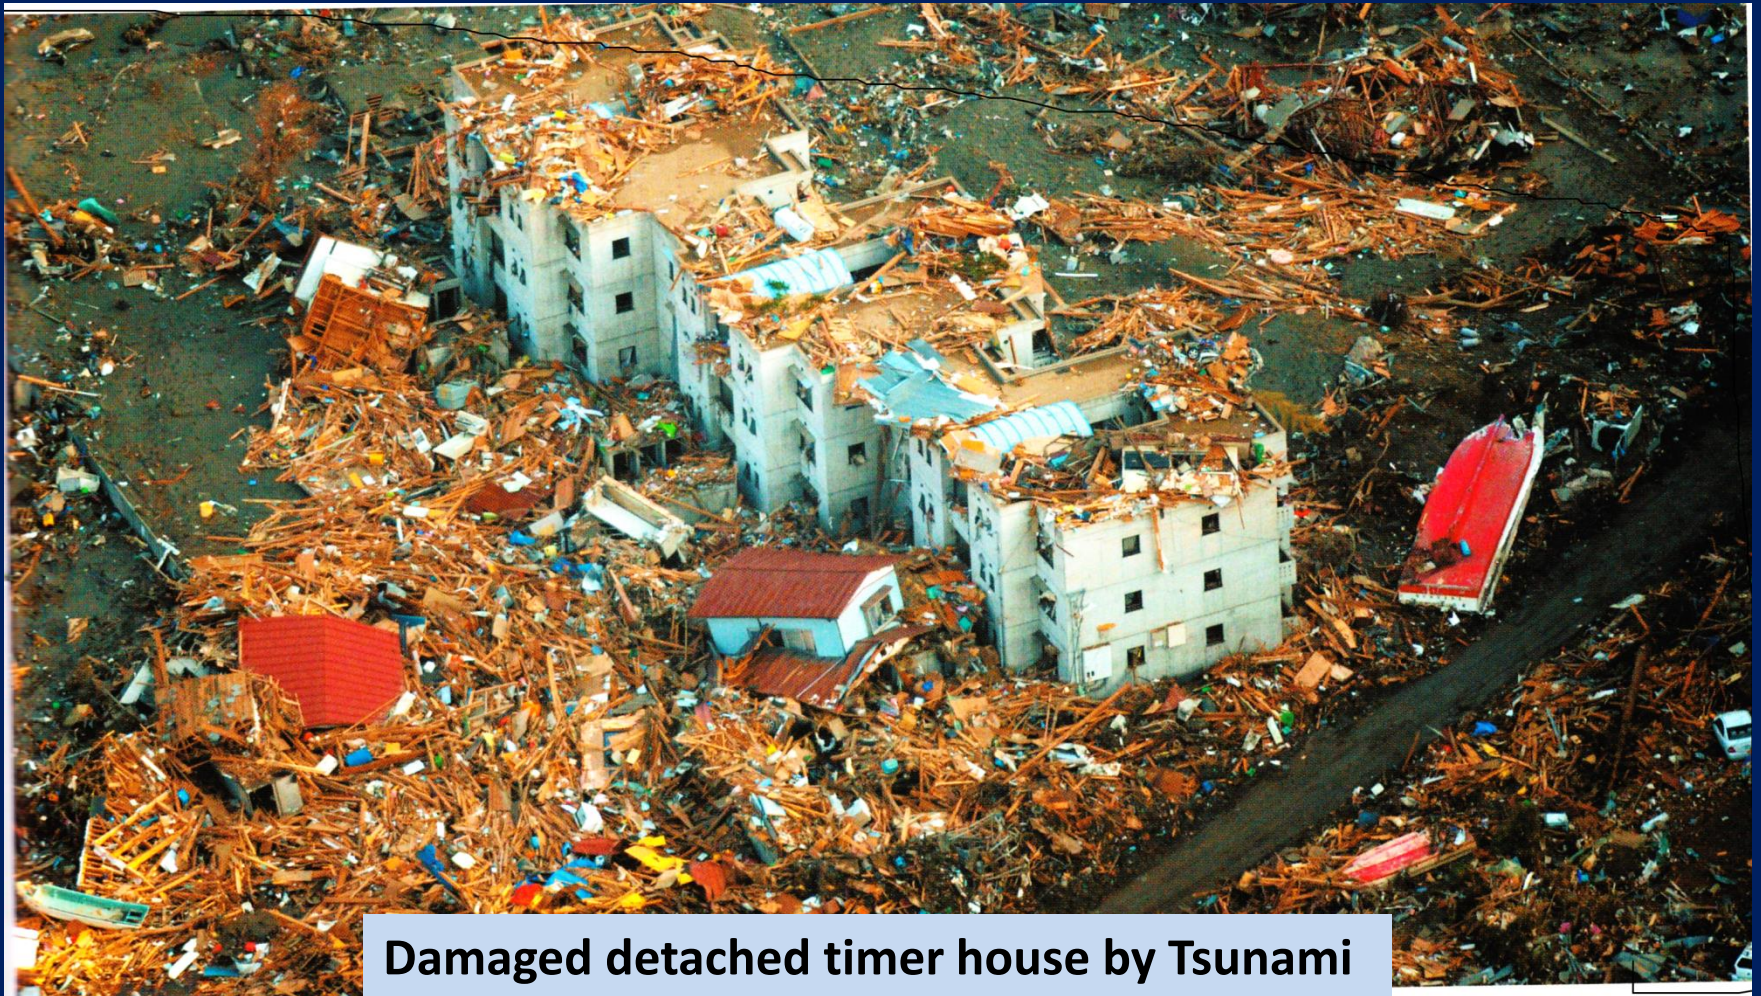
Damaged detached timer house by Tsunami

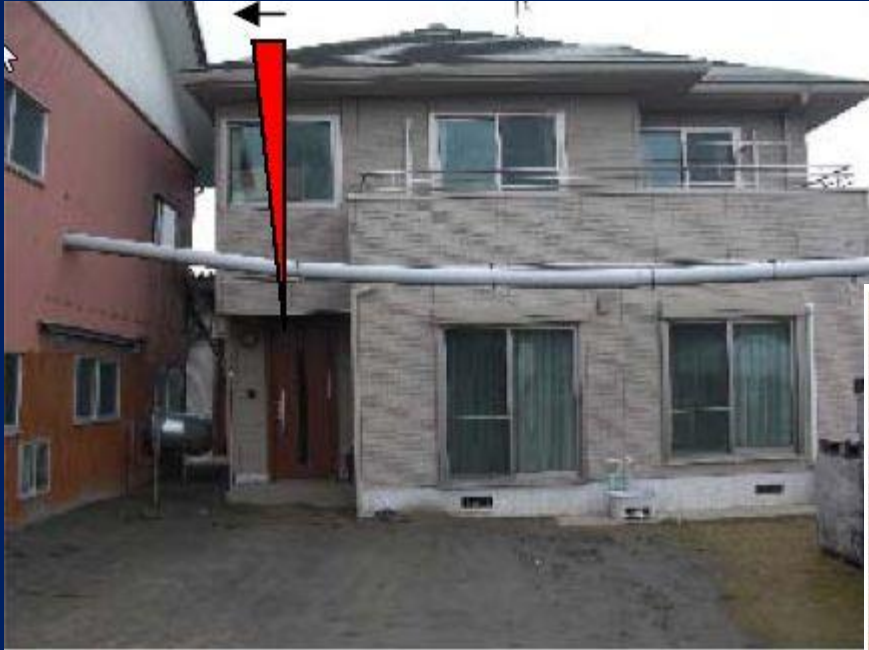
Liquefaction

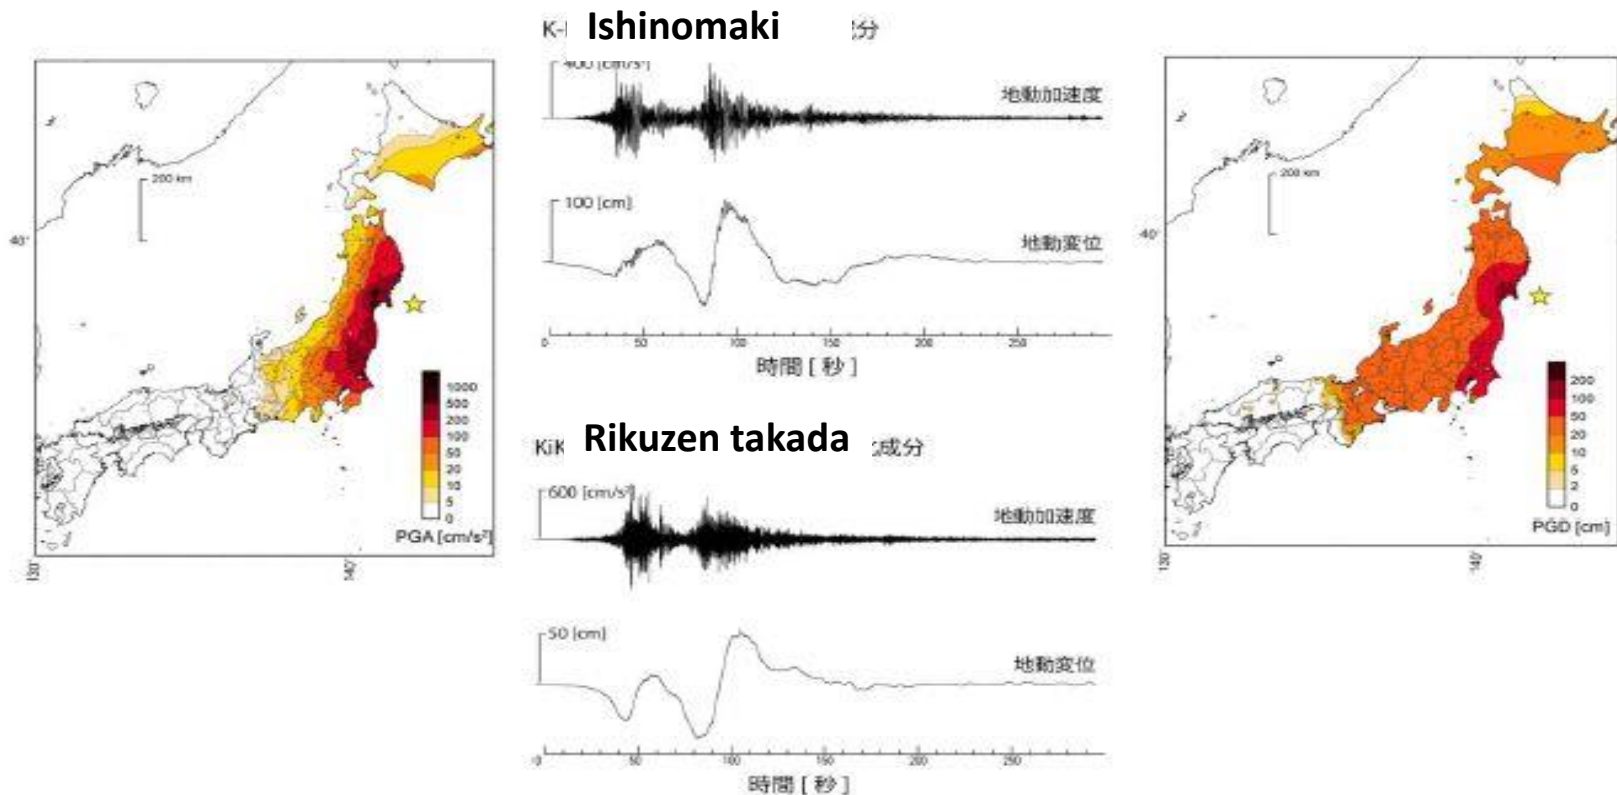
Observed strong ground motions

Long Duration Ground Motion (about 100 seconds)

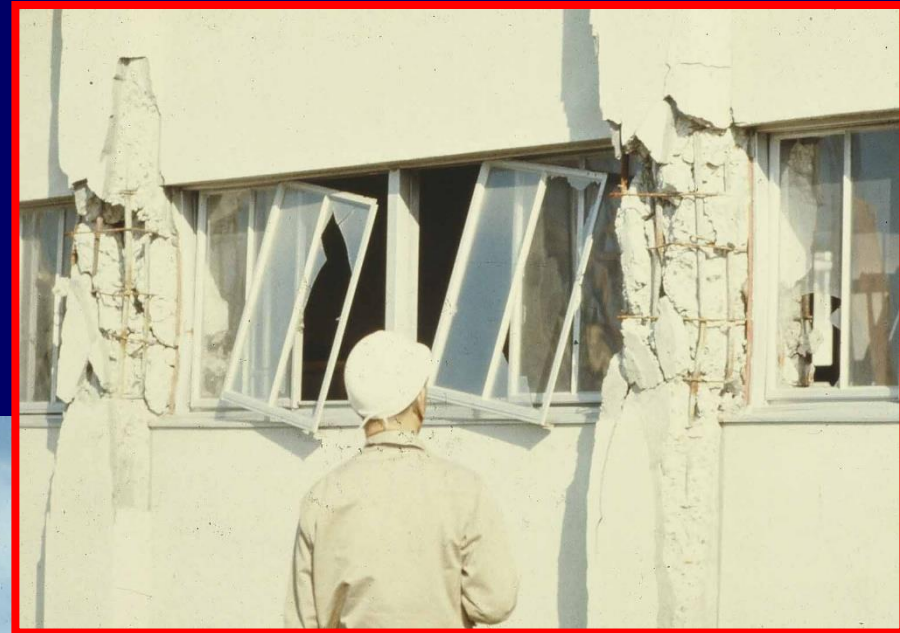
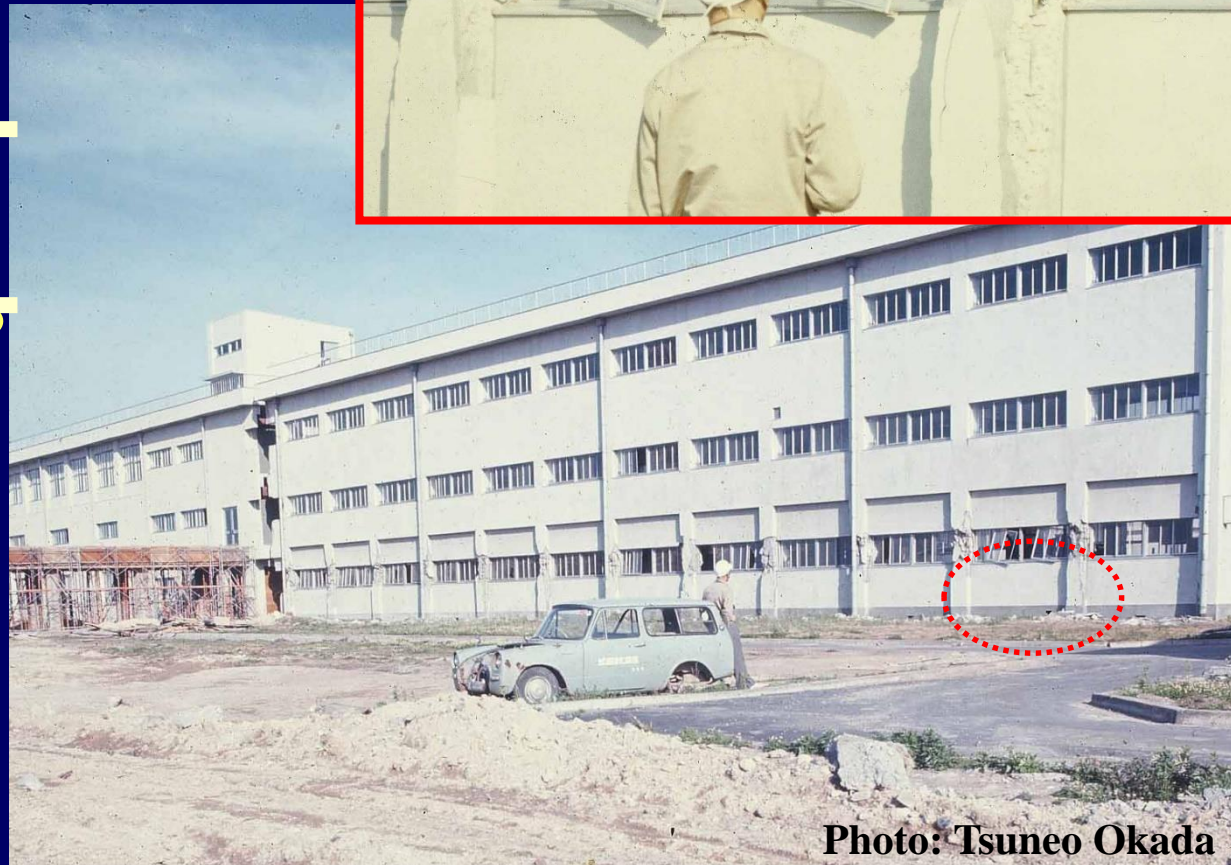
**1968 Tokachi-oki
Earth. (Hachinohe
Technical High
School)**

Example of column failure type

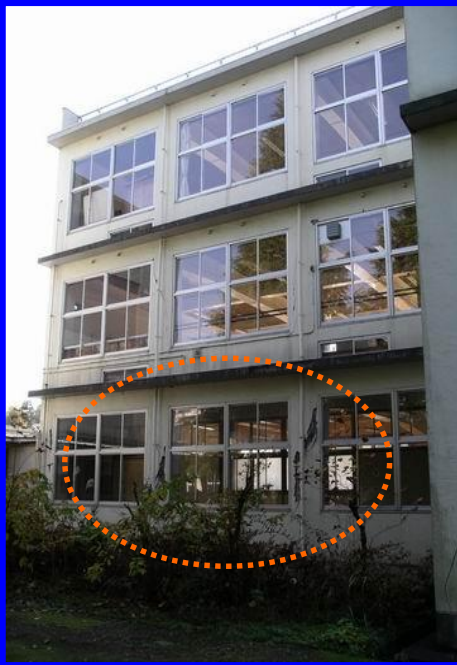
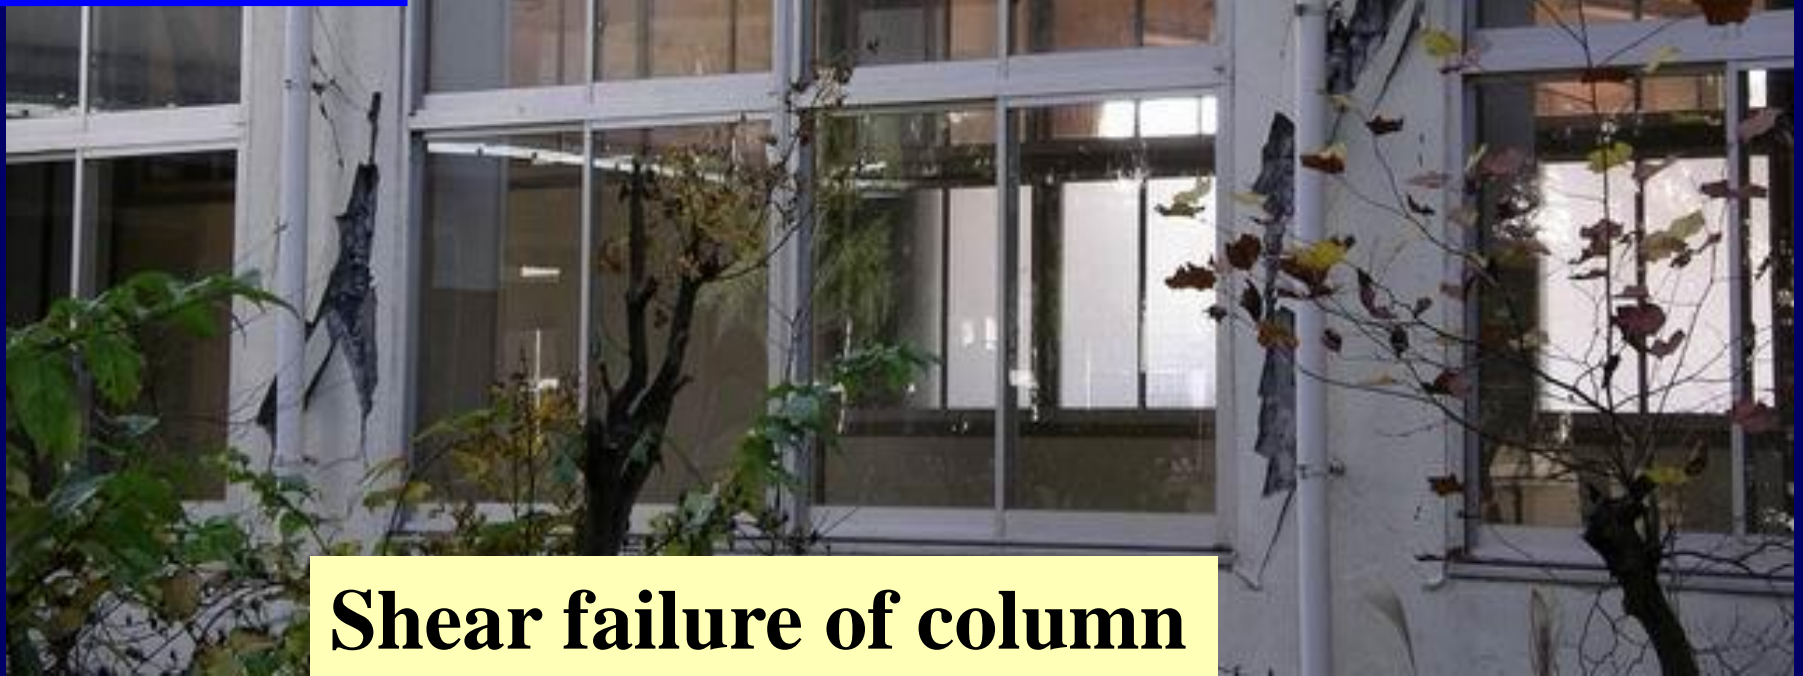
Shear failure of column

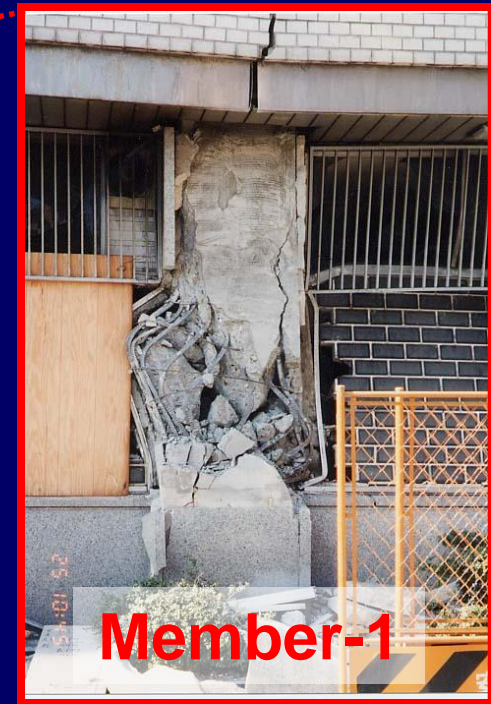
E₀ index (4) Local failure vs. safety

- $E_{0A} = (C_1 + \alpha C_2) \times F_1$
- $E_{0B} = \sqrt{(C_1 \times F_1)^2 + (C_2 \times F_2)^2}$

Allowable of failure of member-1

Not allowable
