Timber Framed Masonry buildings, an earthquake resistance influenced traditional architecture

Andreea DUTU, Hiroyasu SAKATA,

Tokyo Institute of Technology

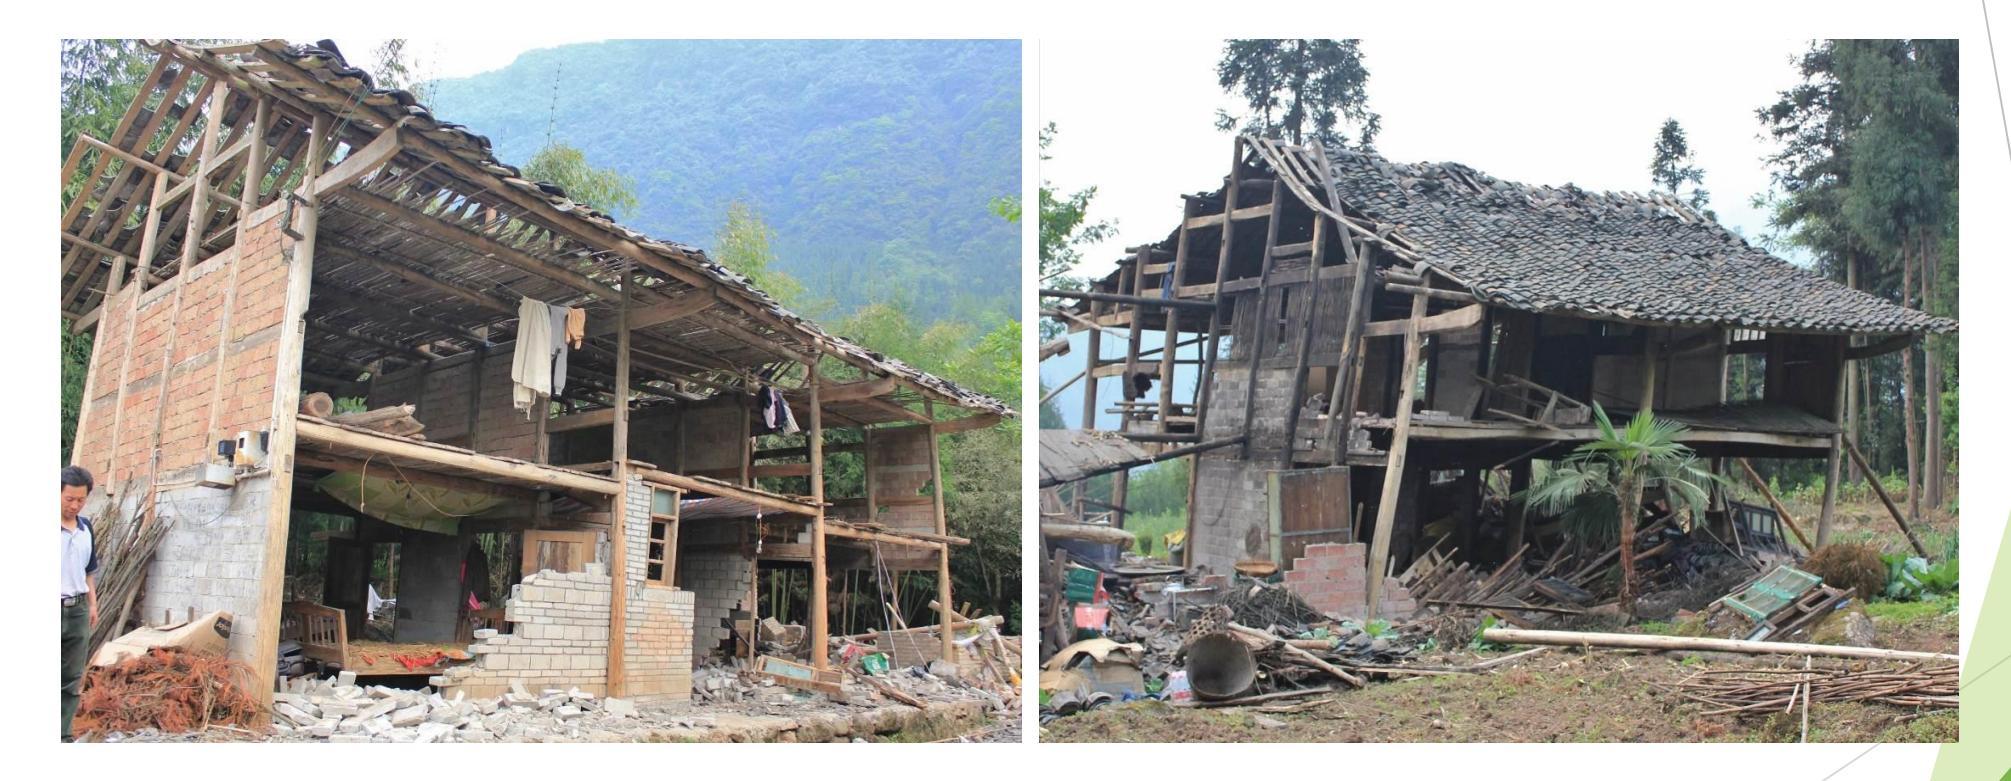
Recent earthquakes showed TFM houses exhibit slight to moderate, but don't usually collapse. The damages are due to poor construction details and/or biological degradation. Out of plane collapse of the masonry panels also occurred, without producing total collapse.

Lushan 2013 earthquake, China [Qu Z., Dutu A., Zhong J. Sun J., (2014) "Seismic Damage of Masonry Infilled Timber Houses in the 2013 M7.0 Lushan Earthquake in China", Earthquake Spectra In press]

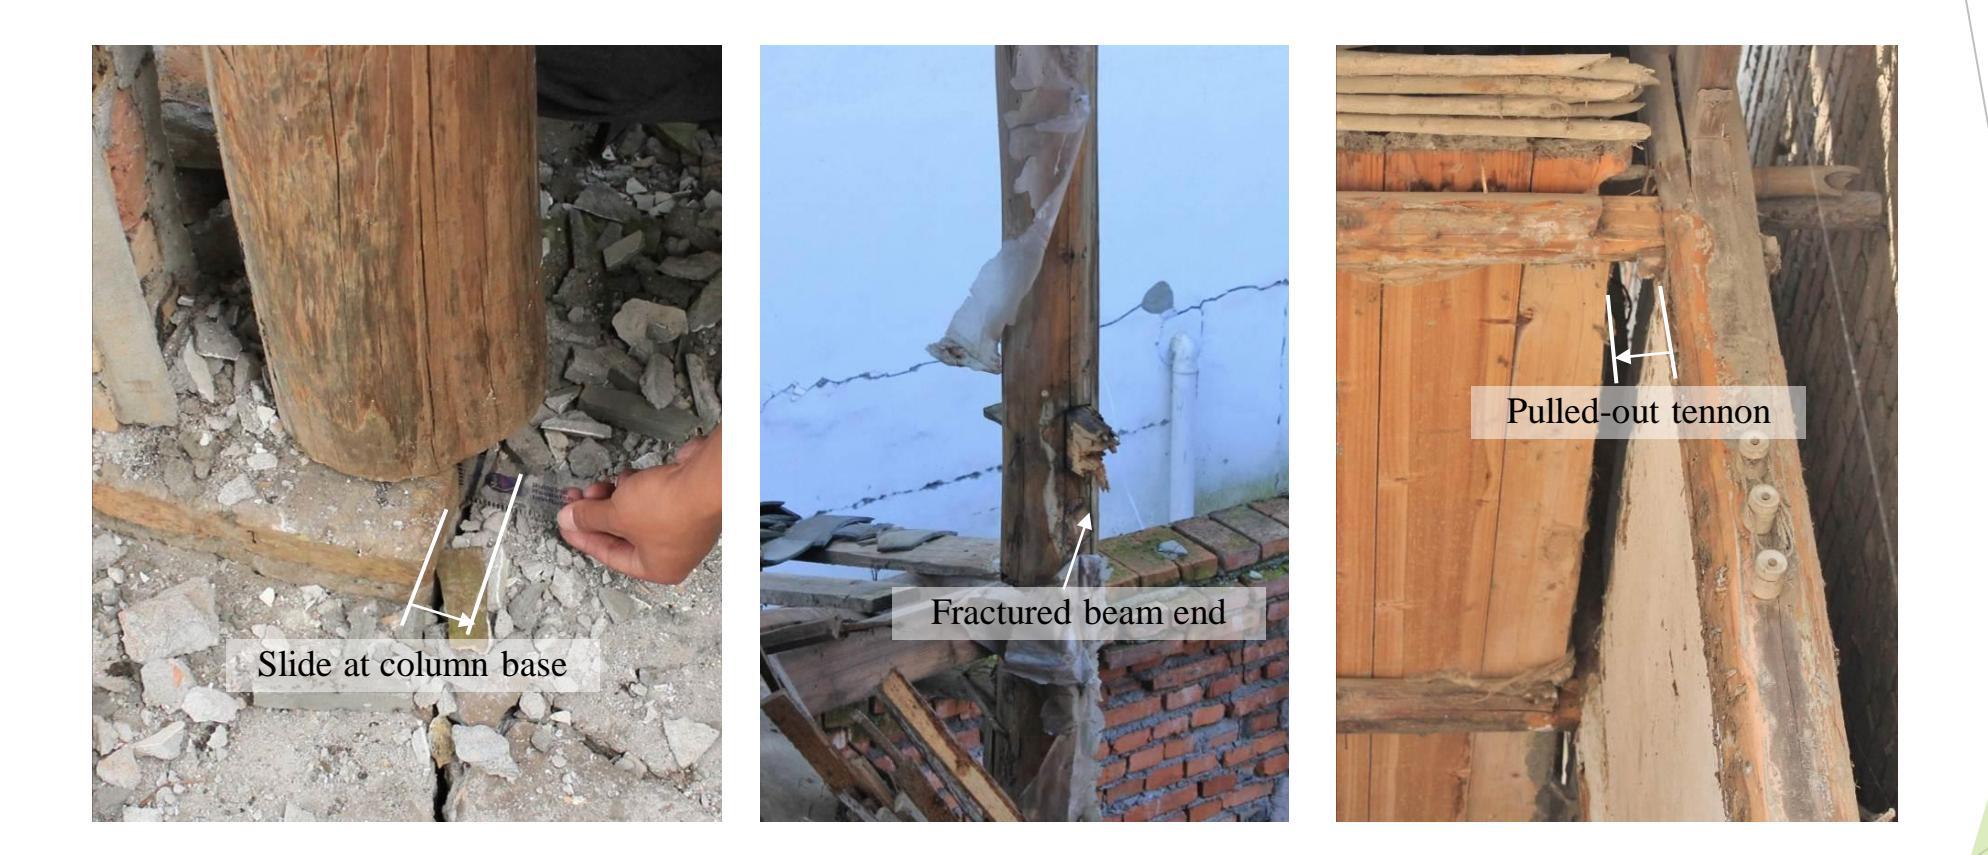
Poor construction details for the connections

Lushan 2013 earthquake, China [Qu Z., Dutu A., Zhong J. Sun J., (2014) "Seismic Damage of Masonry Infilled Timber Houses in the 2013 M7.0 Lushan Earthquake in China", Earthquake Spectra In press] Less than 5% of TFM houses (Gingerbread) collapsed. The rest of them experienced light to moderate damages, just like in the Lushan earthquake, most likely due to poor construction details.

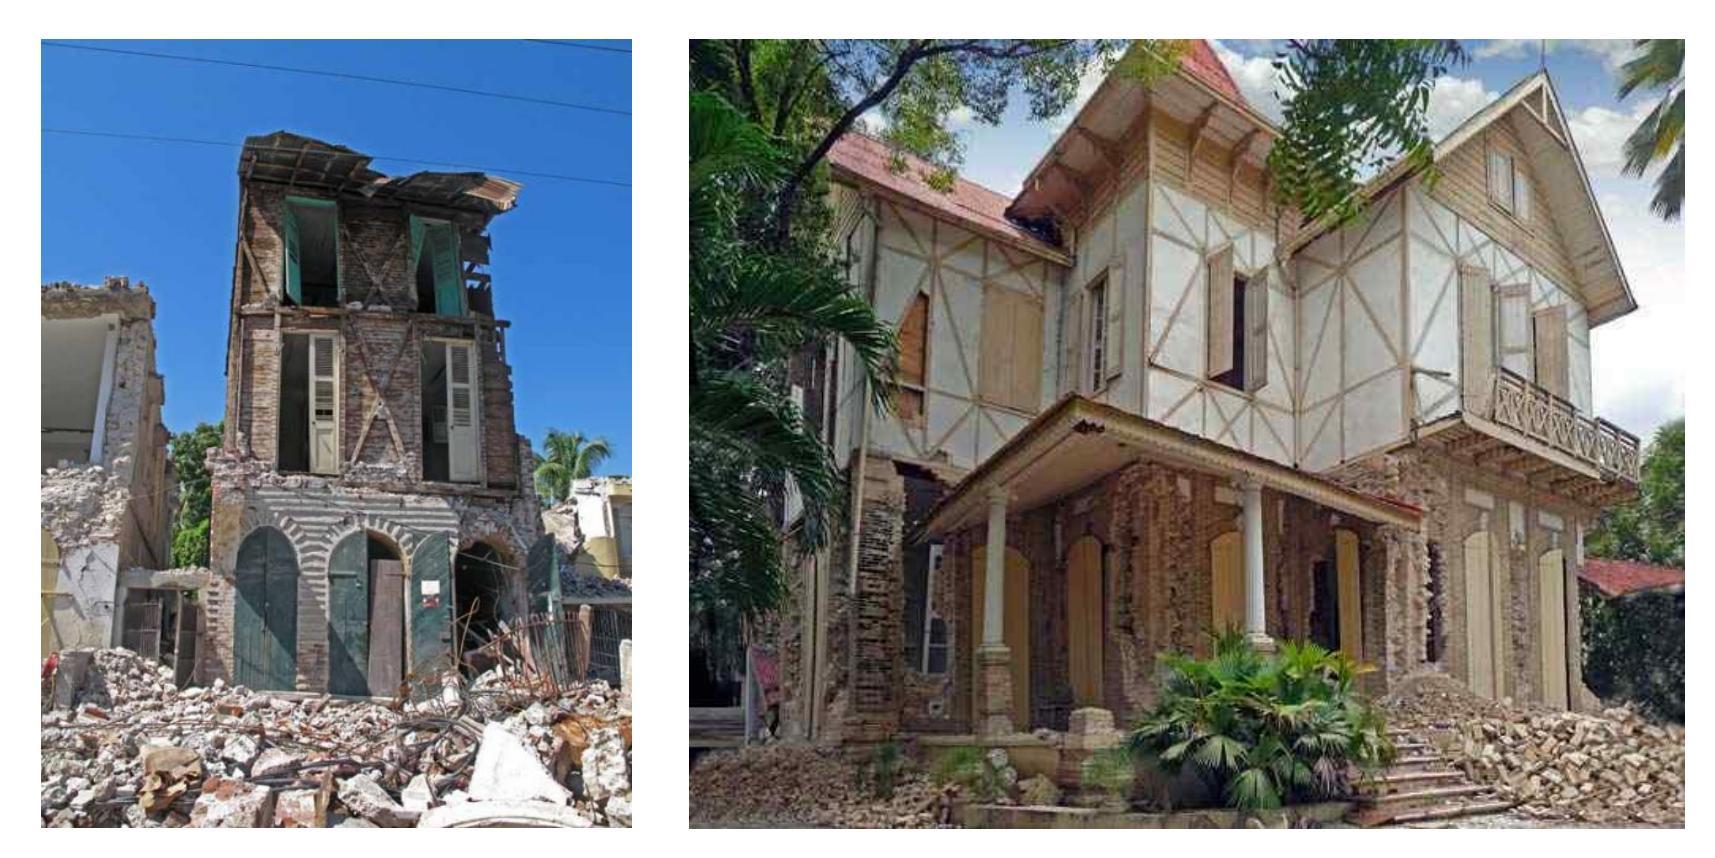
Port-au-Prince 2010 earthquake, Haiti [Langenbach R., Kelley S., Sparks P., Rowell K., Hammer M., Julien O. J. (2010), "Preserving Haiti's Gingerbread Houses", 2010 Earthquake Mission Report]

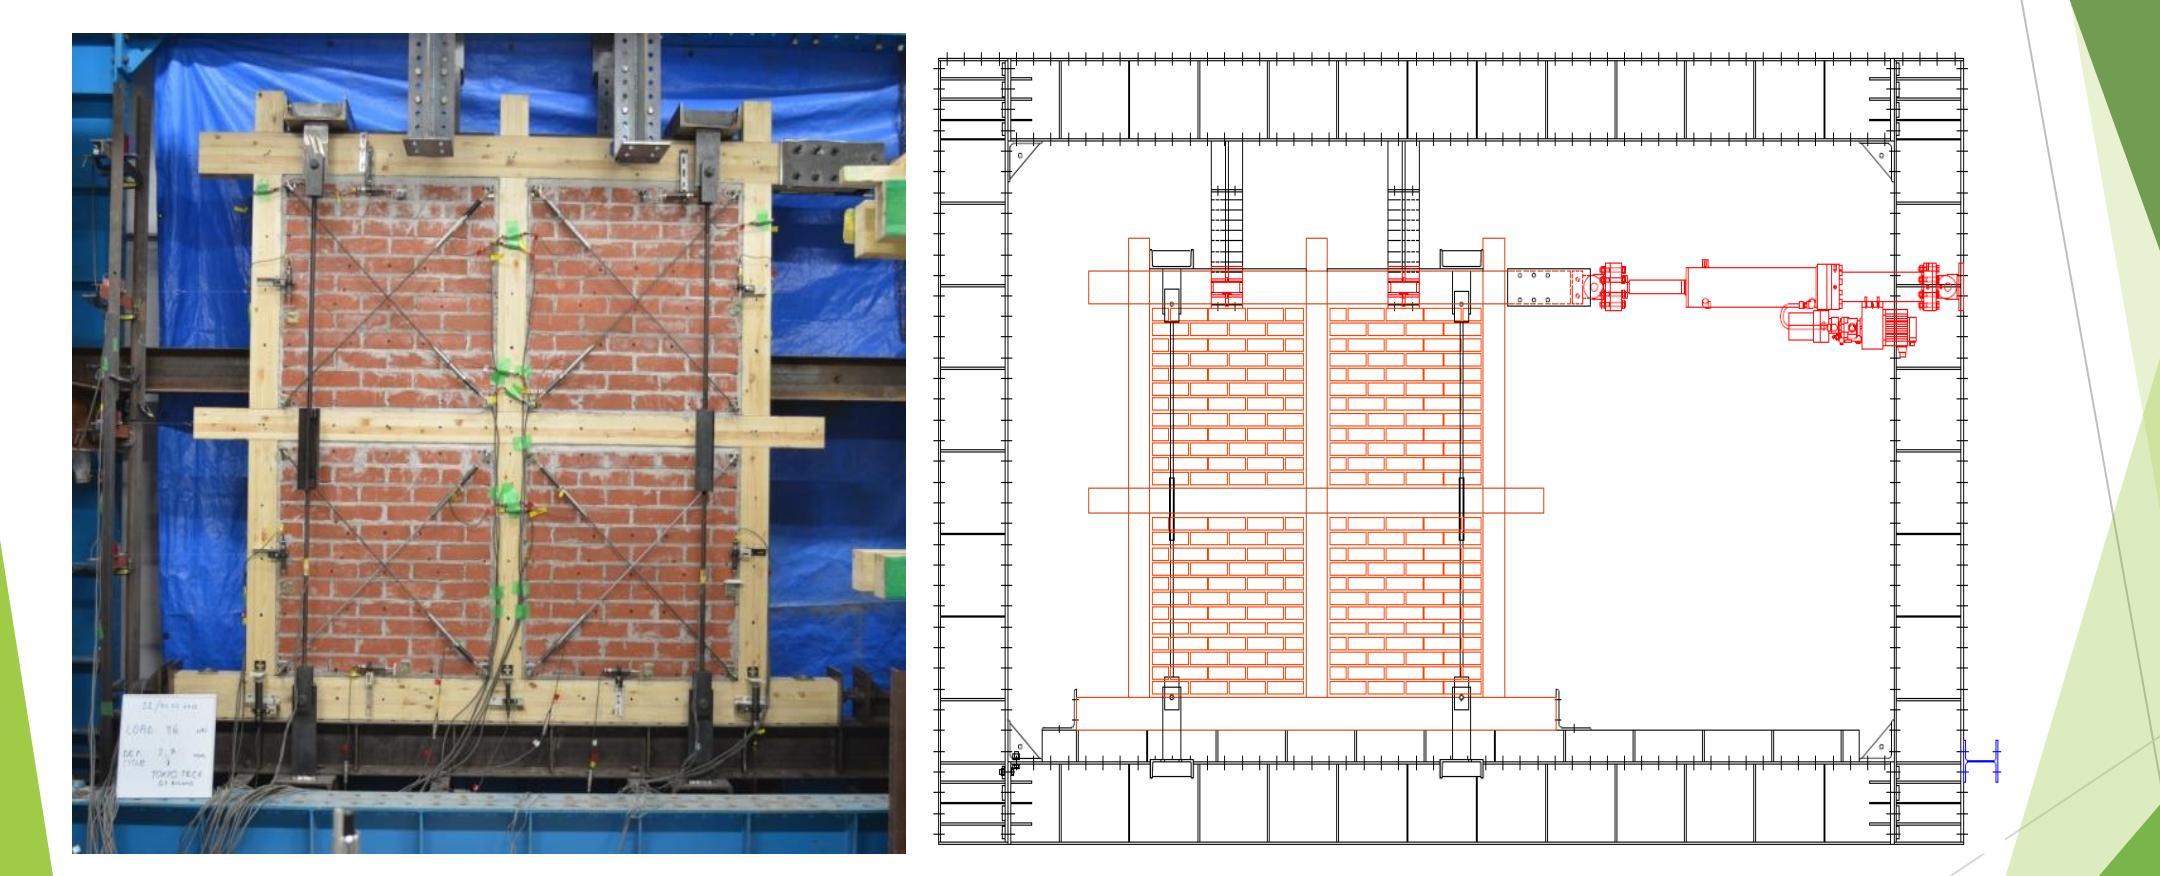
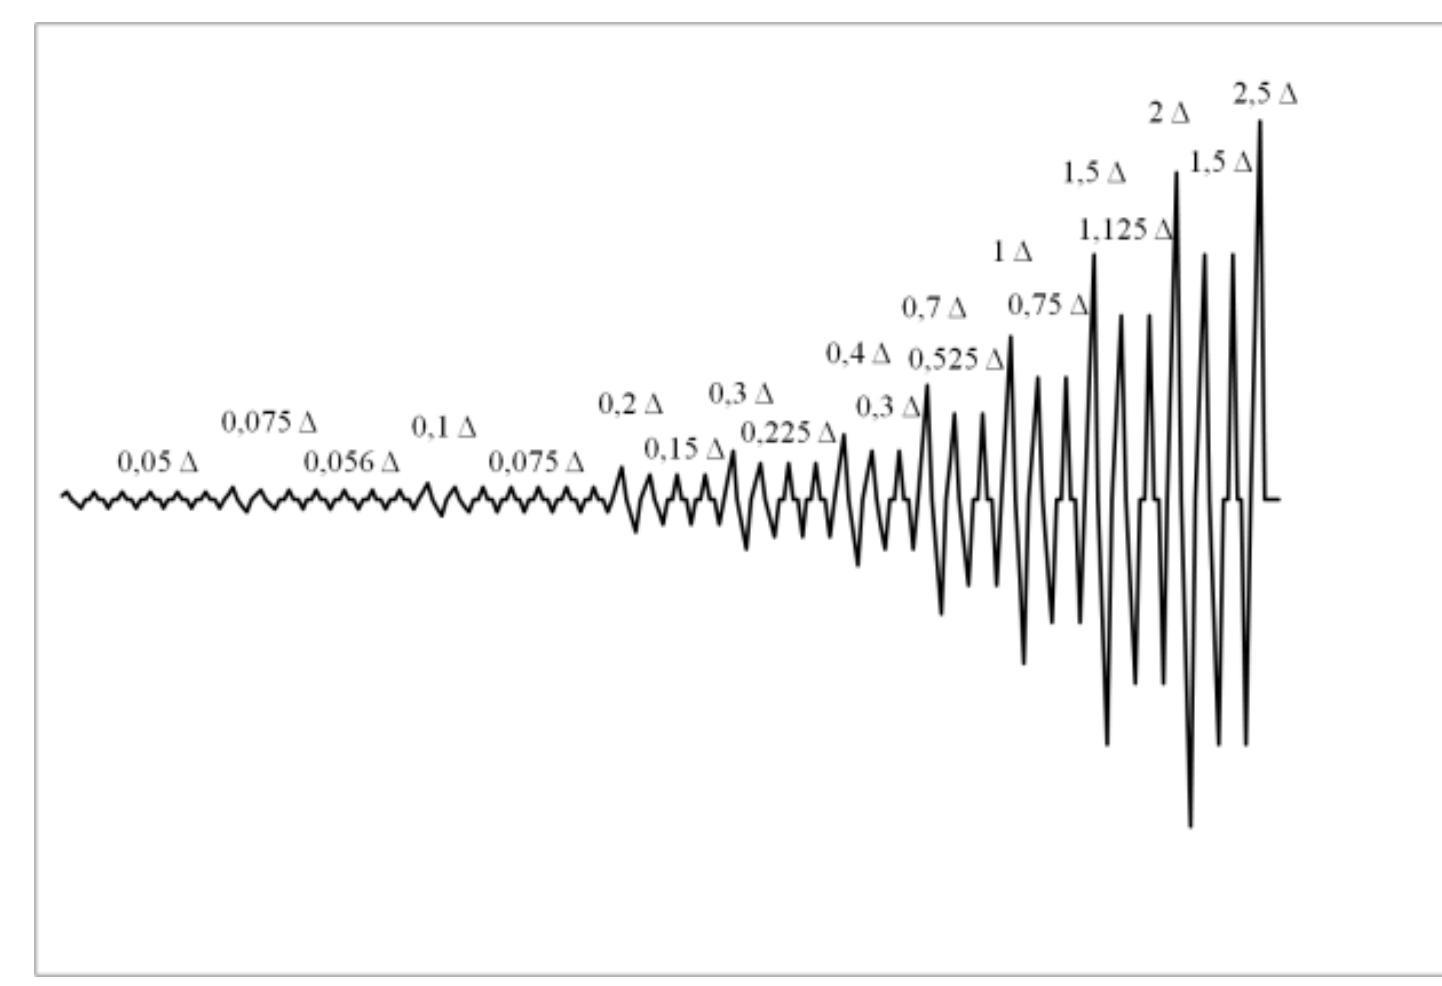
Experimental study on TFM mechanical behaviour – Tokyo Tech

Loading protocol – CUREE – Caltech standard protocol

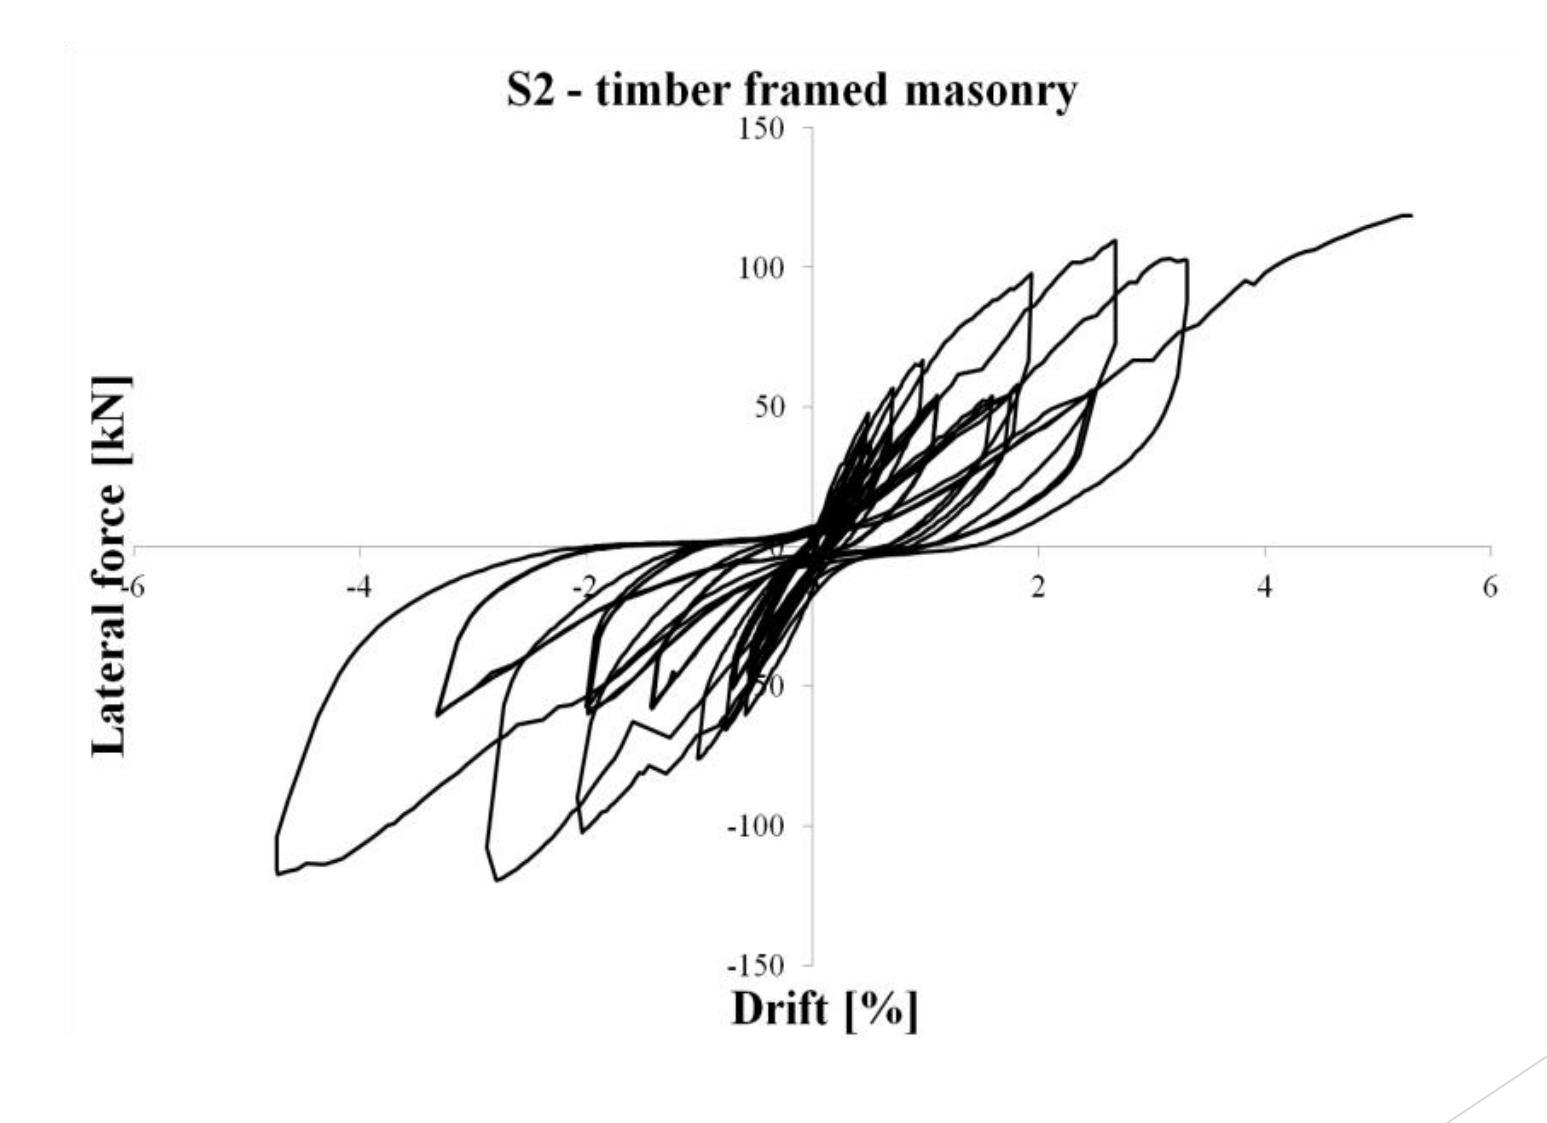
Hysteresis of the TFM wall (S2 specimen)

- TFM is very ductile! The masonry ensures strength and stiffness, while timber is responsible for the significant deformation capacity;
- ▶ The key points are the weak mortar and the embedment of the timber;
- Numerical modeling with FINAL software was successful, but it needs to be simplified.
- Considering the fact that for some countries the TFM are important heritage... we must protect them even from experiencing those light to moderate damages. So we further focused on a strengthening method using AFRP sheets.

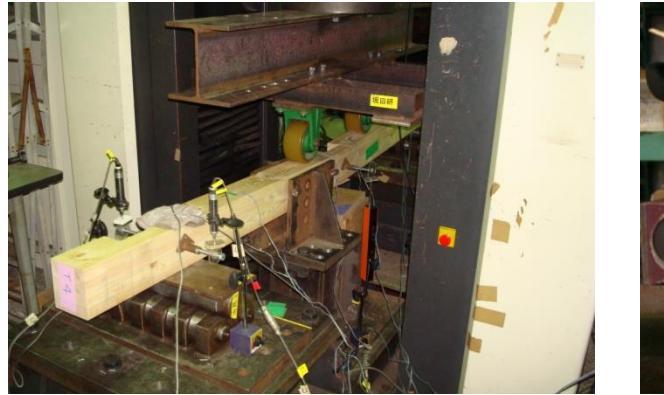
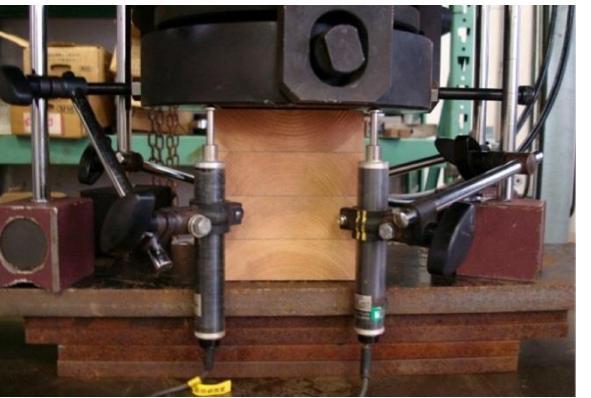
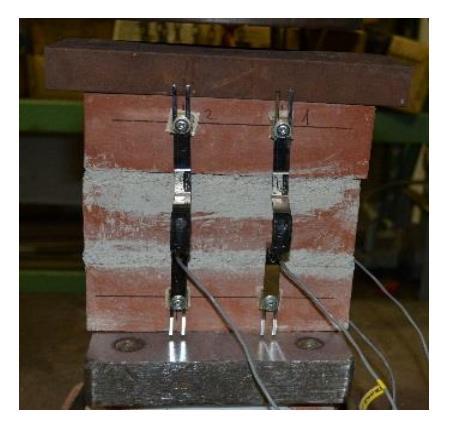
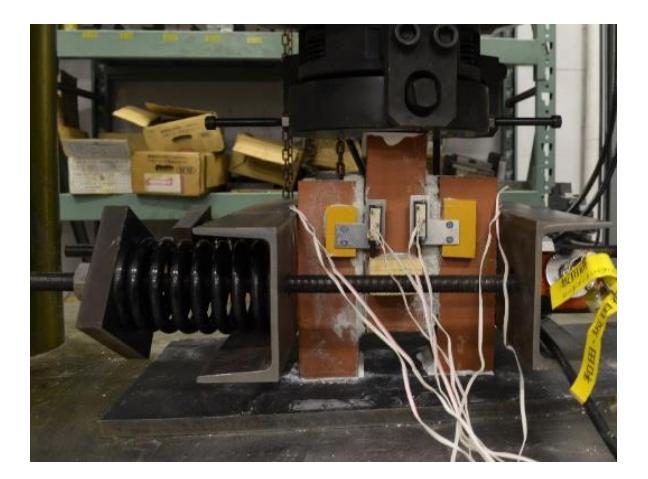
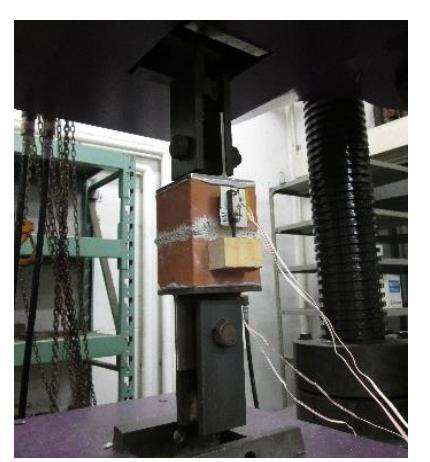
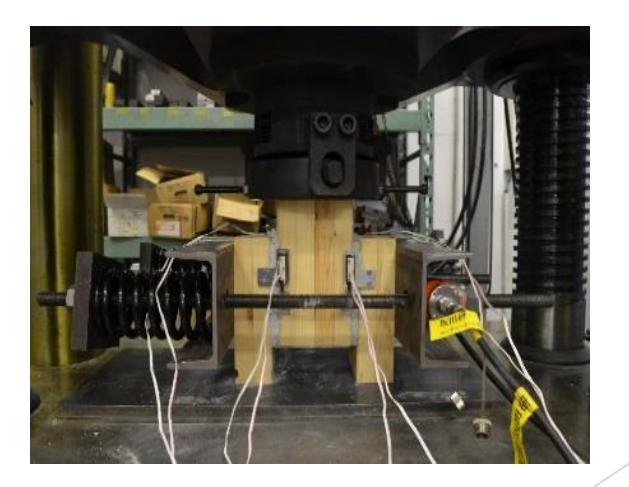
Component materials tests

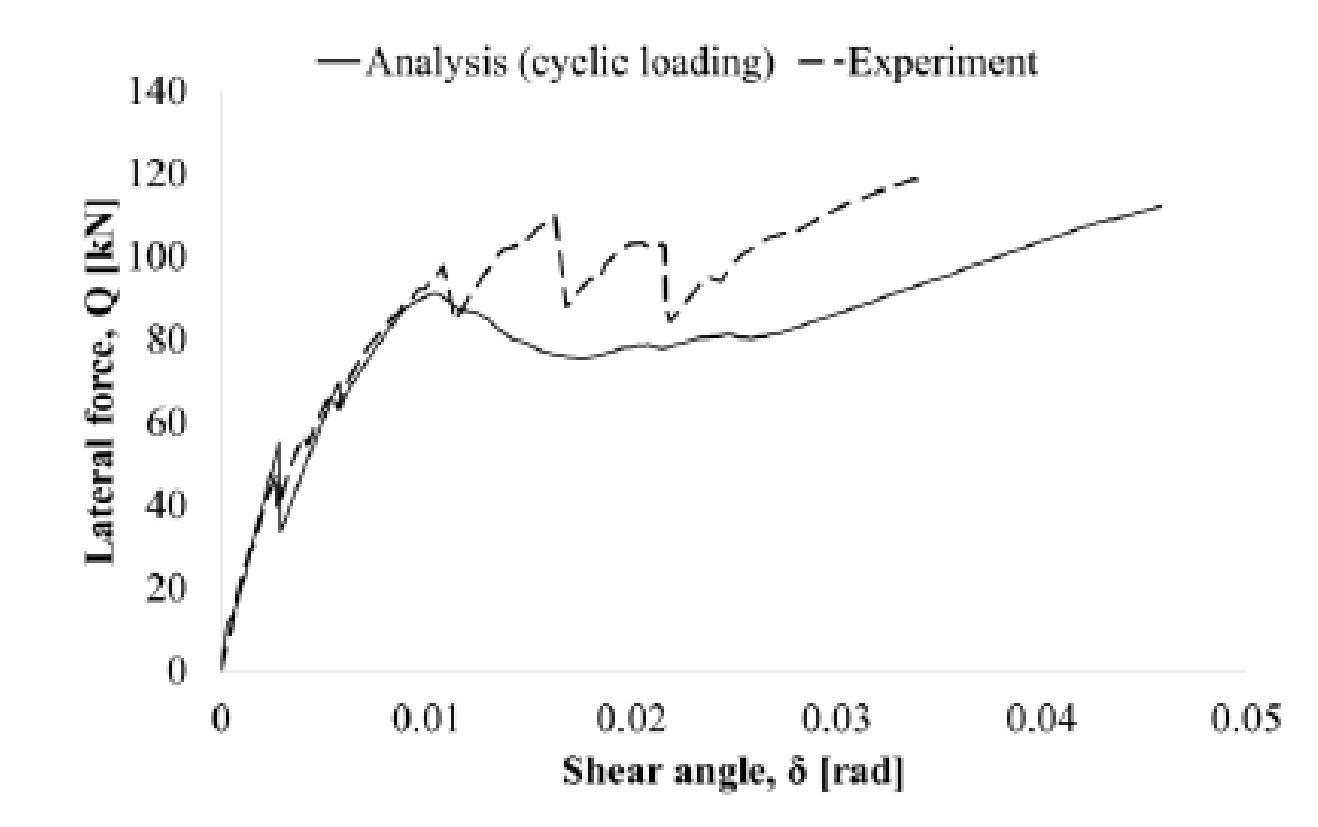
Experimental study vs. FEM analysis
