# Damage due to Earthquakes and Improvement of Seismic Performance of Reinforced Concrete Buildings in Japan

Prof. Maeda Masaki  
Tohoku University

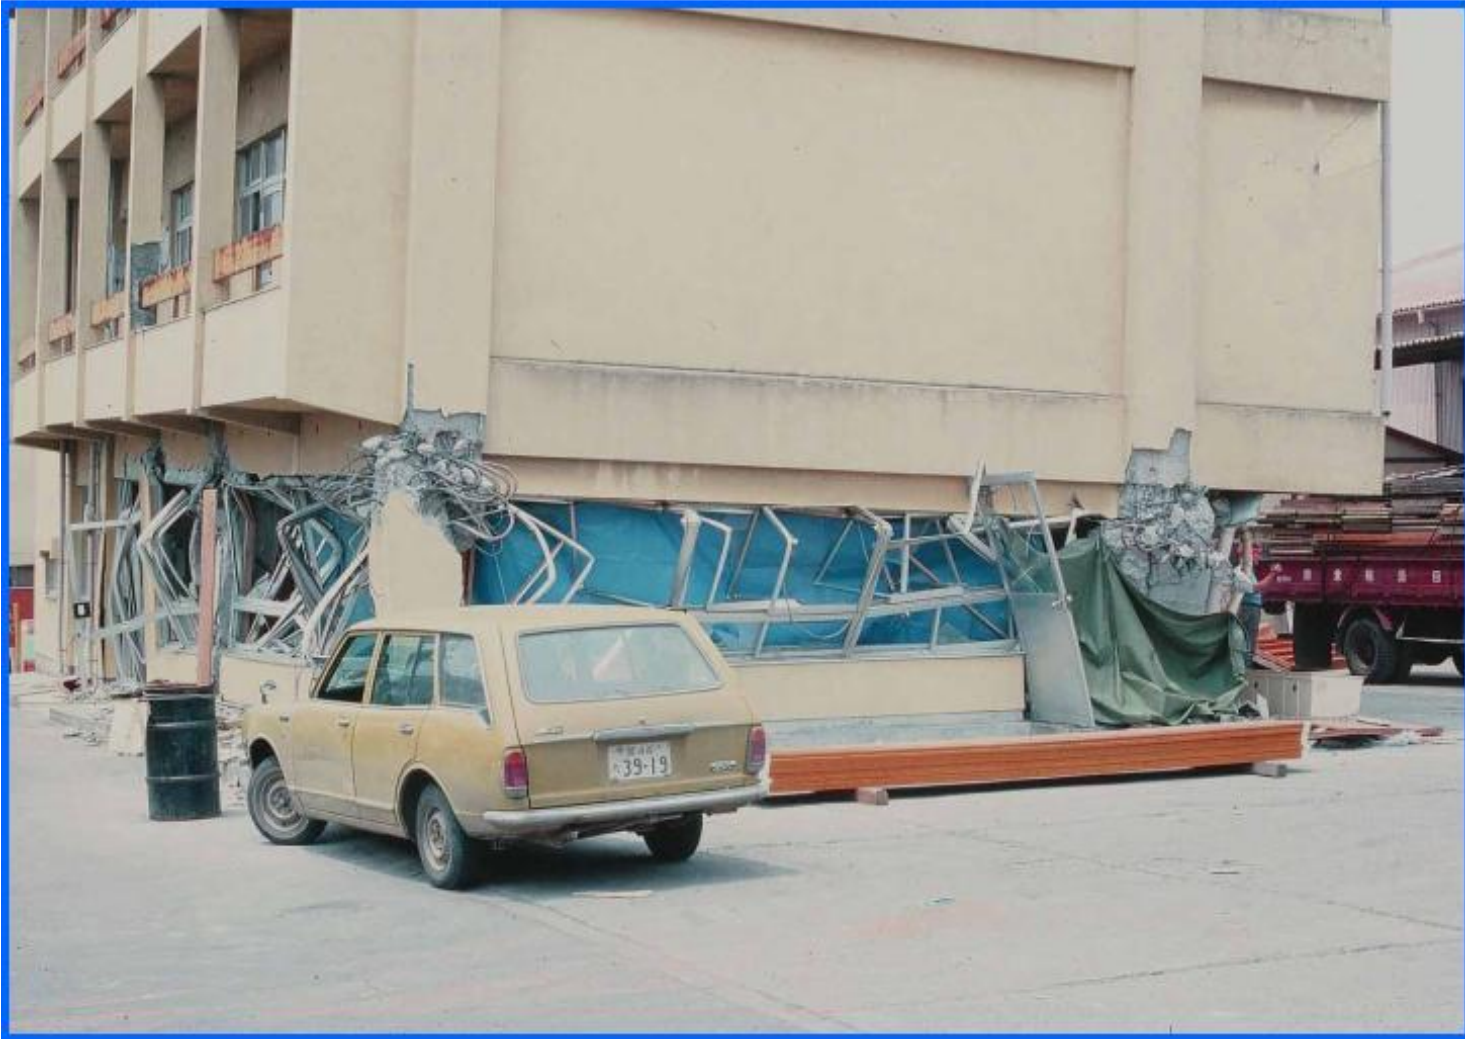
# Collapse of RC Building with soft (1978 Miyagike-oki EQ)

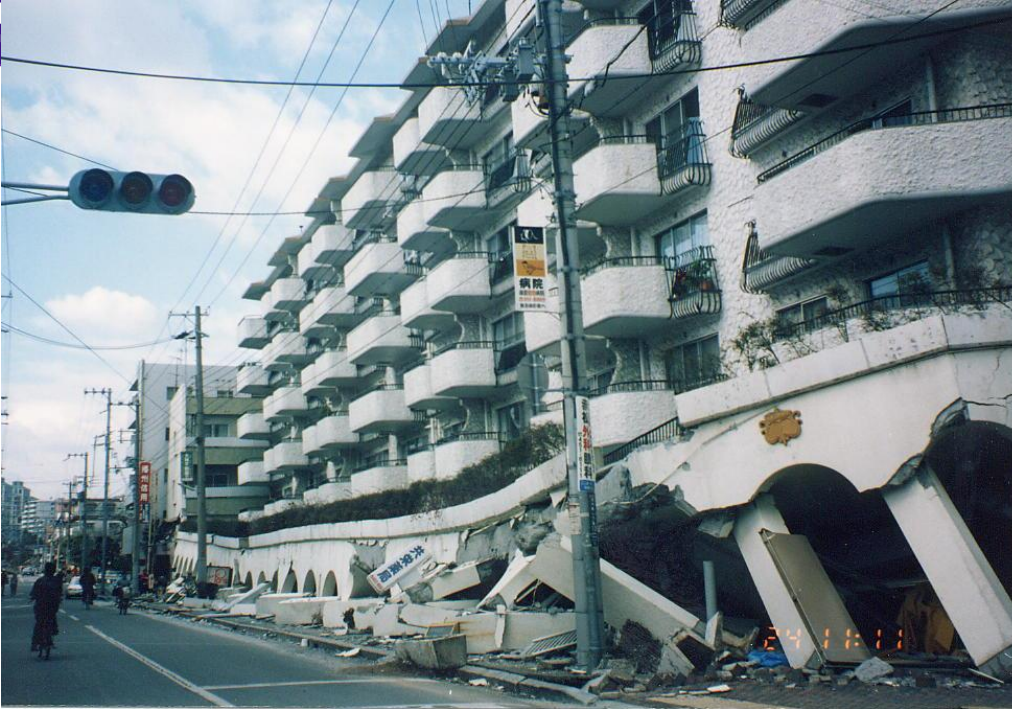
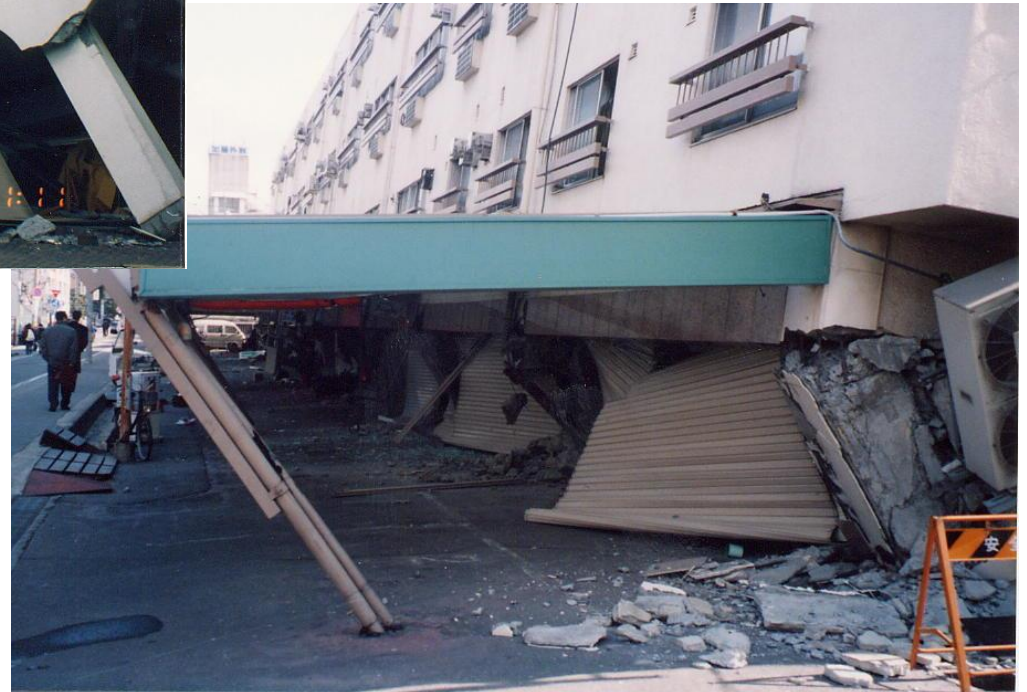
# Collapse of RC Building with soft first story

(1995 Kobe EQ)

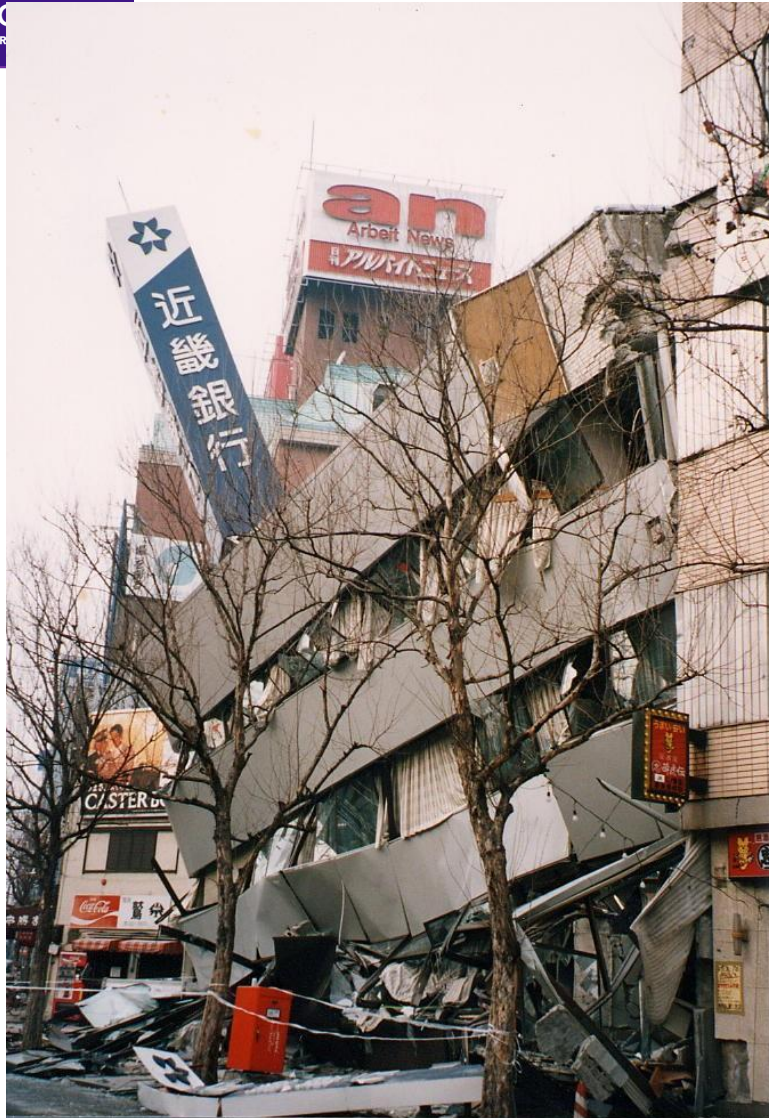
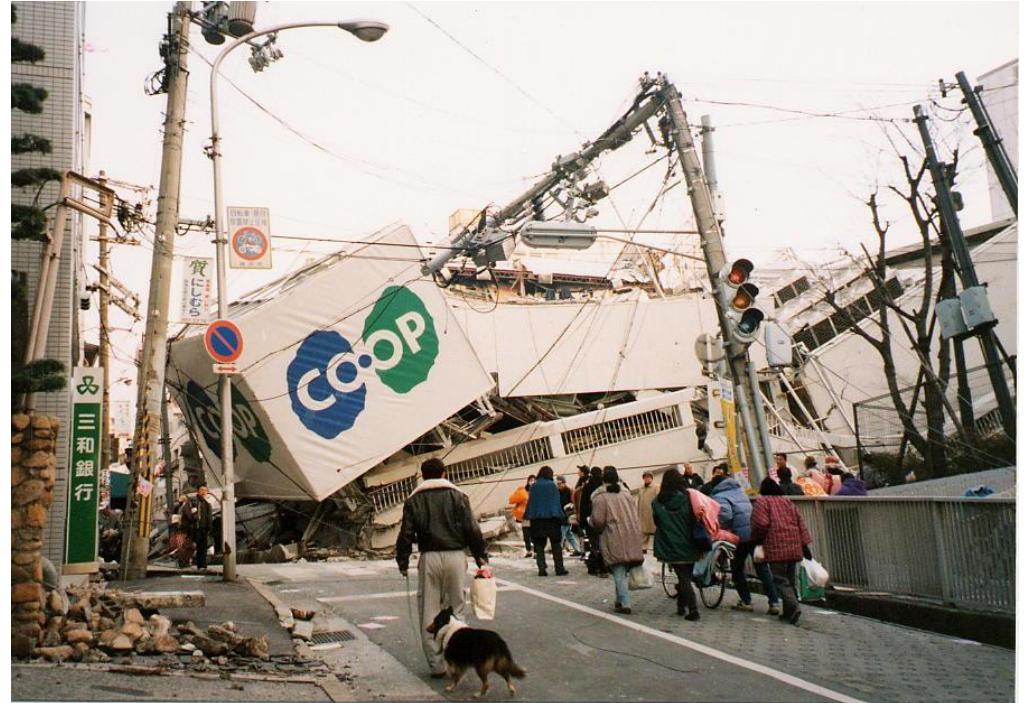
# Total collapse of RC Buildings

Total collapse  
(1995 Kobe EQ)

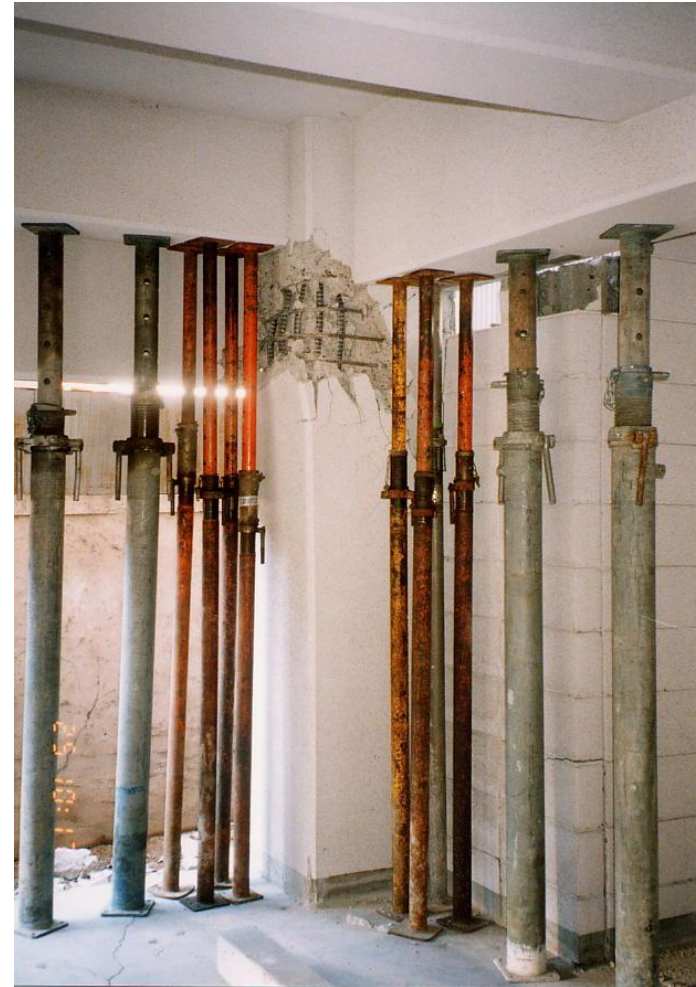
Hoop spacing is 10cm (Post-1971)

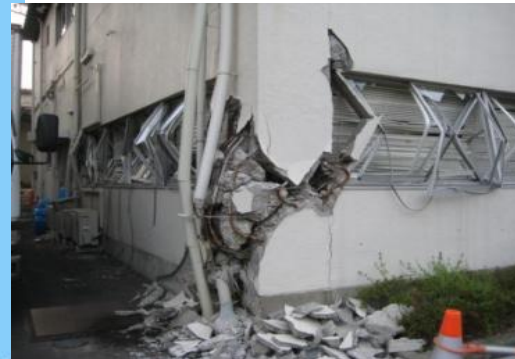
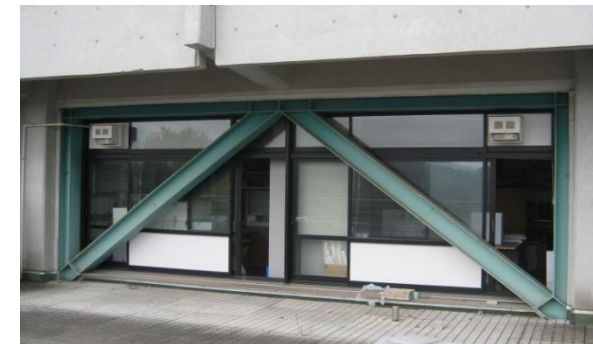
Some old RC building  
was Damaged

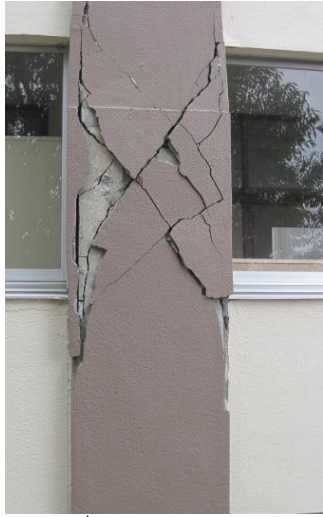
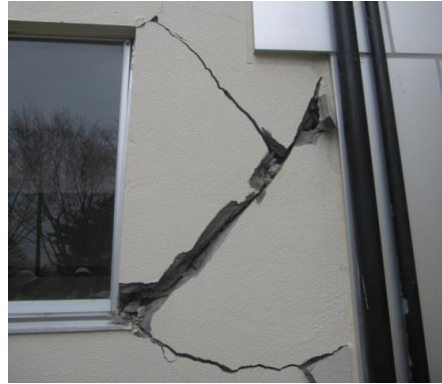
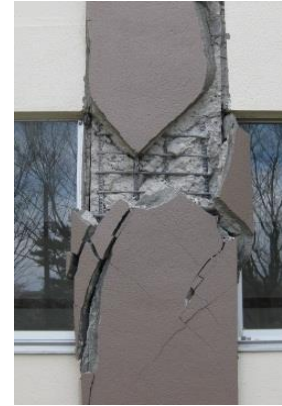
Building (B) 1<sup>st</sup> floor

# Damage distribution in west building

- ◆ Damage was concentrated to short columns in North side corridor.
- ◆  $I_s = \text{strength index} \times \text{ductility} = C \times F = 0.5 \times 1.75 = 0.875$  by ignoring brittle short column.
- ◆ The damage pattern agree with seismic evaluation results.

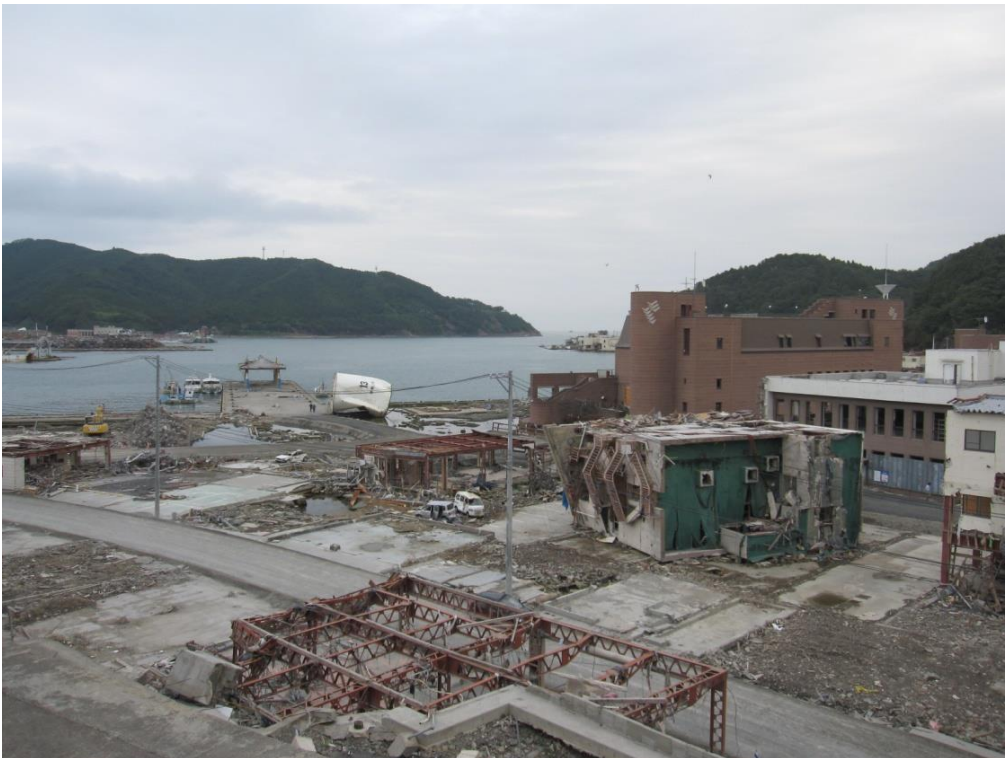
## Onagawa town

# Damage by tsunami

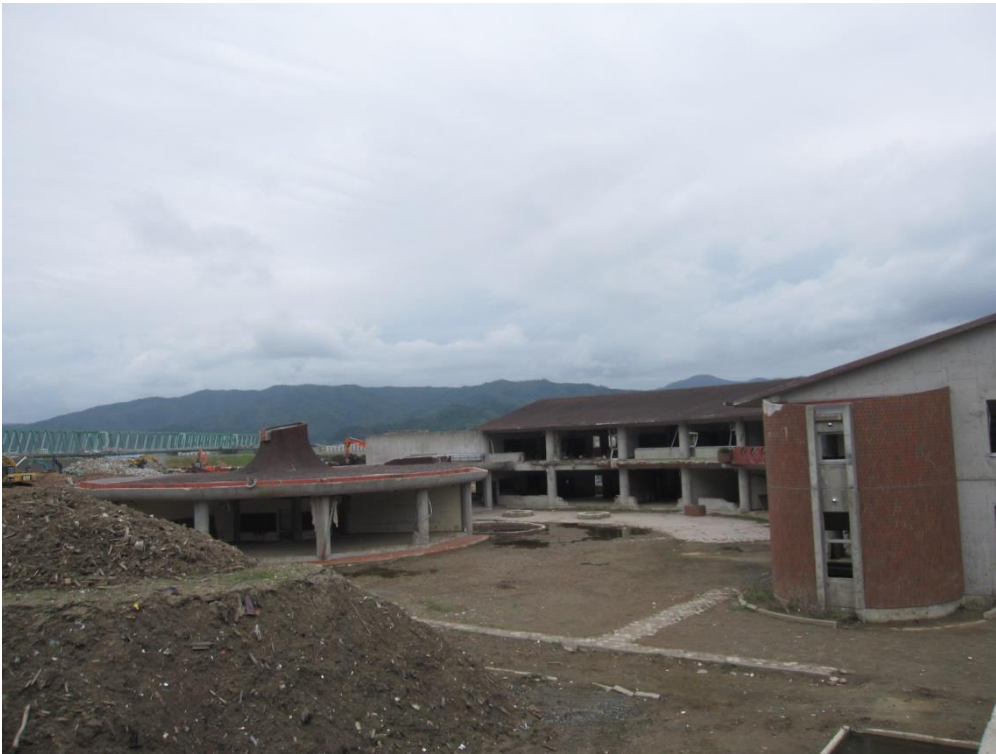
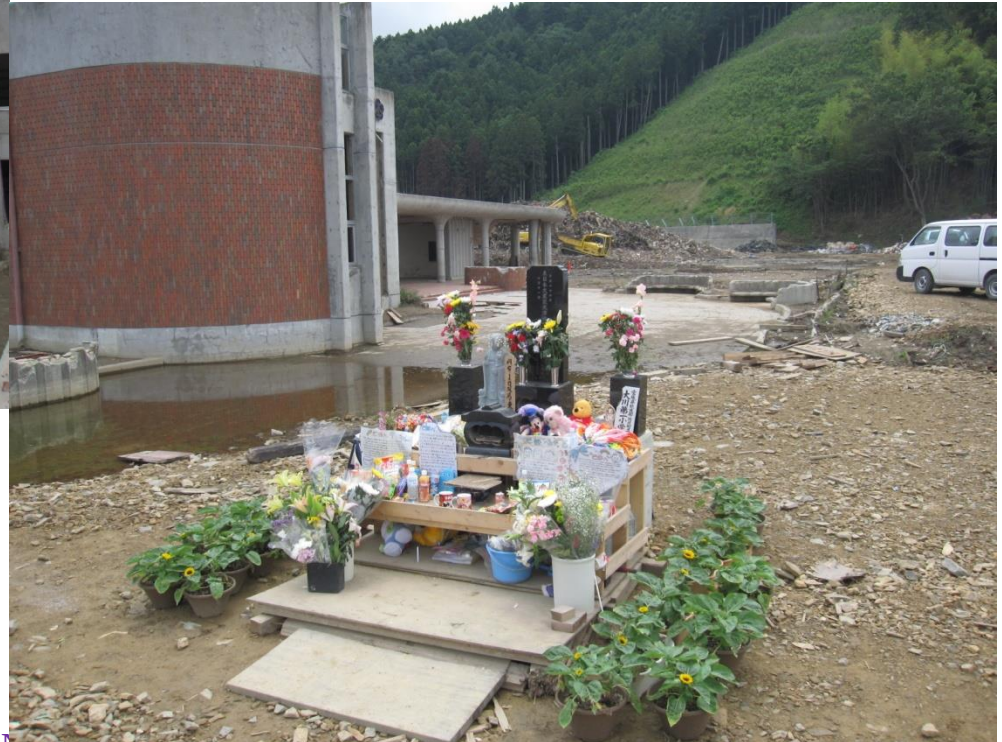
# Damage by tsunami

Most of students and teachers were killed by tsunami.

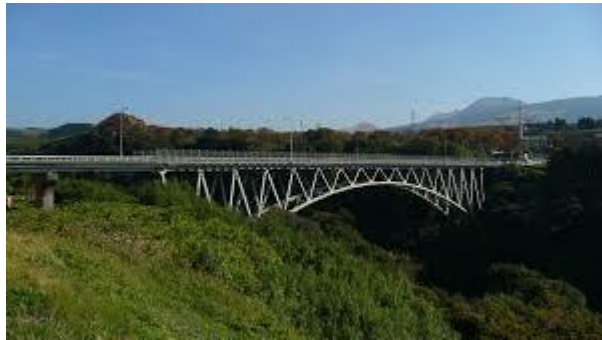
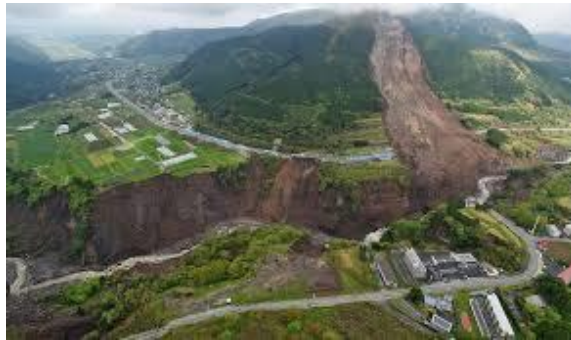
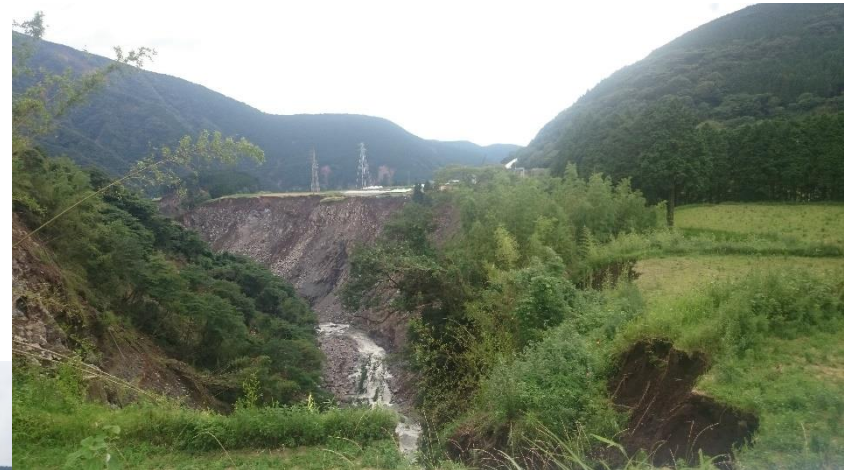
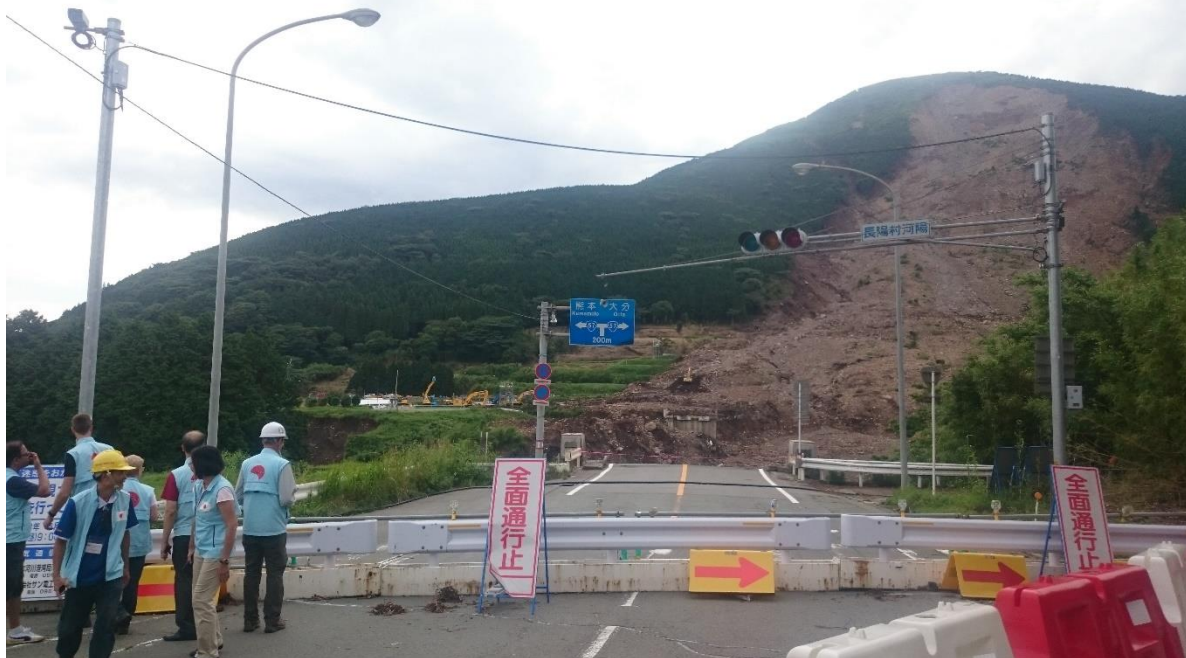
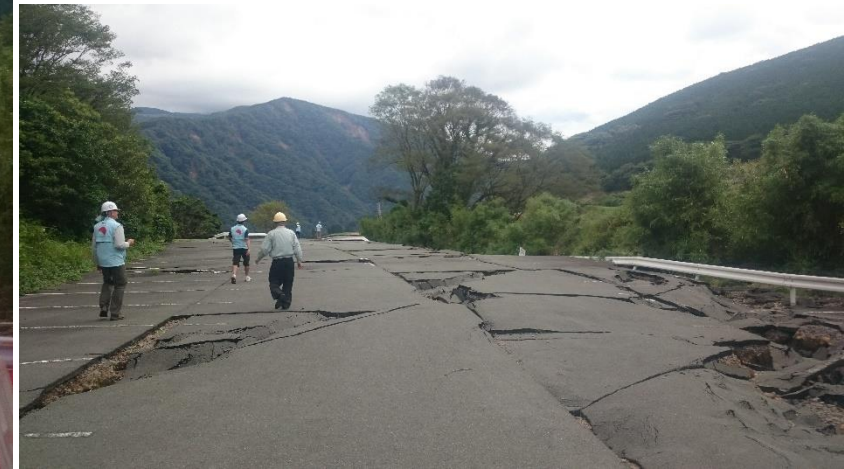
# Damage in Minami Aso village

## ◆ Land slides around Aso Mt.

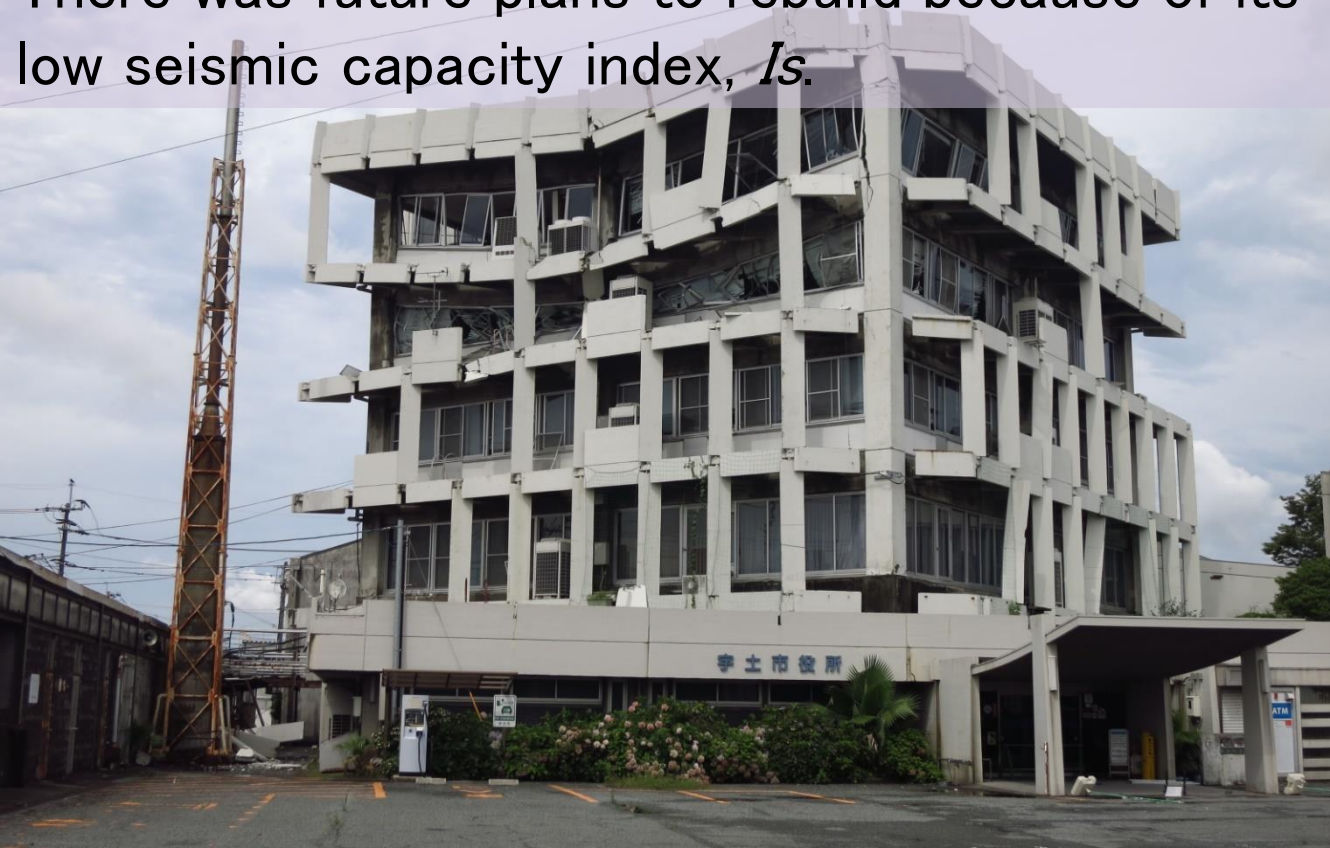
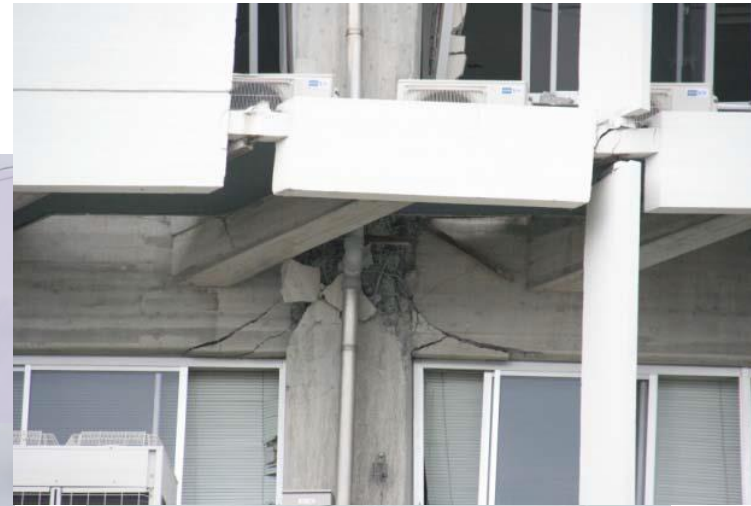
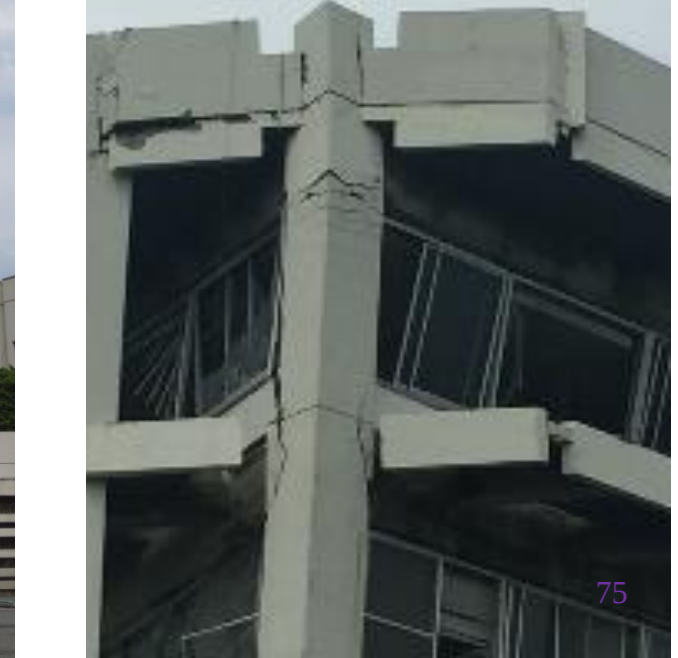
## ◆ City hall (5-story, RC)

Story collapse occurred at the 4<sup>th</sup> story  
There was future plans to rebuild because of its  
low seismic capacity index,  $I_s$ .

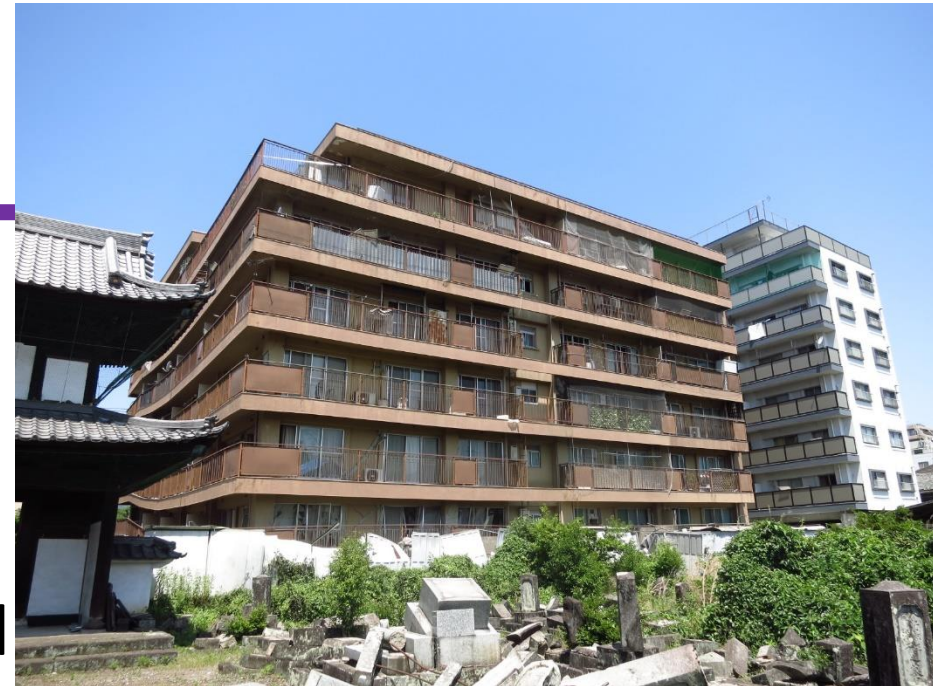
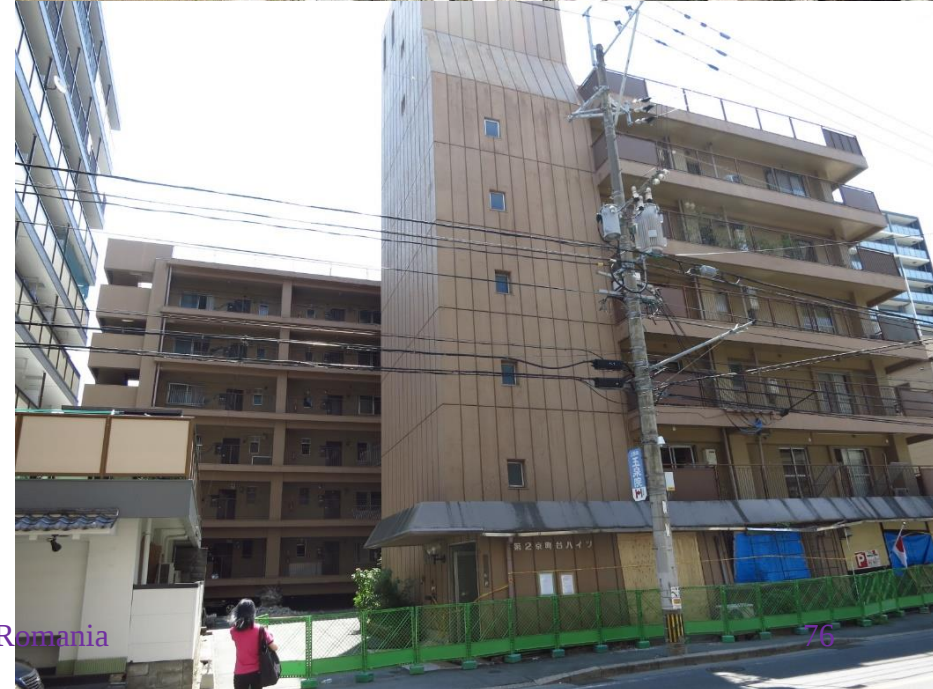
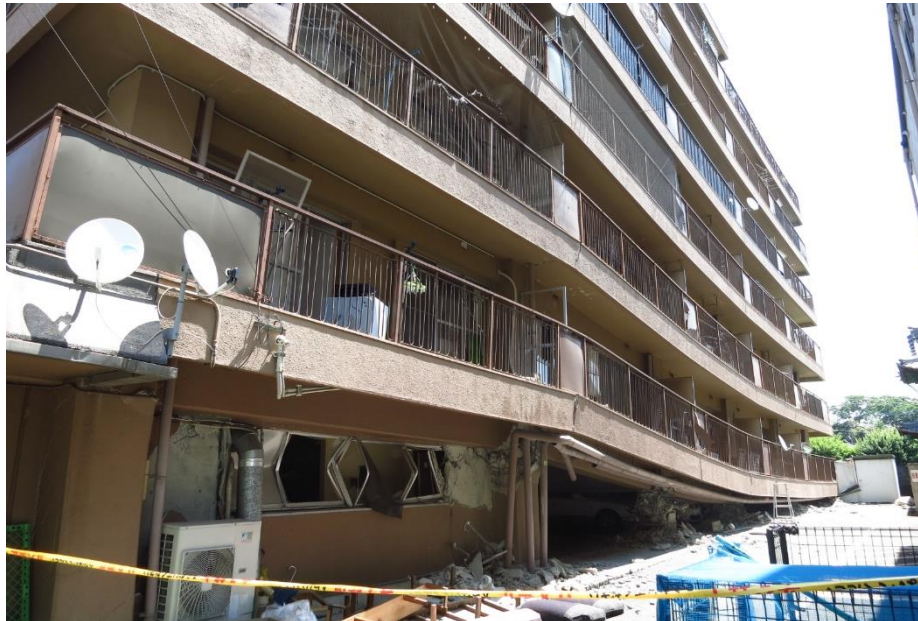
## ◆ Apartment K

- 7-story, RC, designed by old seismic code, without retrofitting
- L shape plan, core wall for EV and staircase located on one side.
