Seismic Isolation Buildings in Japan

Building Research Institute, Japan

Matsutaro SEKI

Damage of Seismic Isolation Buildings Building Research Institute, Japan International Institute of Seismology and Earthquake Engineering (IISEE)

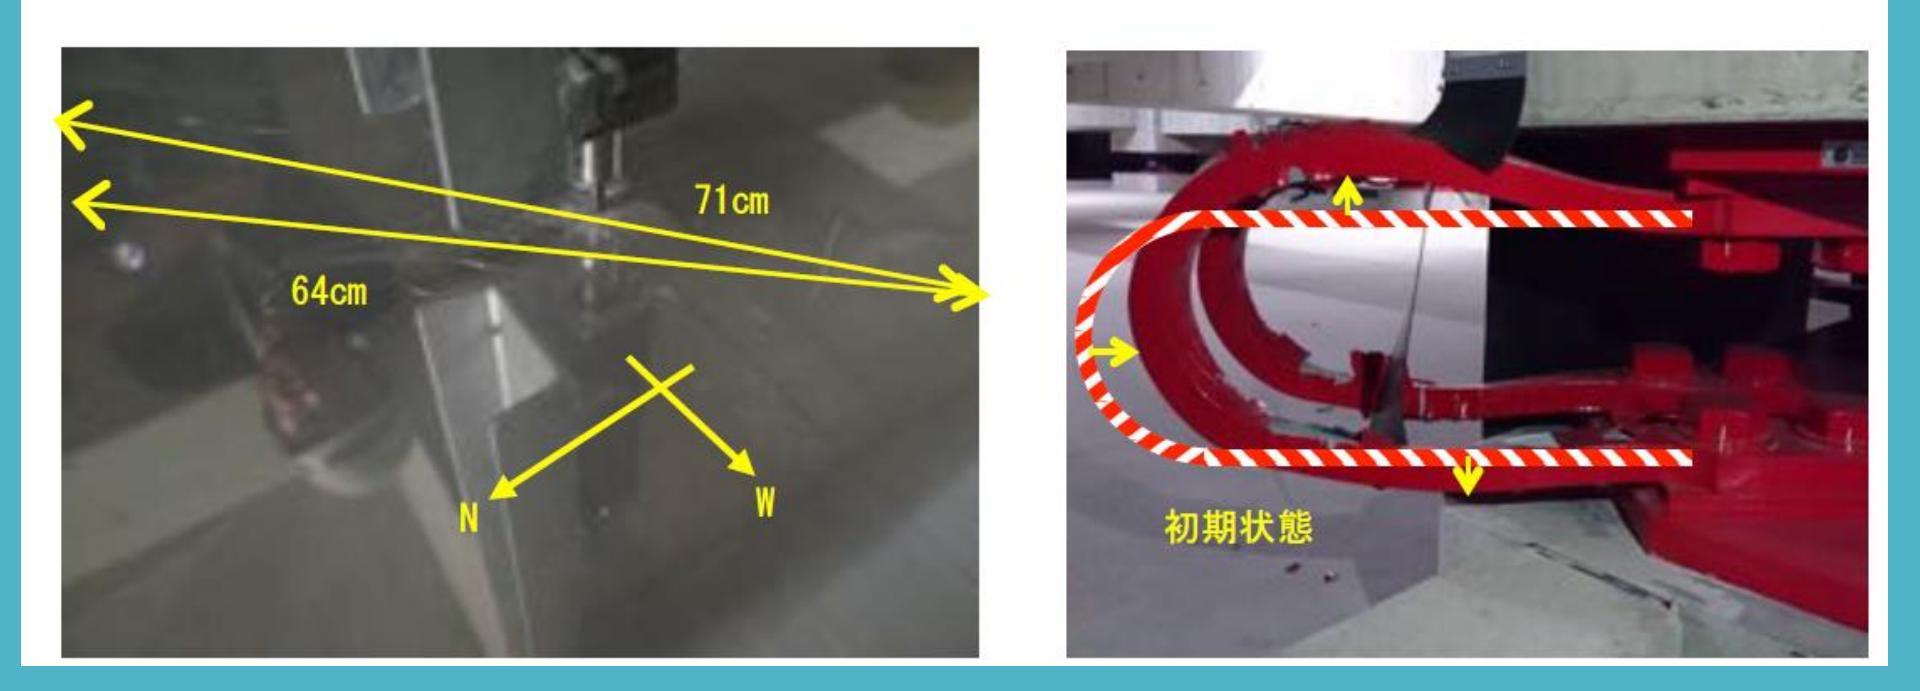
B building: monitoring by scriber, deformed steel damper

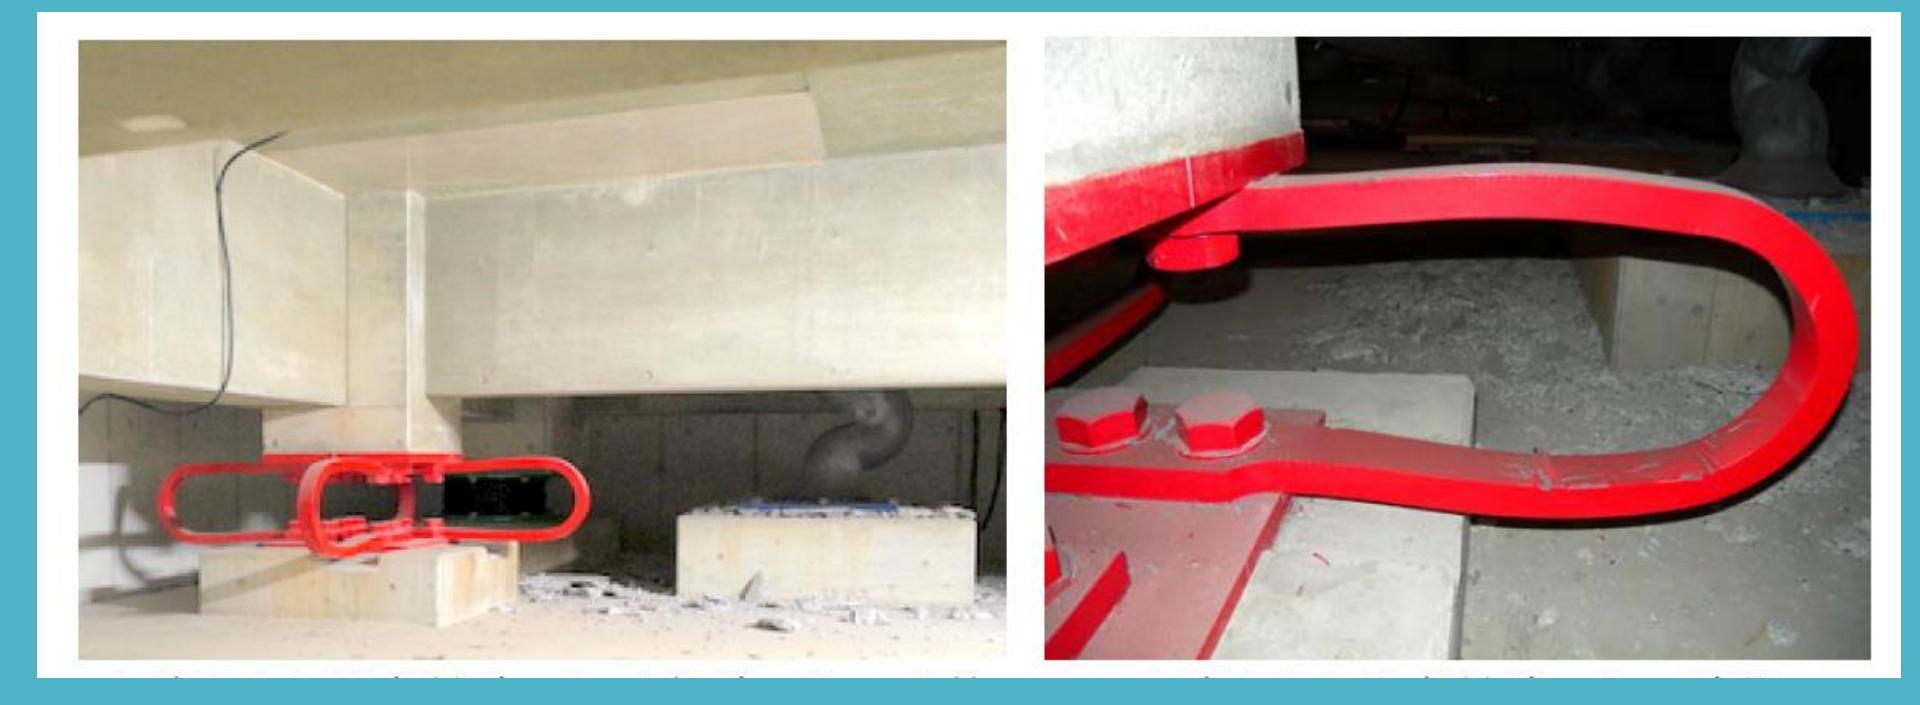
C building: Deformed steel damper

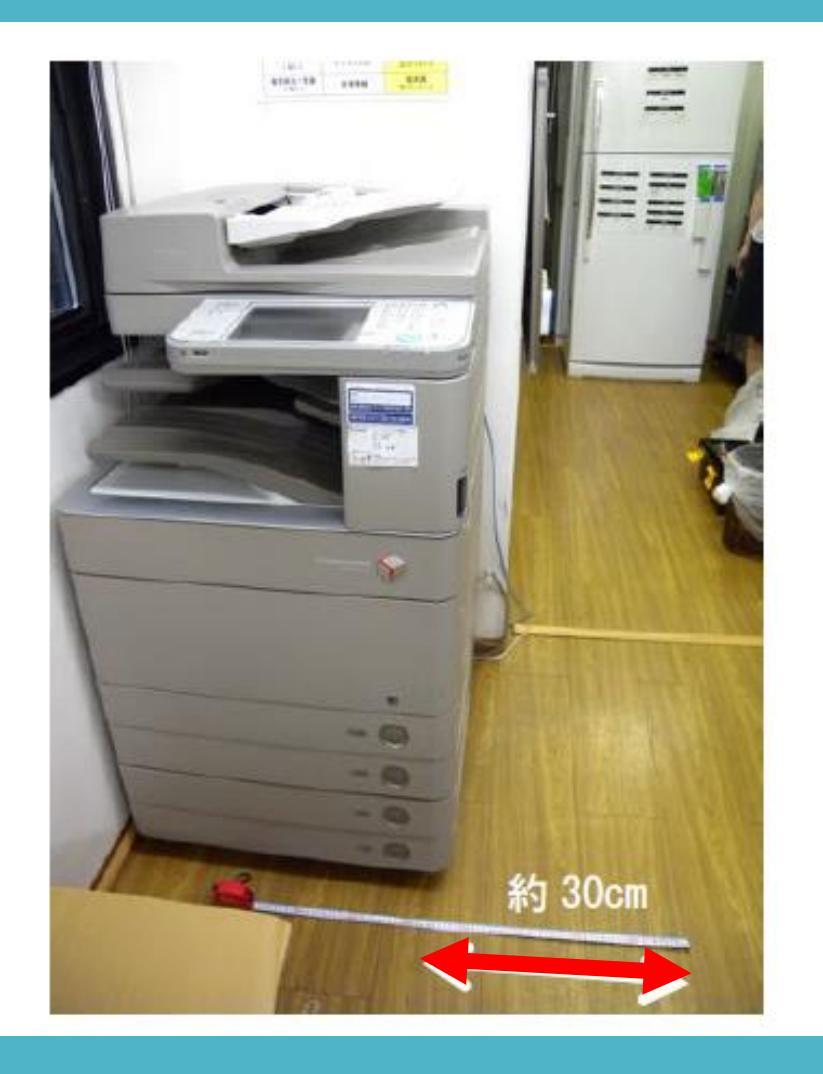
G building: Movement of copy machine, overturning of petition wall

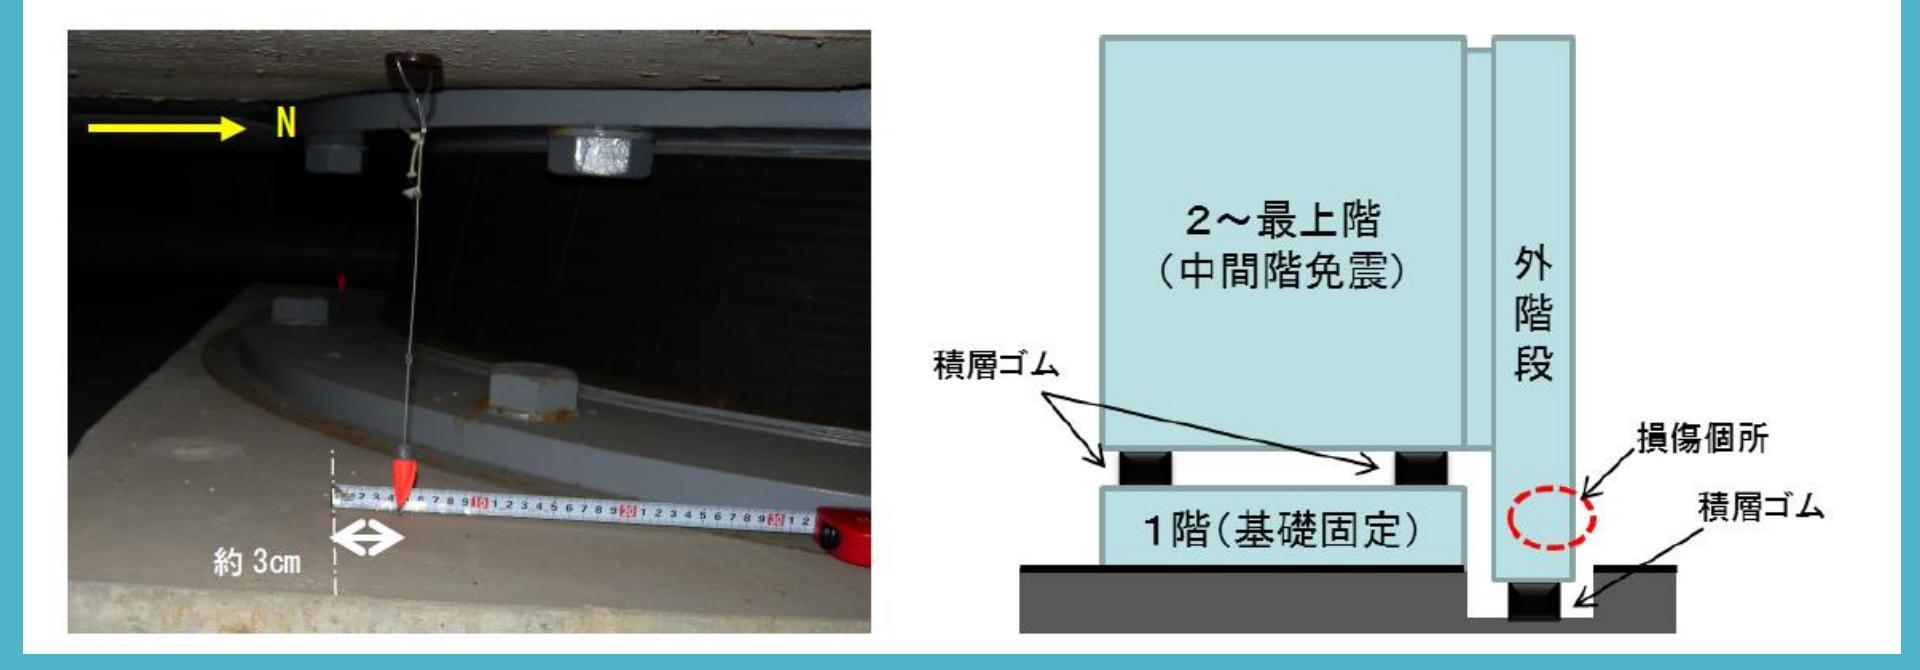
G building: Monitoring by scriber, Section of the building
